Lightning Caused Multiple Deaths: Lethality of Taking Shelter in Unprotected Buildings

Abstract— Lightning affects human beings and animals through several mechanisms of which direct strikes are referred as the most lethal. However, our investigations show that a clear majority of multiple lightning deaths by a single ground flash have been occurred while the victims were inside structures, where injury due to direct strikes is impossible. This study analyses the electric field distribution of a lightning struck unprotected building, during the return stroke current phase. The outcomes depict that the field enhancement at the head level of the occupants at various locations inside the structure is large enough to attract arcing either from the roof or the walls. The field enhancement strongly depends on the type of lightning current and the materials of the roofing and walls. For the simulation of lightning current waveforms and distribution of electrical fields and potentials, MatLab and ANSYS Maxwell software have been used. Consequently, the paper emphasizes the need for implementing low-cost protection schemes in under-privileged societies in regions of high lightning density

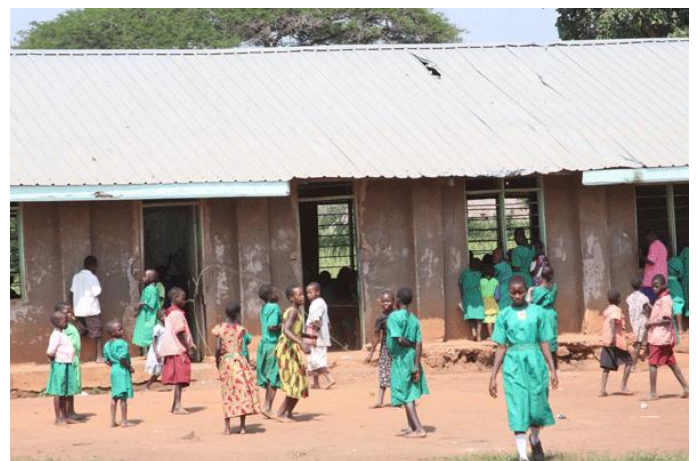
Figure 1. The building that has been lightning affected at Runyanya Primary School in Uganda, one year after the incident. The structure is made of brick with cement or clay plaster and the roof is made of iron sheets. (Photograph with the courtesy of Mr. Hudson Apunyo)

- In June 2011, lightning has struck a junior school in Runyanya Primary School in the Masindi area in western Uganda, killing 18 children and their teacher. Later reports (unconfirmed) state that the teacher has not succumb to his injuries. There were 52 students injured in the event. The building was made of iron roof on brick walls. Figure 1 (Photograph with the courtesy of Mr. Hudson Apunyo) shows the affected school one year after the incident.
- Eight construction workers were killed and six were injured in Mpumalanga, South Africa on the 20th of November 2013, when lightning struck the tent that they were sleeping at night. The tent, which is a temporary structure which had a tin-roof and wooden supports.
