NRC7292 SW PKG

Release Note

(v1.5)

Ultra-low power & Long-range Wi-Fi

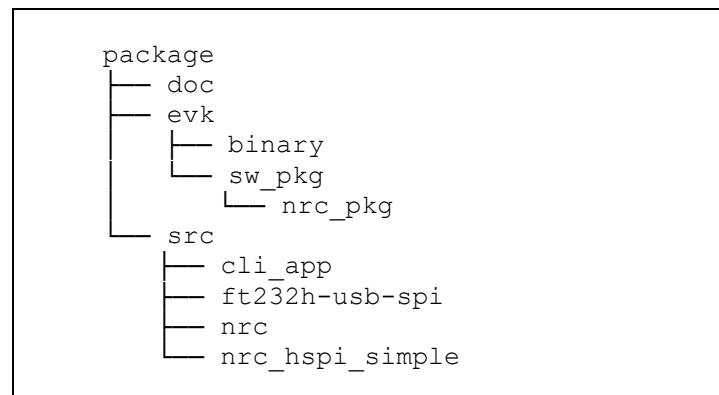
The software release package encompasses all the necessary components for utilizing the most recent features, including firmware libraries, header files, APIs, sample codes, downloader tool, makefile, and documentation. Figure 2.1 illustrates the directory structure of the package, while Table 2.1 presents a summary of its contents.

Figure 2.1 NRC7292 software release package directory
