**TMS320F28069, TMS320F28068,
TMS320F28067, TMS320F28066,
TMS320F28065, TMS320F28064,
TMS320F28063, TMS320F28062 Piccolo MCUs**

Silicon Errata

Literature Number: SPRZ342K
January 2011–Revised June 2016

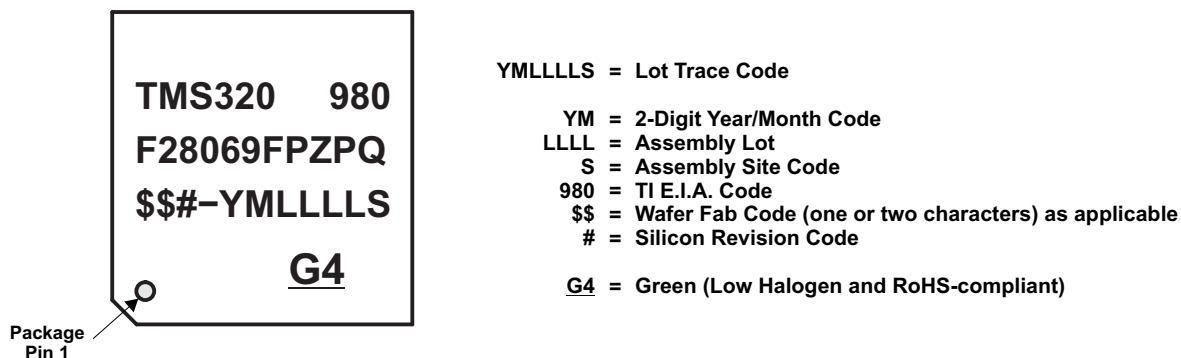
Figure 1. Example of Device Markings

Figure 1 provides an example of the 2806x device markings and defines each of the markings. The device revision can be determined by the symbols marked on the top of the package as shown in Figure 1. Some prototype devices may have markings different from those illustrated. Figure 2 shows an example of the device nomenclature.

Changes from November 10, 2015 to June 3, 2016 (from J Revision (November 2015) to K Revision)		Page
• Figure 1 (Example of Device Markings): Updated figure.....		5
• Section 4.2 (Known Design Exceptions to Functional Specifications): Updated Details of VCU: Overflow Flags Not Set Properly advisory: Changed reference document to <i>TMS320x2806x Technical Reference Manual</i>		27

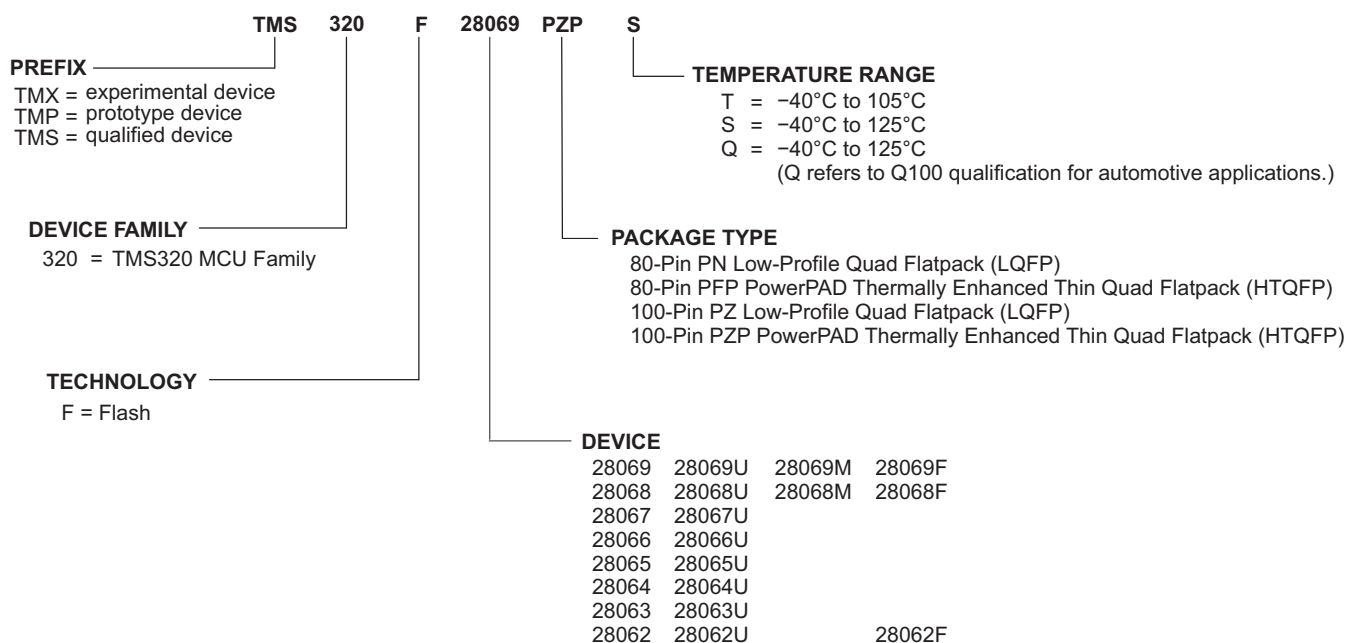
Figure 2. Example of Device Nomenclature

A For more information on peripheral, temperature, and package availability for a specific device, see the [TMS320F2806x Piccolo™ Microcontrollers Data Manual](#).
