PRIMARY USE: Used for analysis of existing stream bank conditions related to a particular stream to predict the appropriate restoration method.

STREAMBANK EROSION SITE ASSESSMENT

What is it? A process to assess the extent of erosion of a streambank and determine the applicability of streambed restoration methods.

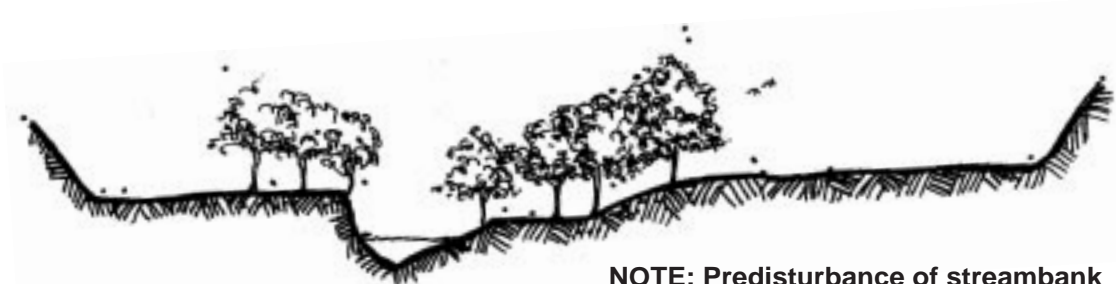
Native Stream Conditions Section View

NOTE: Predisturbance of streambank before streambank erosion site assessment.

Site analysis should include soil, vegetation, and topography. Drainage routes and patterns should be carefully noted. Note extent and type of erosion: none, raindrop, sheet, gully, or channel. Sandy or silty soils have a high potential for erosion. Soil with high gravel content or a mixture including some organic matter will be less susceptible to erosion. Vegetation decreases the erodibility of the soil by increasing infiltration and decreasing water velocity. When assessing the topography, bank slope should be noted. Banks with a slope of less than 7 % over a maximum length of 300 feet (90 m) are low risk while banks having a 7-15 % slope over 150 feet (45 m) are at moderate risk. Banks with greater than a 15 % slope over 75 feet (23 m) are at high risk. As erosion progresses from raindrop to channel erosion, the stability of the bank decreases.
