MaxAir Technical – Using the Rock Pi E Board

The Rock Pi E is based on the Rockchip RK3328 SoC (system on a chip), it can be purchased in a number of configurations.

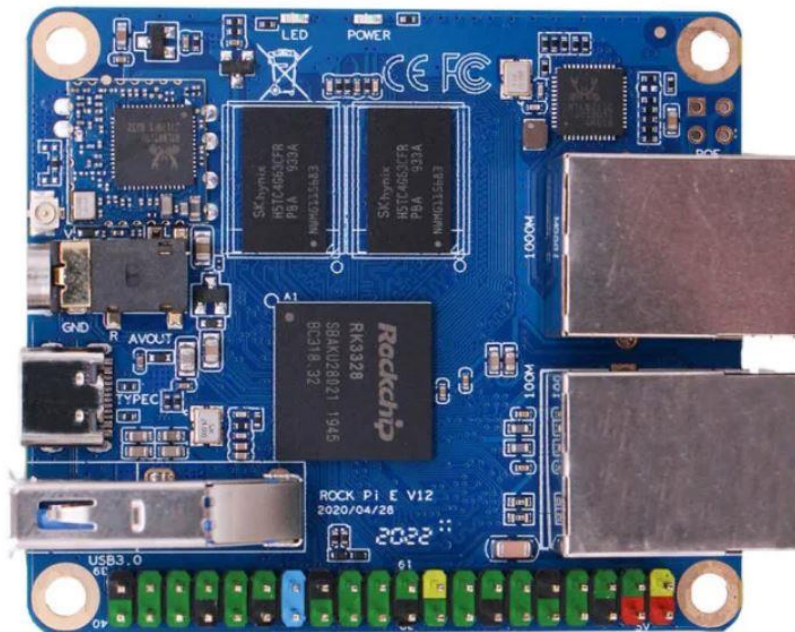
A significant plus for this board is that it can be equipped with an eMMC memory module using sockets on the reverse side of the board.
