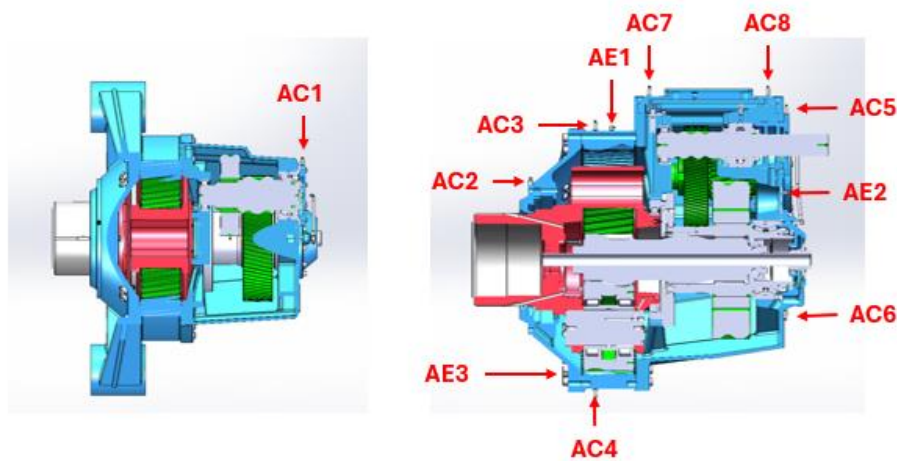
Sensor Number	Location
AC1	ISS Radial
AC2	Main Shaft Radial
AC3	Ring Gear 12 o'clock
AC4	Ring Gear 6 o'clock
AC5	HSS Radial
AC6	LSS Radial
AC7	Upwind HSS Bearing Radial
AC8	Downwind HSS Bearing Radial
AE1	Ring Gear
AE2	Rear Housing
AE3	Front Housing

Figure 26. A diagram showing the sensor placement within the turbine gearbox.

Eight accelerometers have been positioned as close as possible to each bearing. Each accelerometer must be mounted in a location that minimises the vibration transmission route and avoids thin sections (Wilcoxon 2018). This has been applied wherever possible but due to limited access within the housing, there is not always a direct route to the monitored object. It can also be noted that all accelerometers will be stud mounted on clean, unpainted surfaces, to ensure optimal results (Hannah\_G 2023). However, the accelerometers labelled AN7 and AN8 are mounted on a bolted cover, which is not ideal for accurate vibration measurement. Mounting accelerometers on such surfaces can lead to signal attenuation and distortion, as the cover may absorb or dampen vibrations, resulting in inaccurate readings.
