**GigaDevice Semiconductor Inc.**

**Device limitations of GD32F47x/F42x**

**Errata Sheet**

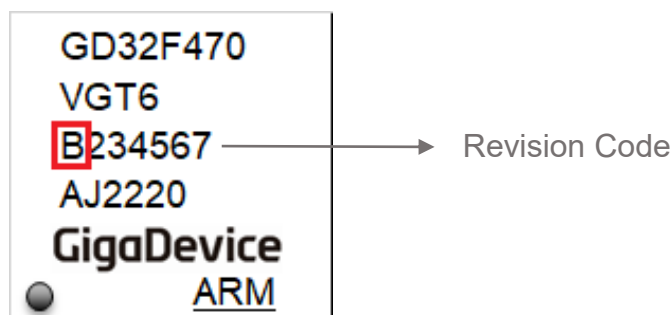
**Figure 1-1. Device revision code of GD32F47x/F42x**

The device revision can be determined by the mark on the top of the package. The 1st code on the line 3 of the mark represents product revision code. As the picture shown in [Figure 1-1. Device revision code of GD32F47x/F42x](#).
