HAZARDOUS MATERIALS ASSESSMENT REPORT

Job details: Owner: Mr. A. & Mrs. A McEvoy
Location: 28 Alt Street, Queens Park. NSW.

Plans for Job No: 7777/16 Revision No: E Dated: 08-09-2016

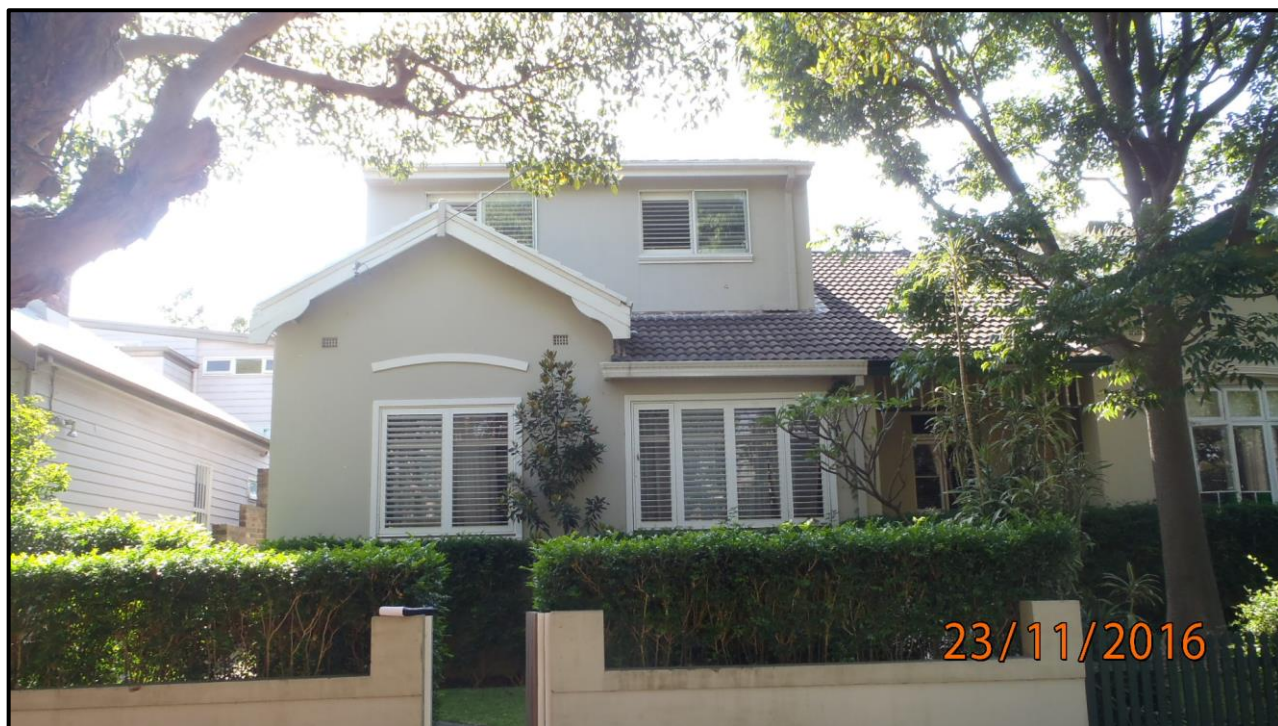
Front western elevation of the residence

Estimated age:	Circa 1910 to 1920 for the original residence with the two-storey addition constructed at an unknown time.
Type of construction:	Semi-detached double storey full brick / brick cavity construction on sandstone block footings supporting a suspended hardwood timber flooring system.
External cladding:	Surface coated clay masonry brickwork with probable asbestos cement [ACM] sheet to the first-floor addition.
Roof:	Common hipped and valley, gable ended roof structure with concrete roofing tiles.
