HAZARDOUS MATERIALS ASSESSMENT REPORT

Job details: Owner: Mr. D. and Dr. F Hudson.
Location: 186 Malabar Road, SOUTH COOGEE.

Our reference: HM05050716

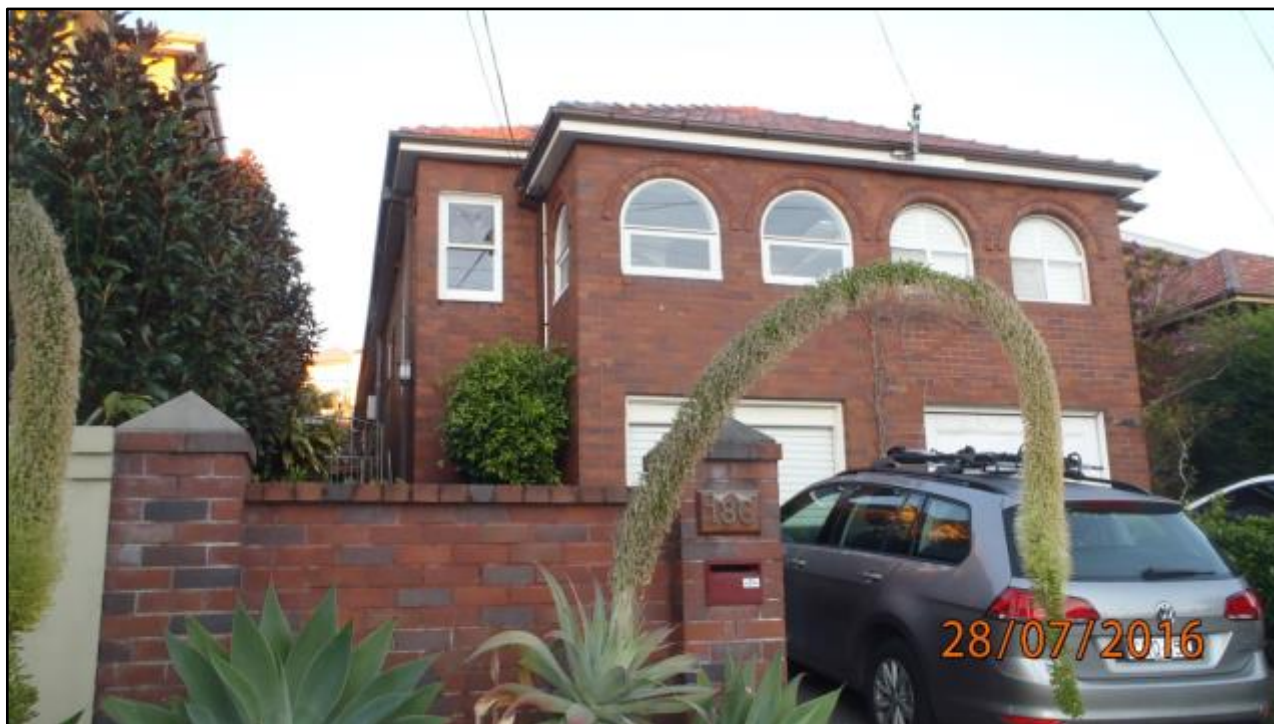
Front north eastern elevation of the residence

Estimated age:	Circa 1920 – 1930 for original residence with the rear extension constructed circa 1995.
Type of construction:	Double storey (garage under) full brick / brick cavity construction built on brick piers and footings supporting a suspended timber floor system to the original residence. The rear extension is of brick veneer construction, built on brick footings supporting a suspended timber floor system.
External cladding:	Clay masonry brickwork
Roof:	Common hipped and valley roof structure with terracotta roofing tiles to the original residence. Skillion roof with corrugated profile sheet metal roofing to the rear extension.
