HAZARDOUS MATERIALS ASSESSMENT REPORT

Job details: Owner/s: Mr. C. & Mrs. M. Morris
Location: 12a Goondari Road, Allambie Heights

Plans for Job No: 7594/14 Revision No: C Dated: 22-10-14

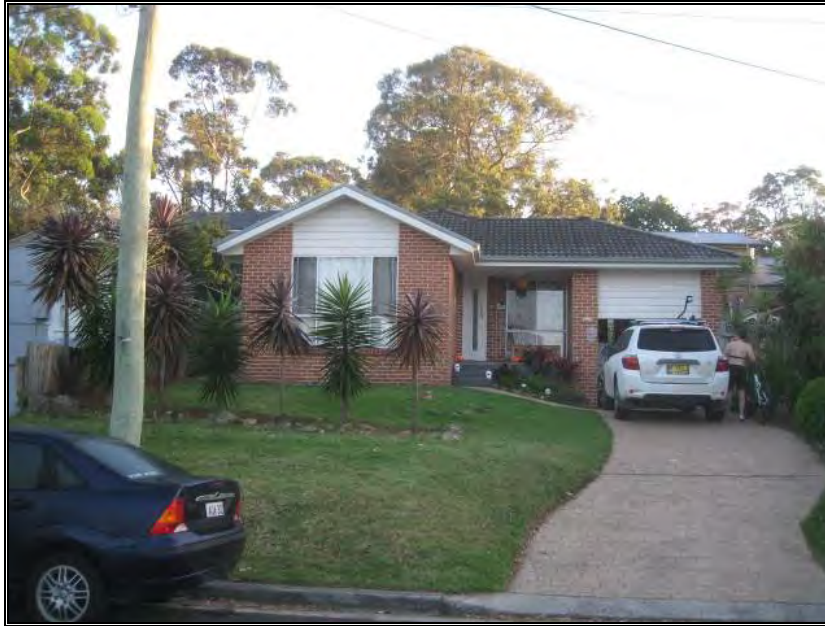
Front south western elevation of the residence

Estimated age:	Circa 2000
Type of construction:	Freestanding single storey brick veneer residence constructed with concrete slab on ground floor system
External cladding:	Clay masonry brickwork
Roof:	Engineered timber trussed hipped and valley roof structure with front elevation gable and concrete roofing tiles
