## **HAZARDOUS MATERIALS ASSESSMENT REPORT**

**Job details:** Owner: Mr. A. & Mrs. R. Gordon.  
Location: 19 Yethonga Avenue, Lane Cove West.

**Our reference:** HM05390117

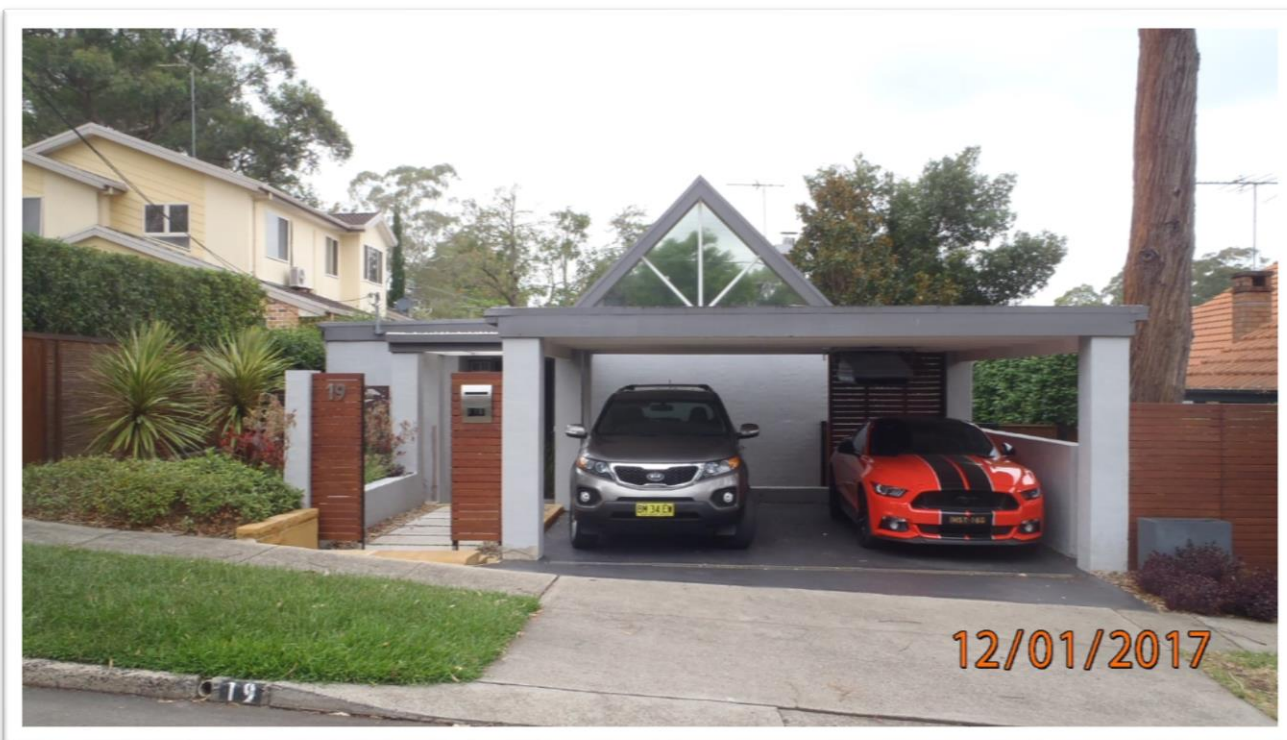
Front northern elevation of the residence

Estimated age:	Circa 1985 - 1990
Type of construction:	Single storey full brick / brick cavity built on a concrete slab floor.
External cladding:	Surface coated clay masonry brickwork
Roof:	Traditional cut and pitched, combination cathedral and flat roof structure with pan profiled sheet metal roofing.
