## **HAZARDOUS MATERIALS ASSESSMENT REPORT**

**Job details:** Owner/s: Dr. M. & Dr. I. Feain  
Location: 20A Everett Street, Maroubra NSW

**Plans for Job No:** 7602/14

**Our reference:** HM03670215

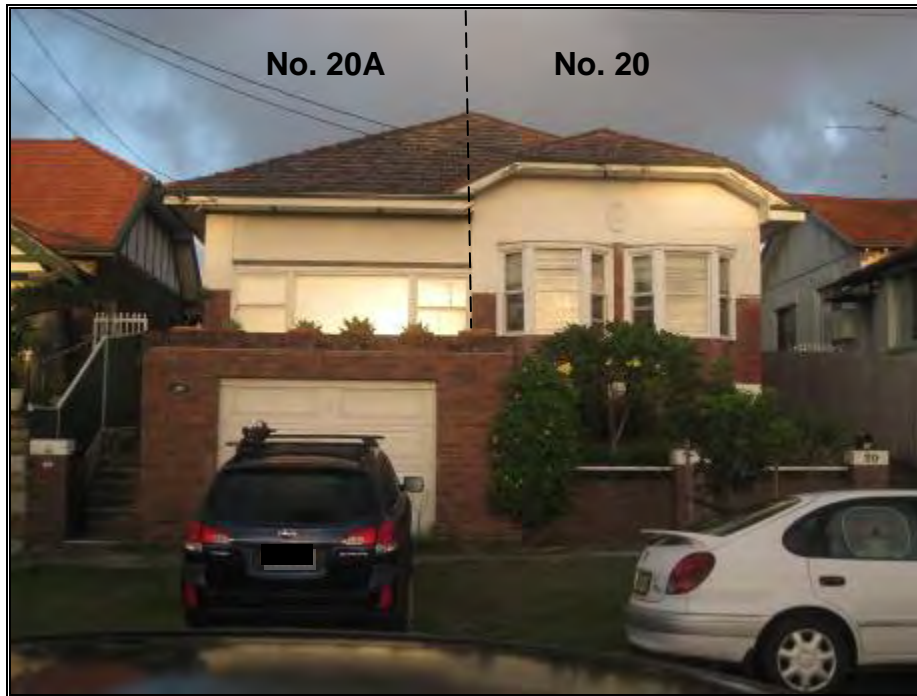
Front eastern elevation of the adjoining properties:  
No.20A and No. 20 Everett Street, Maroubra

Estimated age:	Circa 1930-1940.
Type of construction:	Semi detached single storey full brick / brick cavity construction on brick footings with a suspended timber floor system
External cladding:	Clay masonry brickwork
Roof:	<i>Common</i> traditional cut and pitched timber hipped roof structure with terra cotta tiles.
