HAZARDOUS MATERIALS ASSESSMENT REPORT

Job details: Owner/s: Mr. M. Walsh & Ms. L. Knowles
Location: 15 St James Road, Bondi Junction

Plans for Job No: 7622/14 Revision No: F Dated: 01-04-15

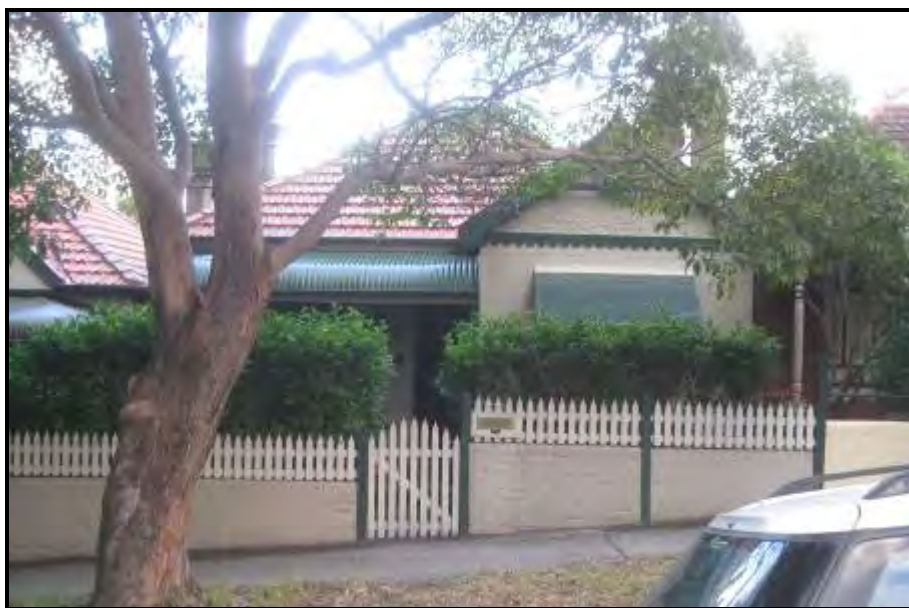
Front eastern elevation of the residence

Estimated age:	Original residence is approximately circa 1900-1910. Rear additions are approximately circa 1980 -1985
Type of construction:	Original freestanding single storey full brick / brick cavity construction on sandstone block footings with internal brick piers and suspended timber floor system. Rear additions are full brick / brick cavity construction on a combination and strip concrete footings and brick internal piers with a suspended timber floor system.
External cladding:	Clay masonry brick work
Roof:	Original roof is a traditional cut and pitched hipped and valley timber structure with a front gable and with terra cotta tiles. Rear addition is a skillion roof with pan profile sheet metal roofing.
