## **HAZARDOUS MATERIALS ASSESSMENT REPORT**

**Job details:** Owner/s: Mr. C. & Mrs. D. Chung  
Location: 111 Elizabeth Street, Ashfield

**Our reference:** HM03431014

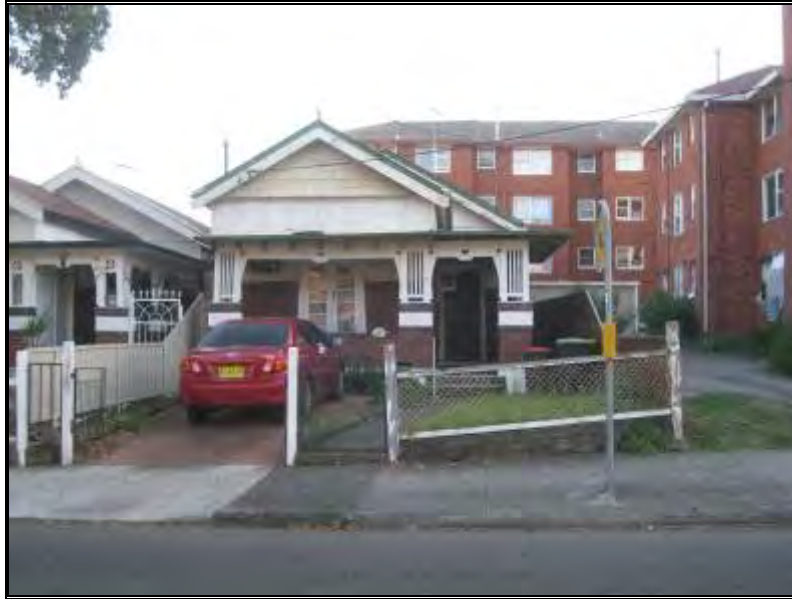
Front southern elevation of the residence

Estimated age:	Circa 1920- 1930
Type of construction:	Freestanding single storey, full brick / brick cavity construction with a suspended timber floor system
External cladding:	Clay brickwork
Roof:	Traditional cut and pitched hipped and valley structure with front gables.
