## **HAZARDOUS MATERIALS ASSESSMENT REPORT**

**Job details:** Owner: Mr. A. & Mrs. K. Rowe.  
Location: 28A Sunbeam Avenue, BURWOOD.

**Our reference:** HM05040716

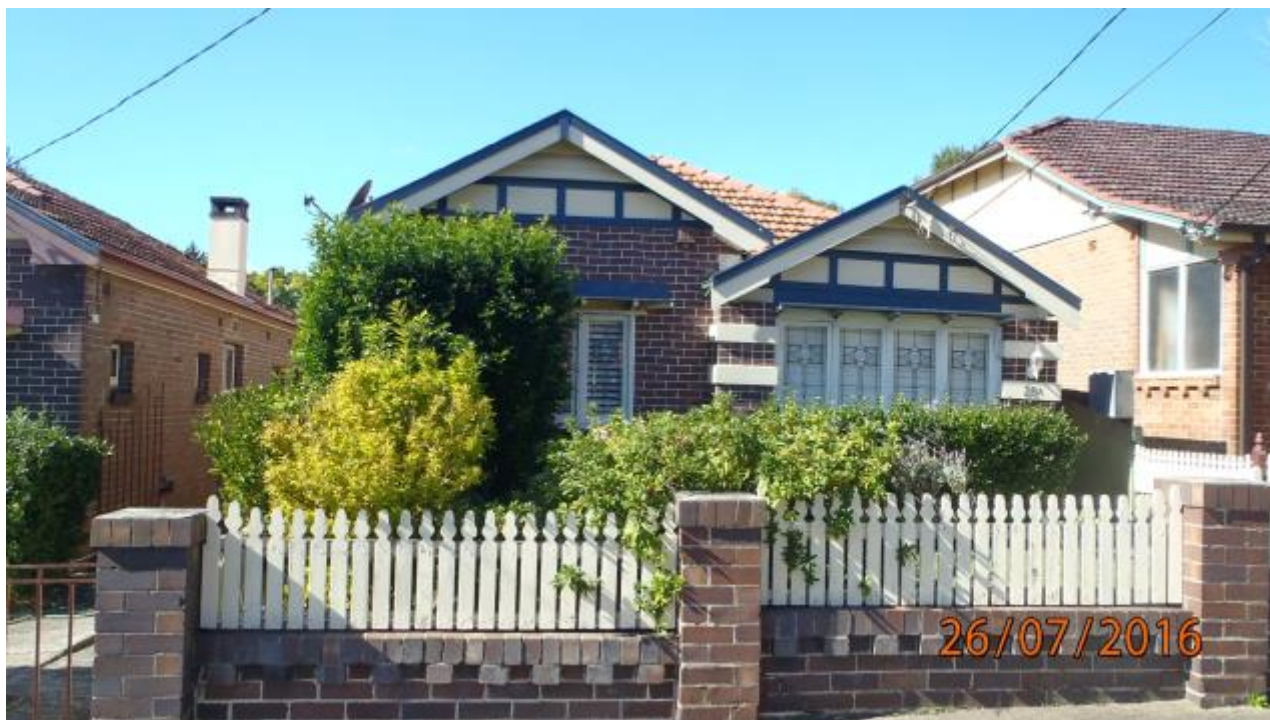
**Front western elevation of the residence**

<b>Estimated age:</b>	Circa 1930 – 1940 for the original residence, with the rear extension constructed circa 1990.
<b>Type of construction:</b>	Single storey full brick/brick cavity construction built on brick piers and brick footings supporting a suspended timber floor system. The rear extension is brick veneer.
<b>External cladding:</b>	Clay masonry brickwork
<b>Roof:</b>	Traditional cut and pitched, gable ended, hip and valley roof structure with terracotta roofing tiles to the original roof line. Rear extension is double skillion roof style with terracotta roof tiles.
