HAZARDOUS MATERIALS ASSESSMENT REPORT

Client: Cape Cod Australia Pty. Limited

Job details: Owner: Mr. R. Wills.
Location: 2 Langer Street, Banksia.

Our reference: HM05920717

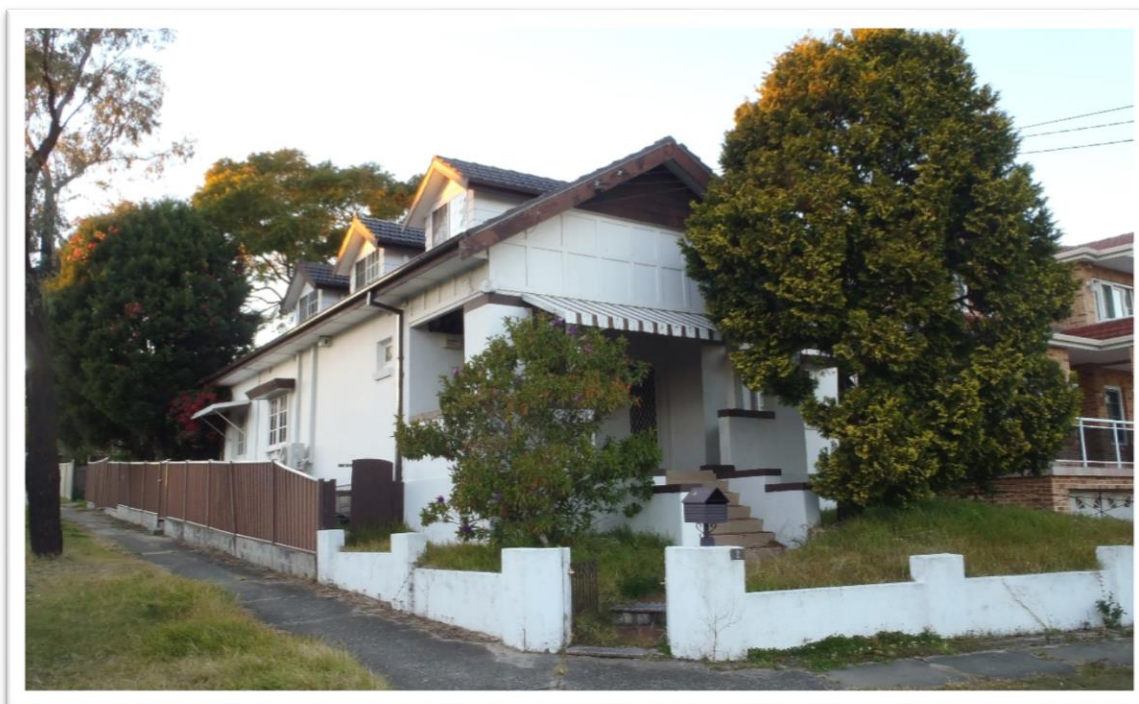
Front western elevation of the residence

Estimated age:	Circa 1930 to 1940
Type of construction:	Freestanding double storey full brick / brick cavity construction built on a combination of sandstone block and brick footings supporting a suspended timber floor system. Upper floor is timber framed and clad construction.
External cladding:	Surface coated clay masonry brickwork to lower level with possible asbestos cement [AC] weatherboard cladding to upper level.
Roof:	Traditional cut and pitched, gable ended with dormer style windows, and terracotta roofing tiles.
