HAZARDOUS MATERIALS ASSESSMENT REPORT

Job details: Owner/s: Mr. J. & Mrs. C. Wells
Location: 12 Goondari Road, Allambie Heights

Plans for Job No: 7598/14 **Revision No:** E **Dated:** 18-12-14

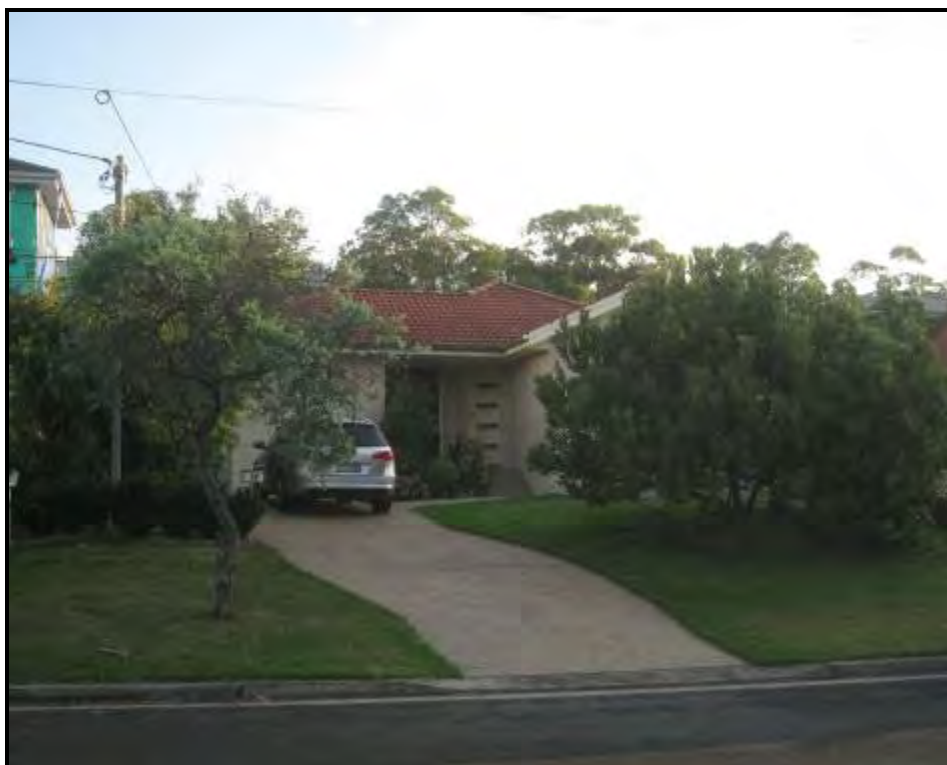
Front south western elevation of the residence

Estimated age:	Circa 2000
Type of construction:	Freestanding single storey brick veneer residence constructed with concrete slab on ground floor system
External cladding:	Clay masonry brickwork
Roof:	Engineered timber trussed hipped and valley roof structure with front elevation gable and terra cotta roofing tiles
