## **HAZARDOUS MATERIALS ASSESSMENT REPORT**

**Job details:** Owner: Mr. J. Erlich & Mrs. M. Marsh.  
Location: 51 Onslow Street, Rose Bay.

**Plans for Job No:** 7772/16

**Our reference:** HM05180916

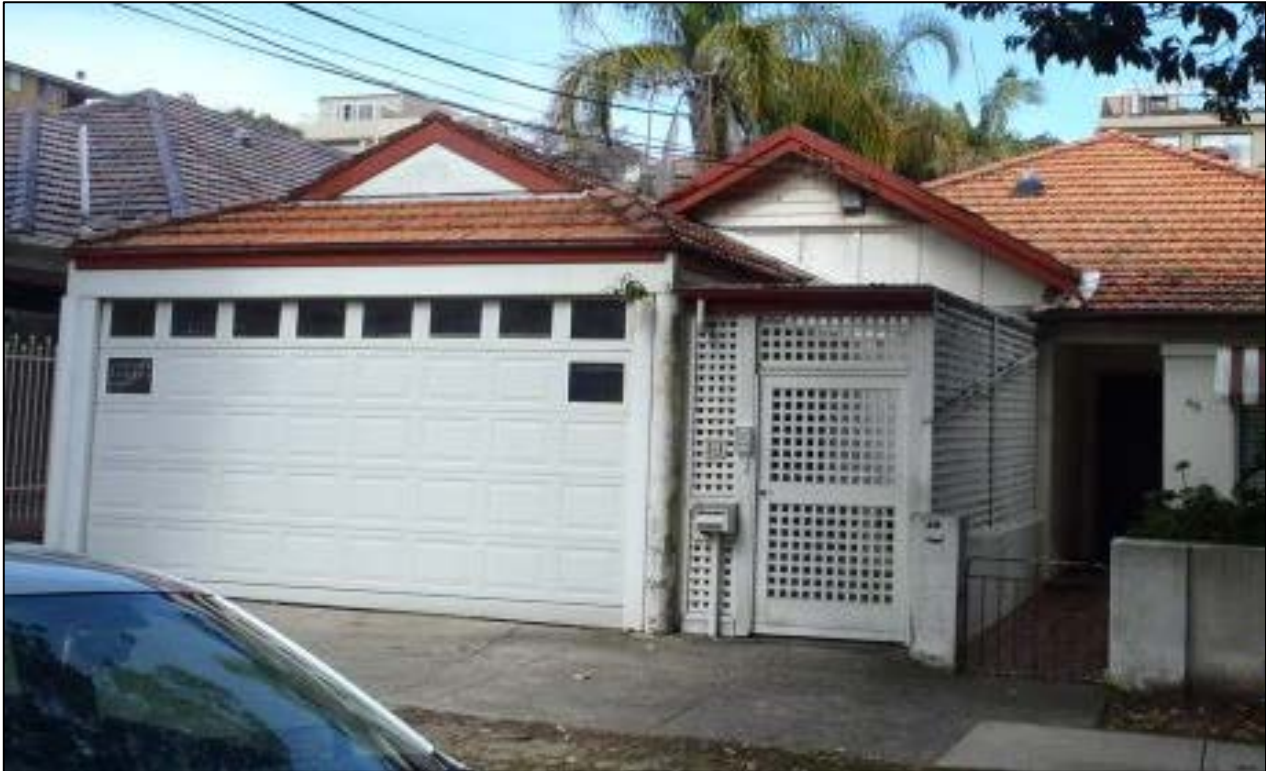
Front northern elevation of the residence

<b>Estimated age:</b>	Circa 1915 – 1925 for the original residence
<b>Type of construction:</b>	Semi-detached single storey full brick / brick cavity construction with a slab on ground flooring system.
<b>External cladding:</b>	Surface coated clay masonry brickwork
<b>Roof:</b>	Common gable ended hipped and valley roof structure with terracotta roofing tiles to the front section and skillion rear section with pre-finished corrugated profiled sheet metal roofing.
