Unit #: **NH-783**
 Unit Location:
 Component: **ENGINE**
 Location: **REAR**
 Serial #:
 Make: **NEW HOLLAND**
 Model: **CR9080, 12.9 LTRS IVECO**
 OAS #:

AGAT Laboratories
 Equipment Reliability and Lubricants Testing Services
 3650 21st Street N.E., Calgary, AB, T2E6V6
 Phone:(403)299-2000 Fax:(403)299-2105

Date analyzed: **11/08/22**
 Work order: **22C180703**
 Oil brand & grade: **UNKNOWN**
 Client Ref #:

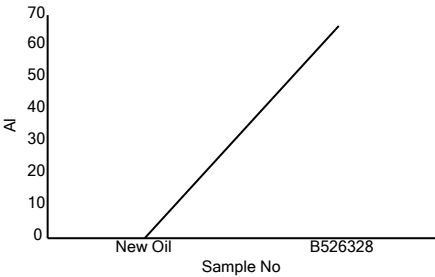
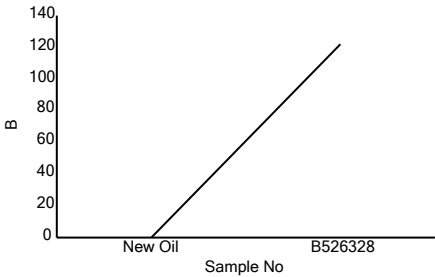
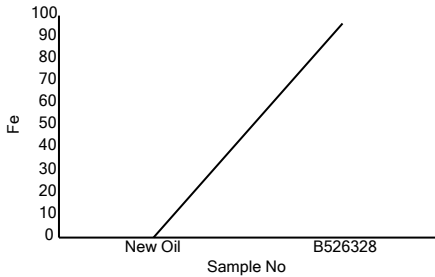
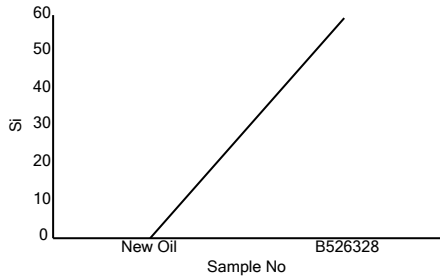
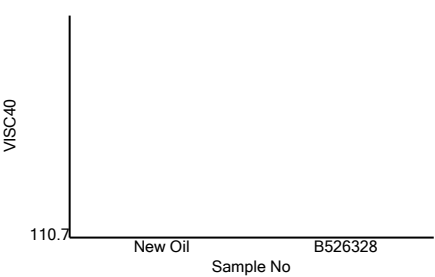
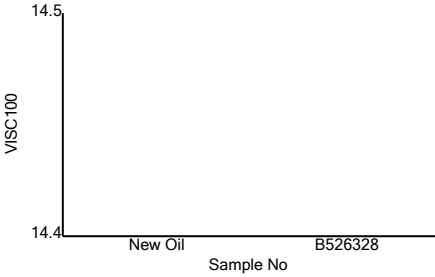
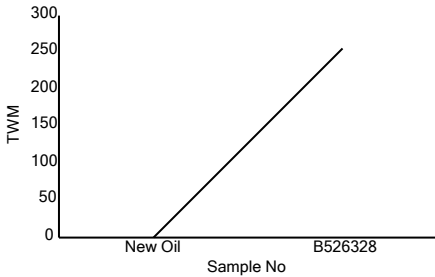
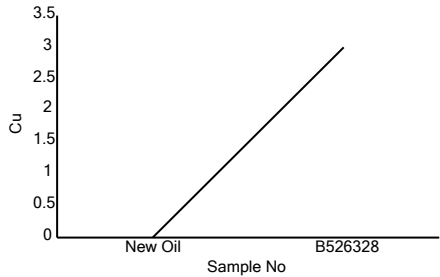
Trend Graphs

Oil brand & grade: UNKNOWN
Sample #: **C-983716**
Date Sampled: 11/08/22
Date Analyzed: 11/08/22
Work order: 22C180703
Client Ref #:

Your Sample Score: 9

Rankings: 0-3 Normal, 4-6 Reportable, 7-10 Critical
