WAN Link Performance & Strategy Report

****Location:**** NEW SEB Tanishq Store, delhi

****Vendor:**** AIRTEL

****Link Type:**** ILL

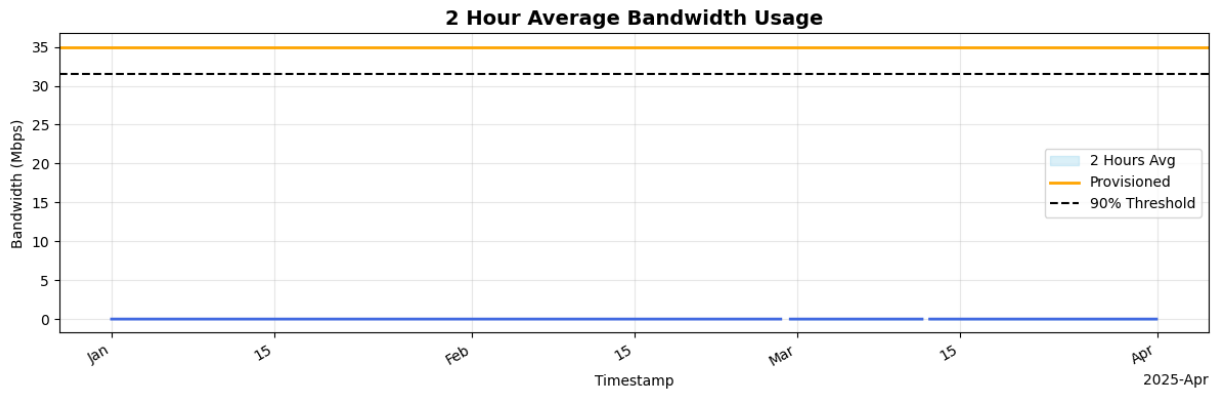
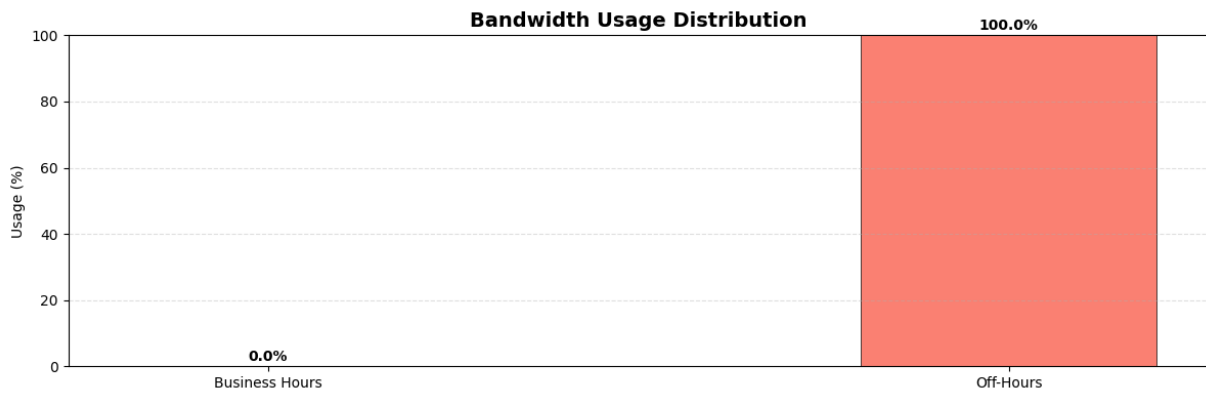
Visual Insights

Analysis shows this 35 Mbps link is completely inactive, with zero recorded traffic across more than 127,000 data points. Usage is consistently 0.00 Mbps during both business and off-hours. This total lack of utilization is a significant anomaly, suggesting the circuit is not correctly configured or is serving a non-operational purpose.

There are no performance risks, congestion, or bottlenecks. While SLA compliance is 100% "Excellent," this is solely due to the complete absence of traffic on the network.
