**\*\*Subject\*\*:** WAN Link Performance & Capacity Report - Sikkim Watches Factory

---  
- **\*\*Location\*\*:** Sikkim Watches Factory, Sikkim  
- **\*\*Vendor\*\*:** JIO  
- **\*\*Link Type\*\*:** ILL  
- **\*\*Business Hours\*\*:** 09:00–18:00  
- **\*\*Provisioned Speed\*\*:** 30.0 Mbps  
---

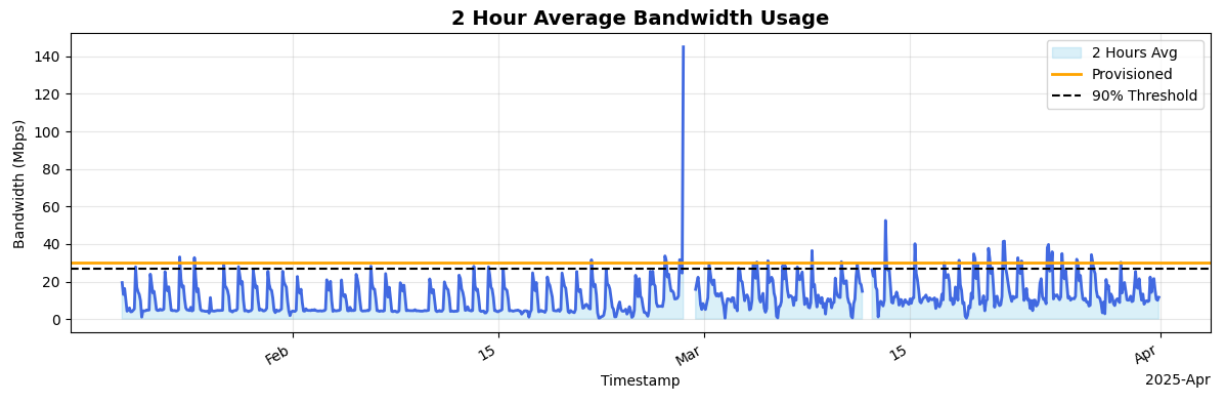
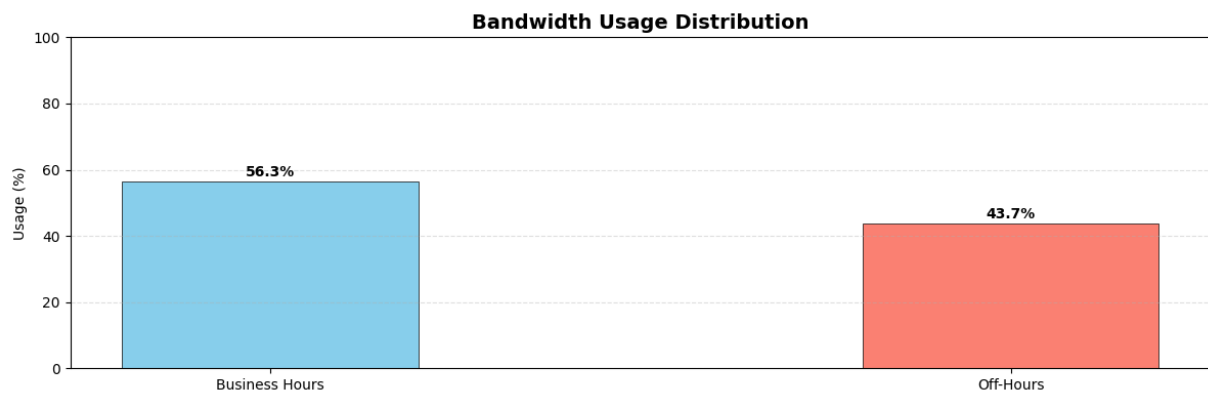
## Visual Insights

The 30 Mbps link is heavily utilized during business hours, with usage regularly spiking to and beyond its provisioned capacity. While the overall average usage is moderate (11.76 Mbps), frequent demand peaks saturate the connection, indicating a recurring pattern of high-intensity activity. An extreme peak of over 3.5 Gbps was recorded, which is a significant anomaly that should be investigated for a potential network misconfiguration or security event.

The primary risk is consistent network congestion. The link operated above 90% capacity for over 108 hours, directly impacting application performance and user experience. These frequent bursts create a critical bottleneck, leading to packet loss and high latency. The link is non-compliant with performance SLAs for a significant portion of the time (14.54%).
