# Notes for STM32 MCUs

Tips, hints, and tricks when working on STM32 ARM Cortex-M MCUs

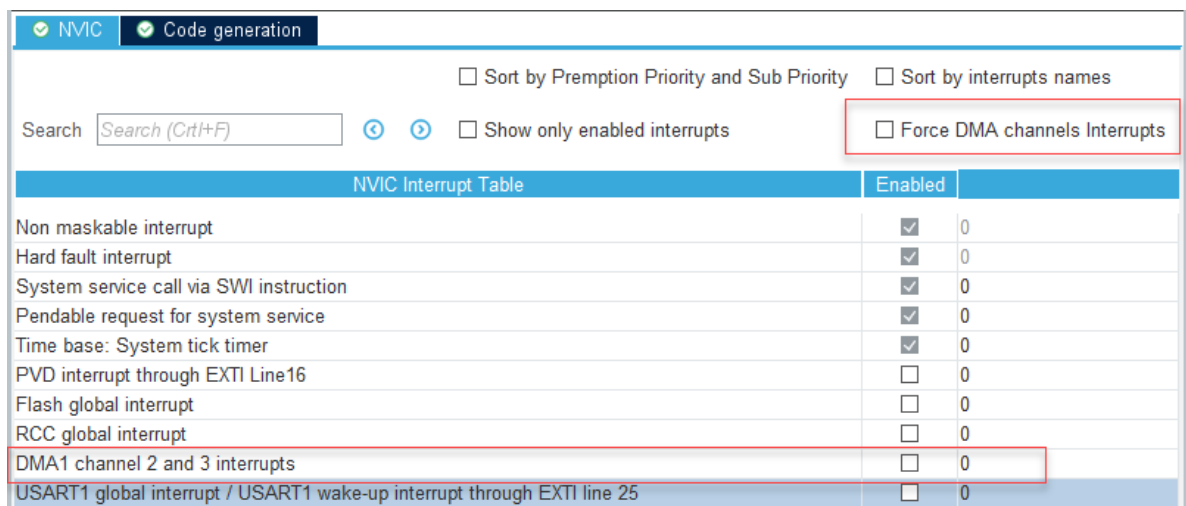
The function `HAL_DMA_PollForTransfer()` works properly only when the DMA interrupts are disabled. It needs to turn off the option *Force DMA Channels Interrupts* to be able to disable DMA interrupts.

*Force turning off DMA interrupt*

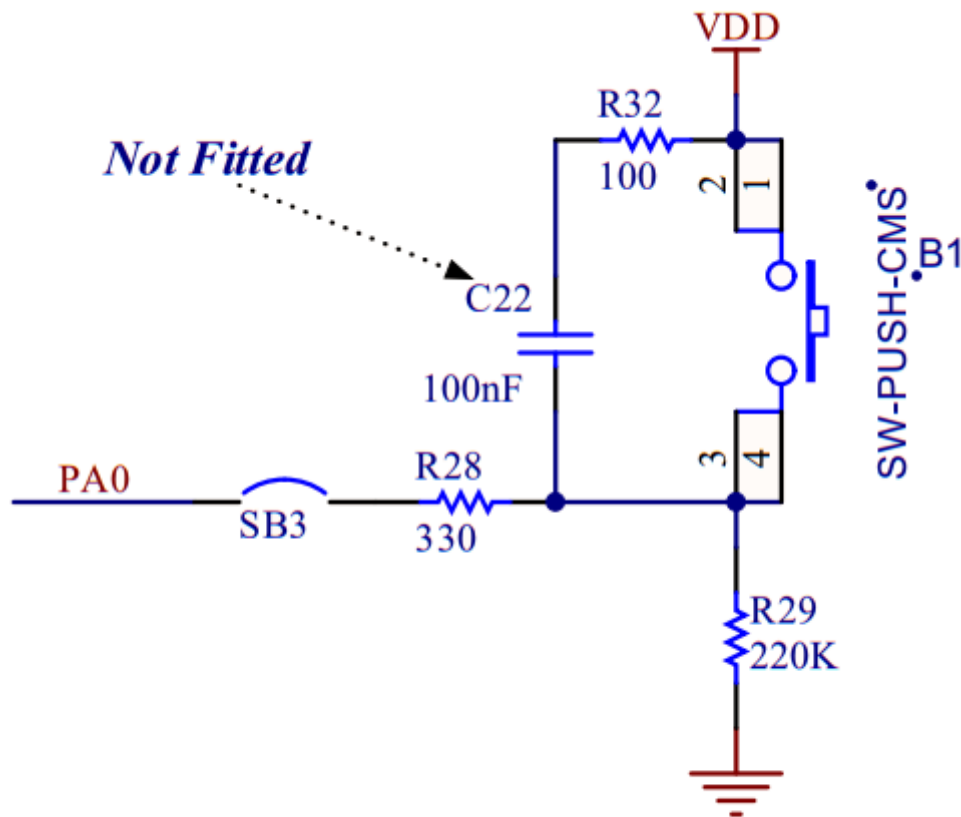
### USER & WAKE-UP Button

At the time I wanted to see input bouncing on the push button soldered on my STM32F0 Discovery board, I plugged my Logic Analyzer to the pin **PA0**. The weird thing was that the logic level of **PA0** is always High, even when I pressed on the button. Without logic analyser plugged in, the button works well.

*A button using pull-down resistor*
