# Notes for STM32 MCUs

Tips, hints, and tricks when working on STM32 ARM Cortex-M MCUs

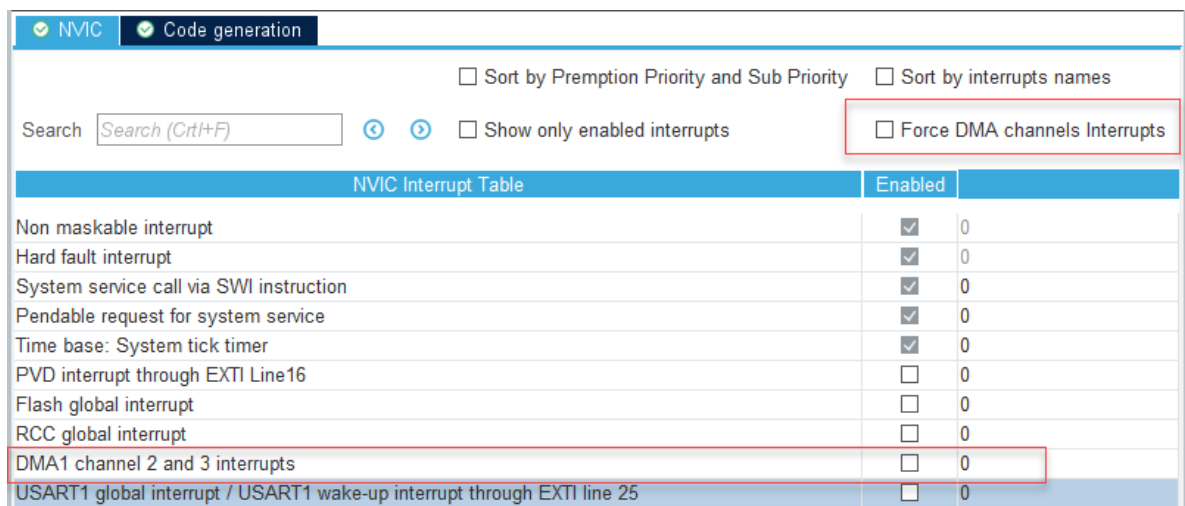
The function `HAL_DMA_PollForTransfer()` works properly only when the DMA interrupts are disabled. It needs to turn off the option *Force DMA Channels Interrupts* to be able to disable DMA interrupts.

*Force turning off DMA interrupt*
