BURNED-AREA REPORT**PART I - TYPE OF REQUEST****A. Type of Report**

PART II - BURNED-AREA DESCRIPTION**A. Fire Name:** Bedrock Fire**B. Fire Number:** OR-WIF-230266**C. State:** OR**D. County:** Lane**E. Region:** R6**F. Forest:** Willamette**G. District:** Middle Fork Ranger District**H. Fire Incident Job Code:** P6QEW823 (0618)**I. Date Fire Started:** 7/22/2023**J. Date Fire Contained:** 98% 9/19/2023**K. Suppression Cost:** \$63,411,028 (9-17-23)**L. Fire Suppression Damages Repaired with Suppression Funds (estimates):**

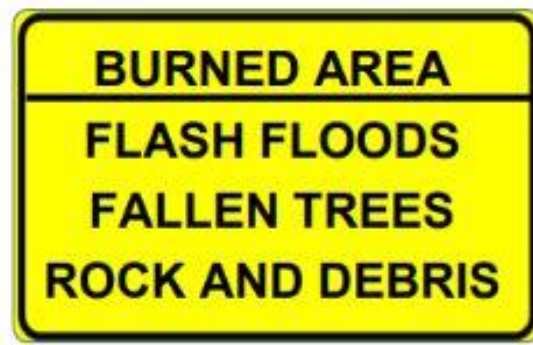
Design/Construction Specification(s): “Burned Area” warning signs along the roads shall measure, at a minimum, 30 inch by 36 inch and consist of 0.08” aluminum, sheeted in high intensity yellow with black letters, which is shown in the photo below. The “BURNED AREA” lettering shall be 4C inch.

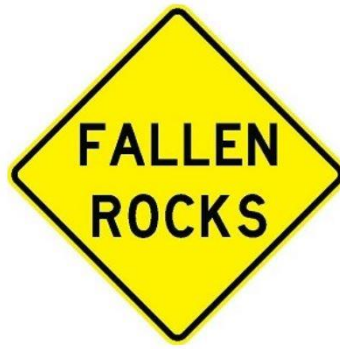
Design/Construction Specification(s): “FALLEN ROCKS” warning signs along the roads shall measure, at a minimum, 36 inch by 36 inch and consist of 0.08” aluminum, sheeted in high intensity yellow with black letters, which is shown in the photo below. The “FALLEN ROCKS” lettering shall be 4C inch.

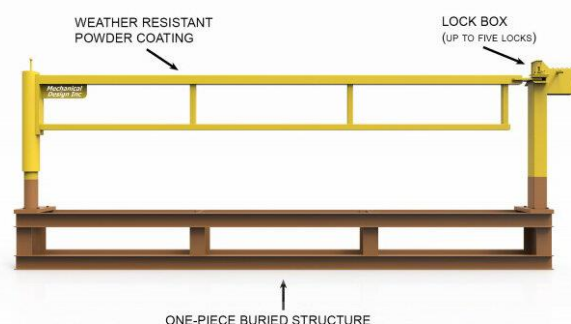
Design/Construction Specification(s): The gates shall be constructed according to the *Standard Specifications for Construction of Roads and Bridges on Federal Highway Projects FP-14* (Similar to the photo below). All signing associated with the gate installation shall follow Forest Service Engineering Manual 7100-15 and the Federal Highways Manual of Uniform Traffic Control Devices (MUTCD). This includes typical gate barricade markers and object markers and any signs that may be installed with the gate such as a road closed sign.

All gates shall be constructed as shown in Figure 1 and shall have signage that meets the MUTCD standards for road closures.

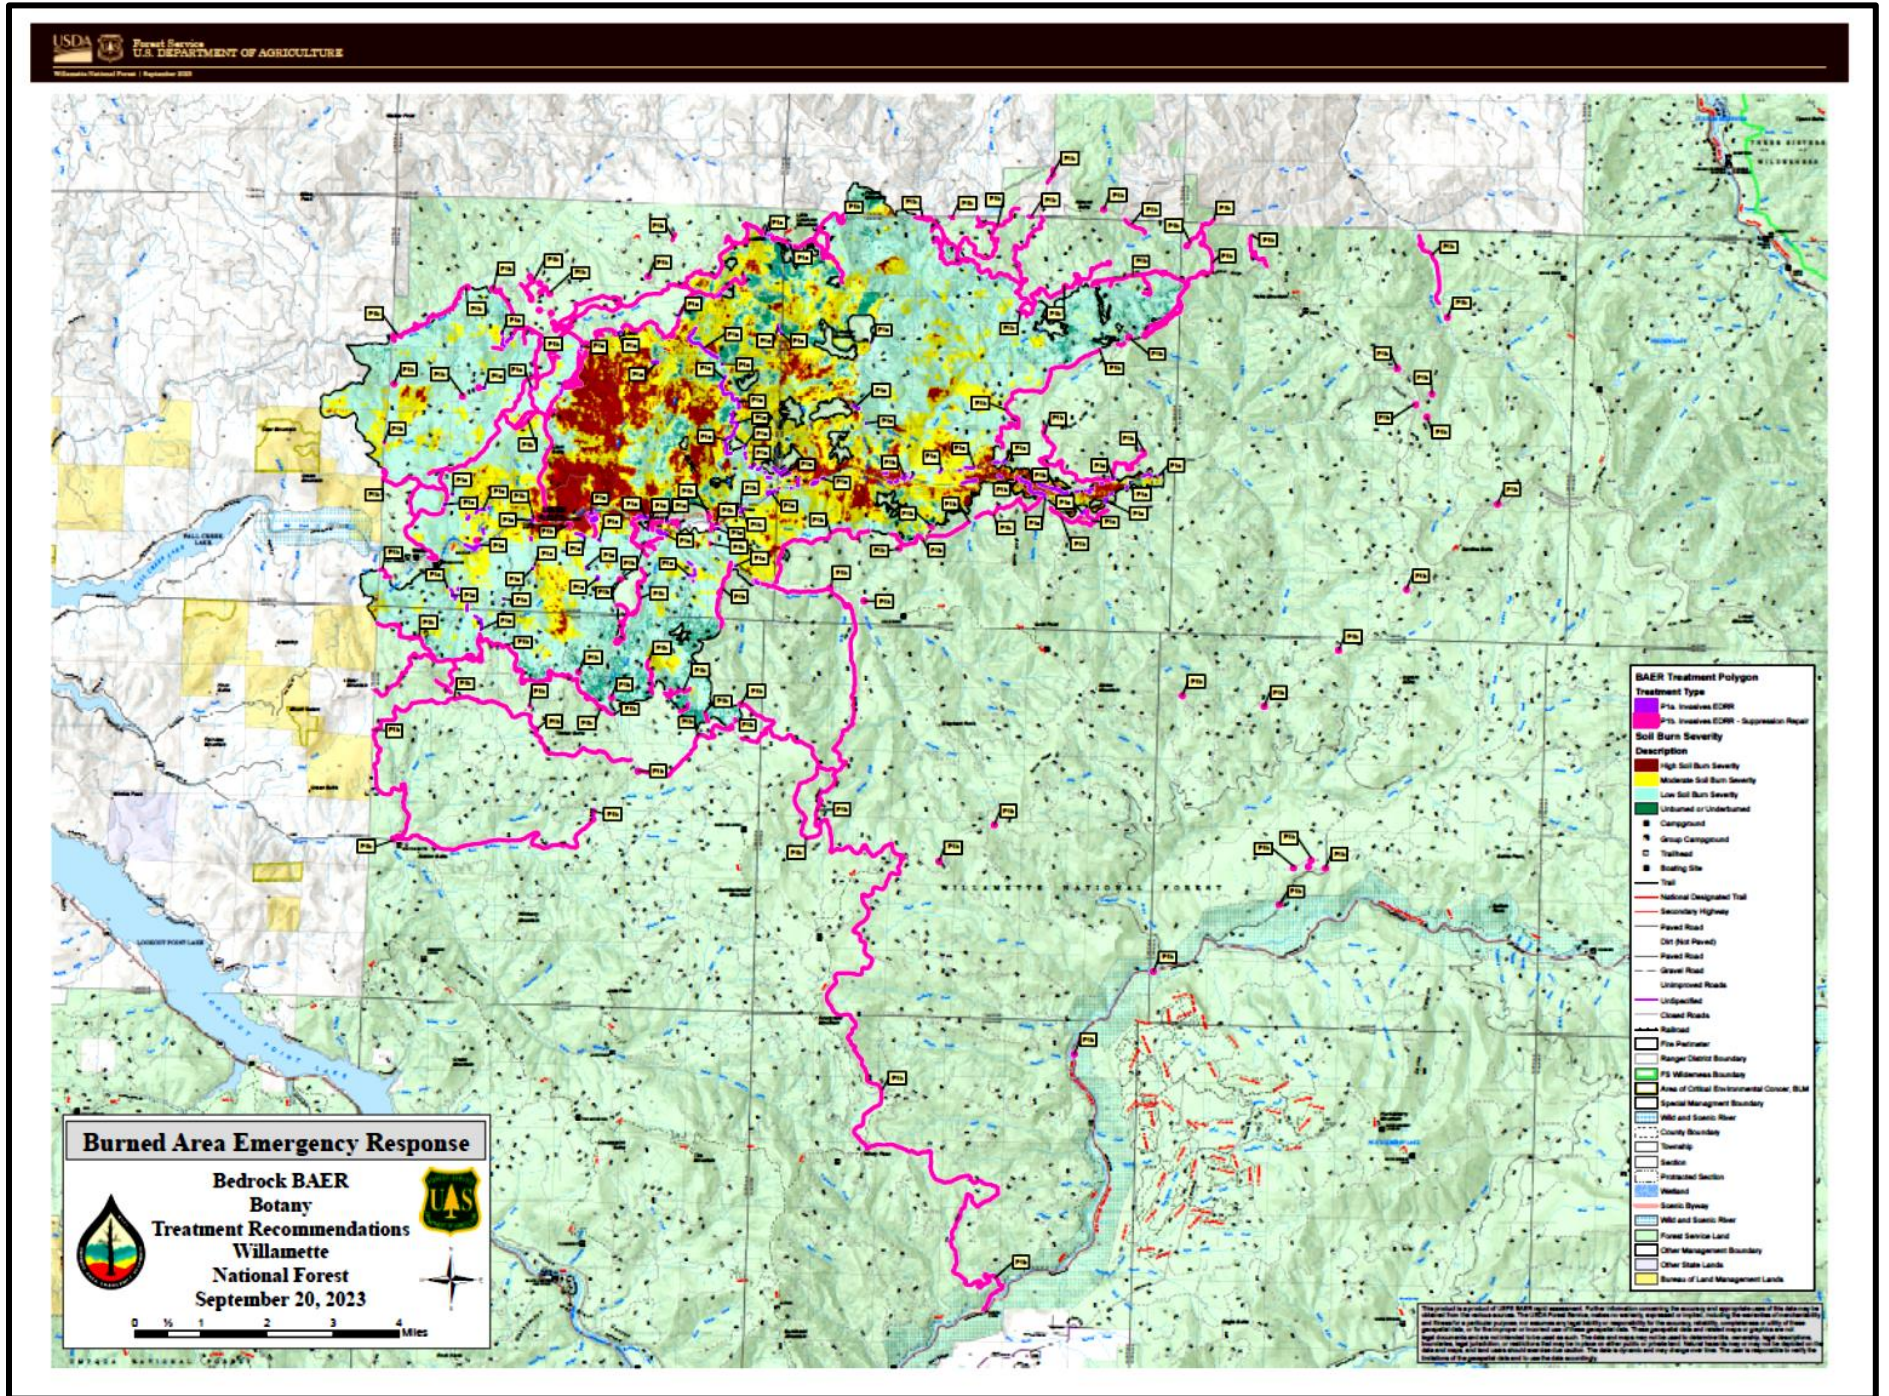
Location (Suitable) Sites: The curbing on Alder Creek Bridge is located along Fall Creek Road (FSR #1800000) at approximately milepost 18.8.

Design/Construction Specification(s): Replacement of the damaged curbing shall be per Section 716 of the *FP14-Standard Specifications for Construction of Roads and Bridges on Federal Highway Projects*.
