Date of Report: 10/3/2022

FAIRVIEW FIRE BURNED AREA REPORT

A. Fire Name: Fairview	B. Fire Number: RRU-129712
C. State: CA	D. County: Riverside
E. Region: 05	F. Forest: San Bernardino National Forest
G. District: San Jacinto Ranger District	H. Fire Incident Job Code: PNP1S8 (1522)
I. Date Fire Started: 09/05/2022	J. Date Fire Contained: 9/23/2022
K. Suppression Cost: \$39,274,234=estimated	
L. Fire Suppression Damages Repaired with Suppression Funds (estimates) across all ownerships Fireline (miles): Dozerlines: 47.7; Handlines: 28.4; Completed Road as Line: 8.6; Completed Fuel Break: 4.6; Mileage Repaired: 2.3; Still In Need of Repair: 74.9

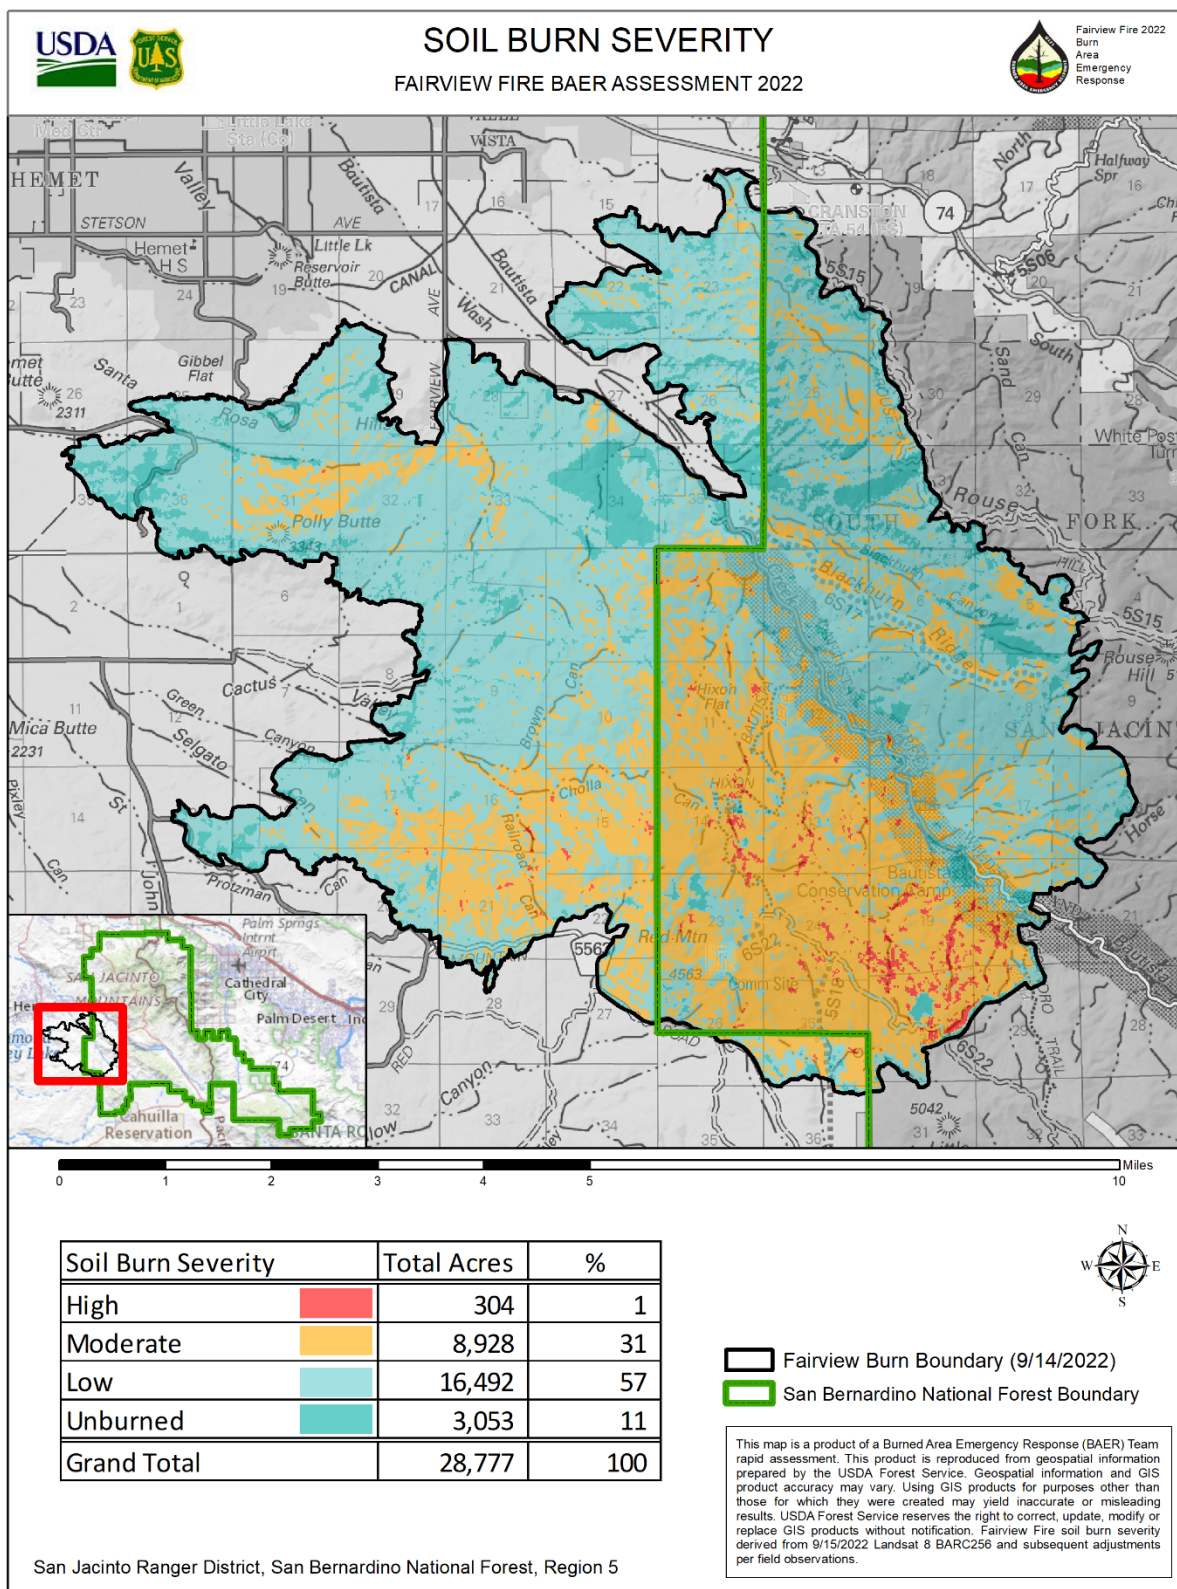
Figure 1. Soil Burn Severity – Fairview Fire

Table 6, Table 7, and Figure 1 display the soil burn severity within the Fairview Fire perimeter.
