Version information

Contents (9.6.2011)

1 AS3.0.90 version information	1
1.1 New functions	1
1.2 Important notes	4
1.2.1 Motor temperature model was deactivated (only in V1.181 – V1.183)	4
1.2.2 CHM files can no longer be opened from the network after Windows update	4

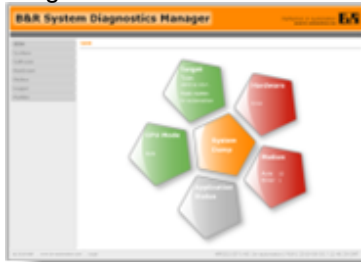
System Diagnostics Manager

The I/O and axis monitors in SDM increase the efficiency of commissioning and service. The newly integrated system dump function simplifies support and documents the actual state of the machine.

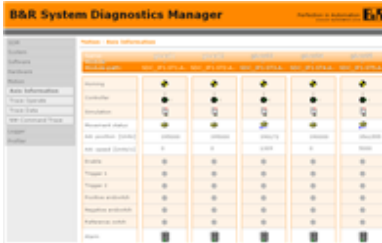
SDM Motion

The integration of motion diagnostics places actual status info, logbooks and oscilloscope functions at your fingertips.

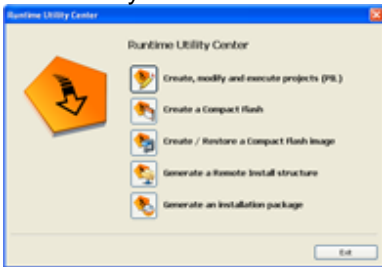
The Runtime Utility Center is a tool integrated in Automation Studio to help users install and distribute projects.
