Before, our distributor FAE raised an issue regarding the implementation of BLE ESB MPSL on the 5340 network core. The details can be found at <https://devzone.nordicsemi.com/support/316715>.

However, in the case of the 5340, the situation is different. When `MPSL_TIMESLOT_SIGNAL_EXTEND_FAILED` occurs, and after applying for `MPSL_TIMESLOT_SIGNAL_ACTION_REQUEST`, the Bluetooth protocol stack enters an abnormal working state. In this state, the thread functions normally, but the Bluetooth protocol stack does not respond to any events.

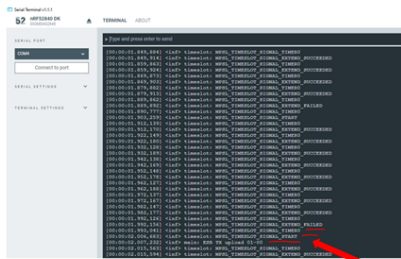
Log for normal NRF52 conditions as shown in the diagram:

After SIGNAL_EXTEND_FAILED, start
a new timeslot request successfully

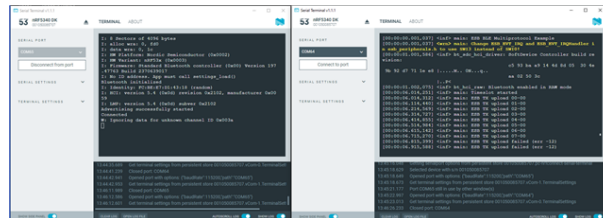
Thanks for your great help!! now The ble + ESB is work in NCS 2.5
