Nvidia OEM Network Product Update

2025 Q1

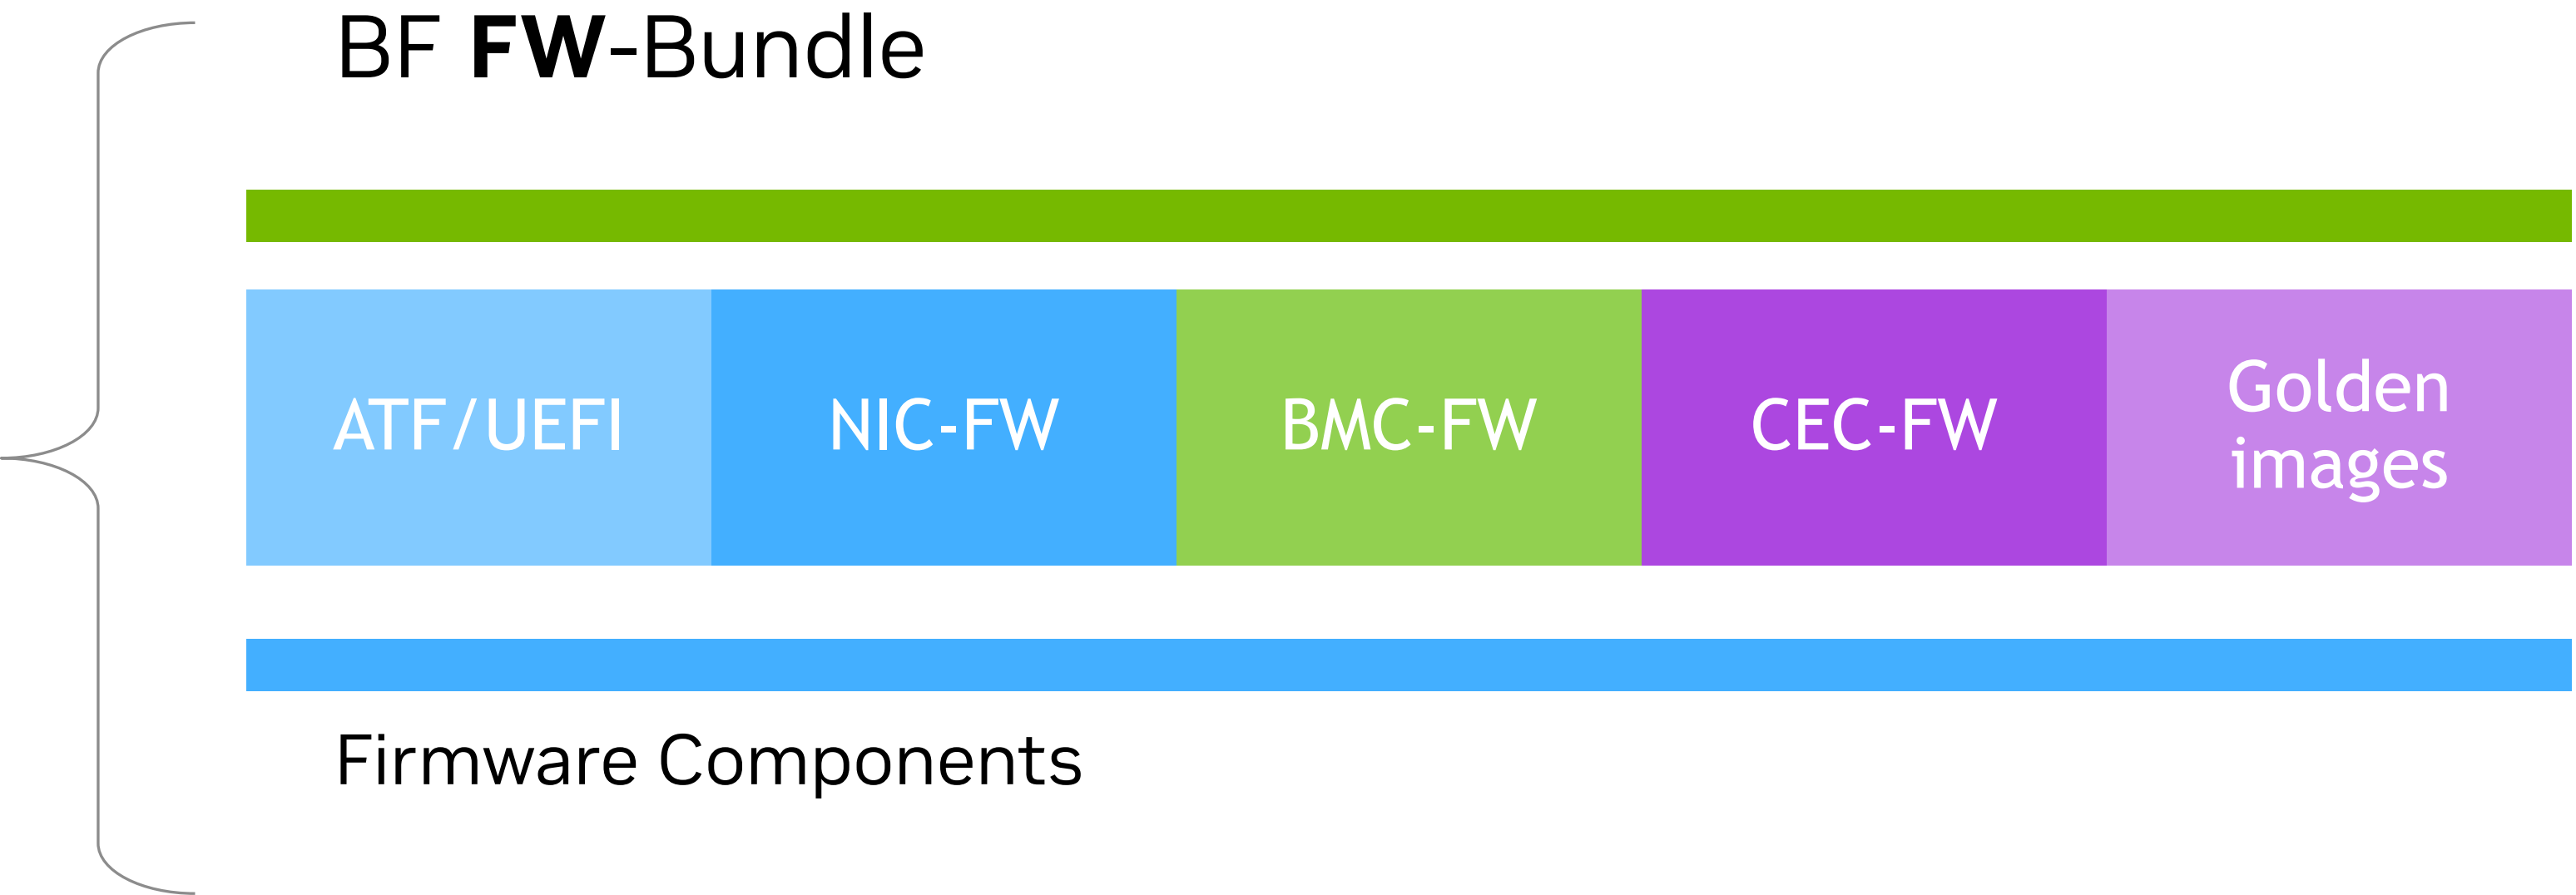
***new* Firmware-only Bundle**

- “light” in size
- Used for day2 provisioning w/o impacting installed ARM-OS.

NOTE: requires customers to upgrade packages separately (e.g., via Linux standard tools (yam/apt upgrade)).

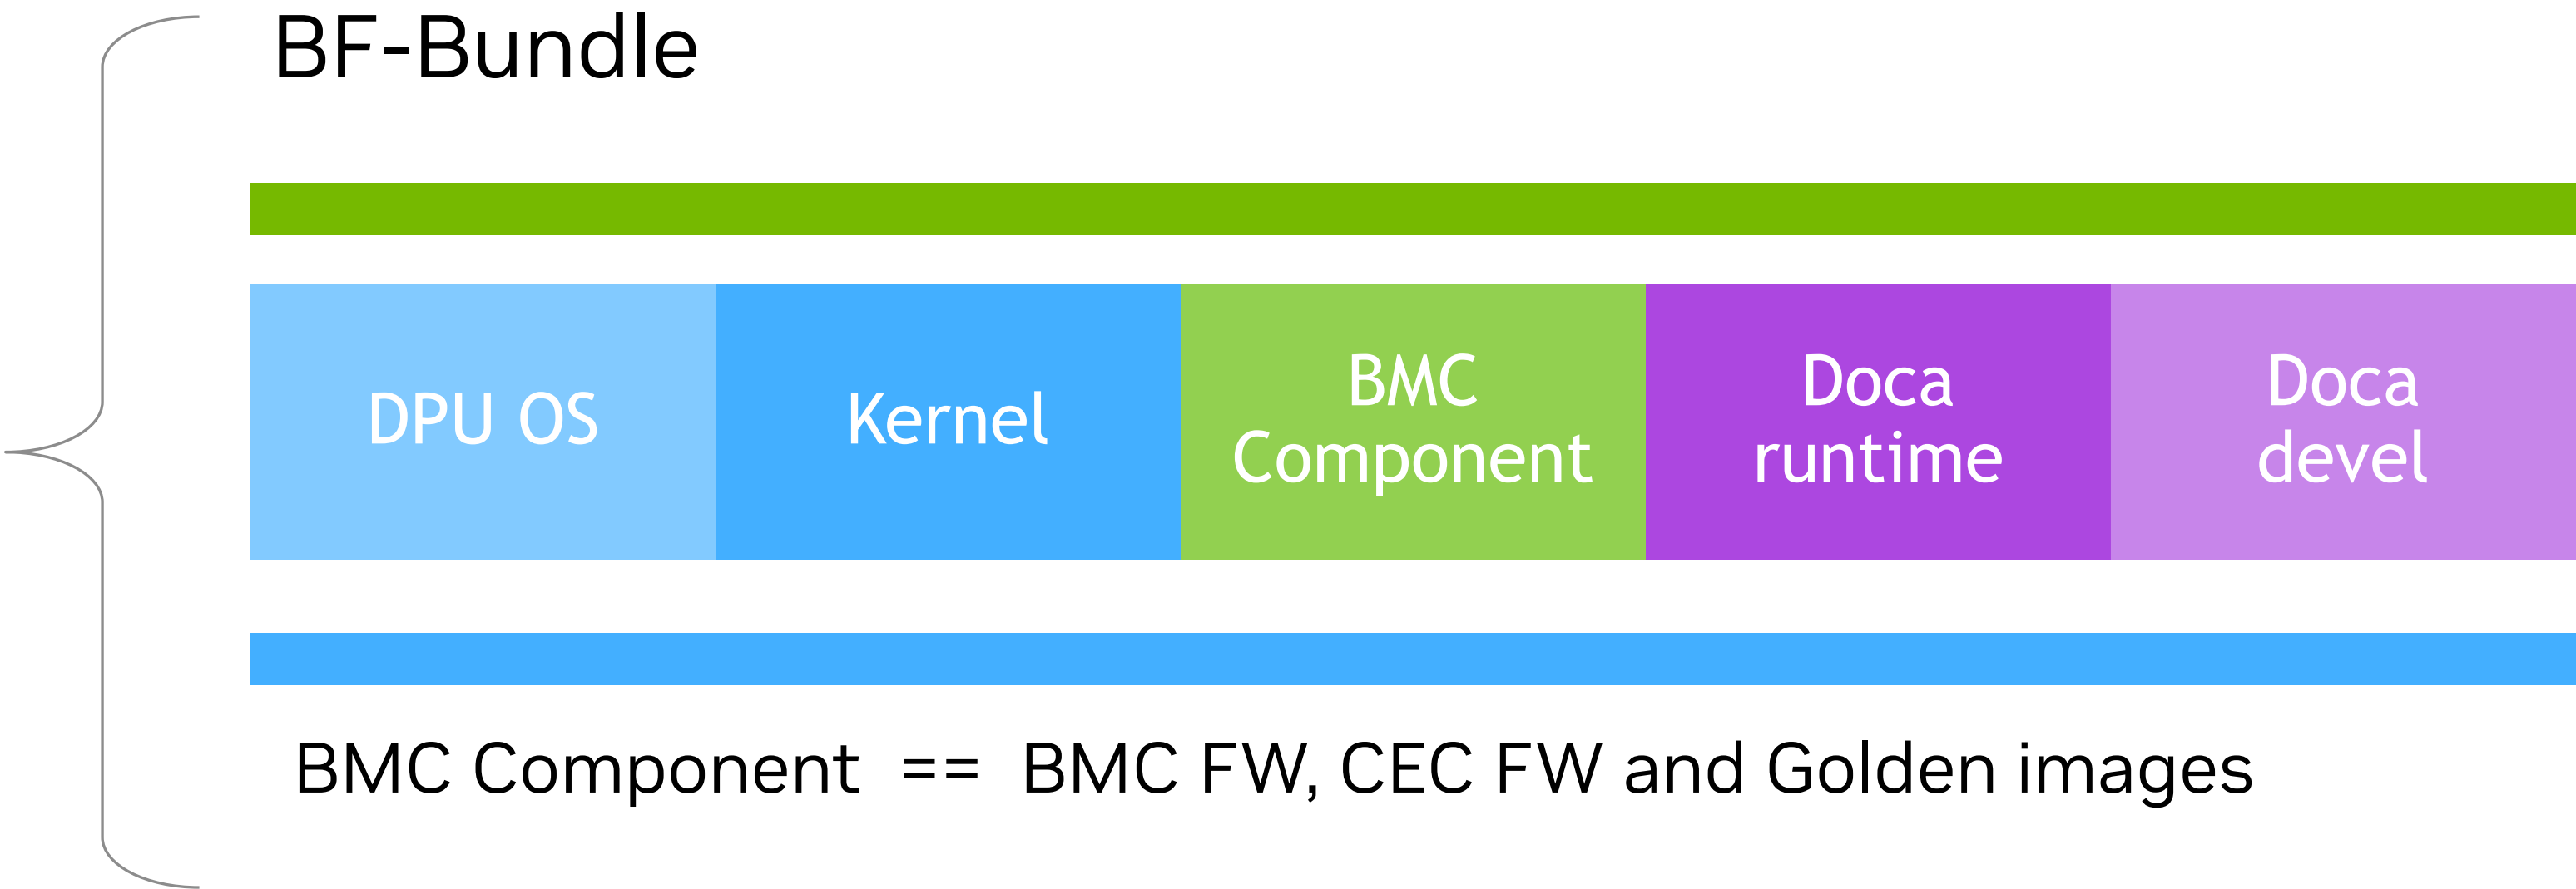
BF-Bundle (full BFB)

- Installs everything / (OS, Kernel, pre-built binaries).
- **Purpose:** Production Line / Recovery

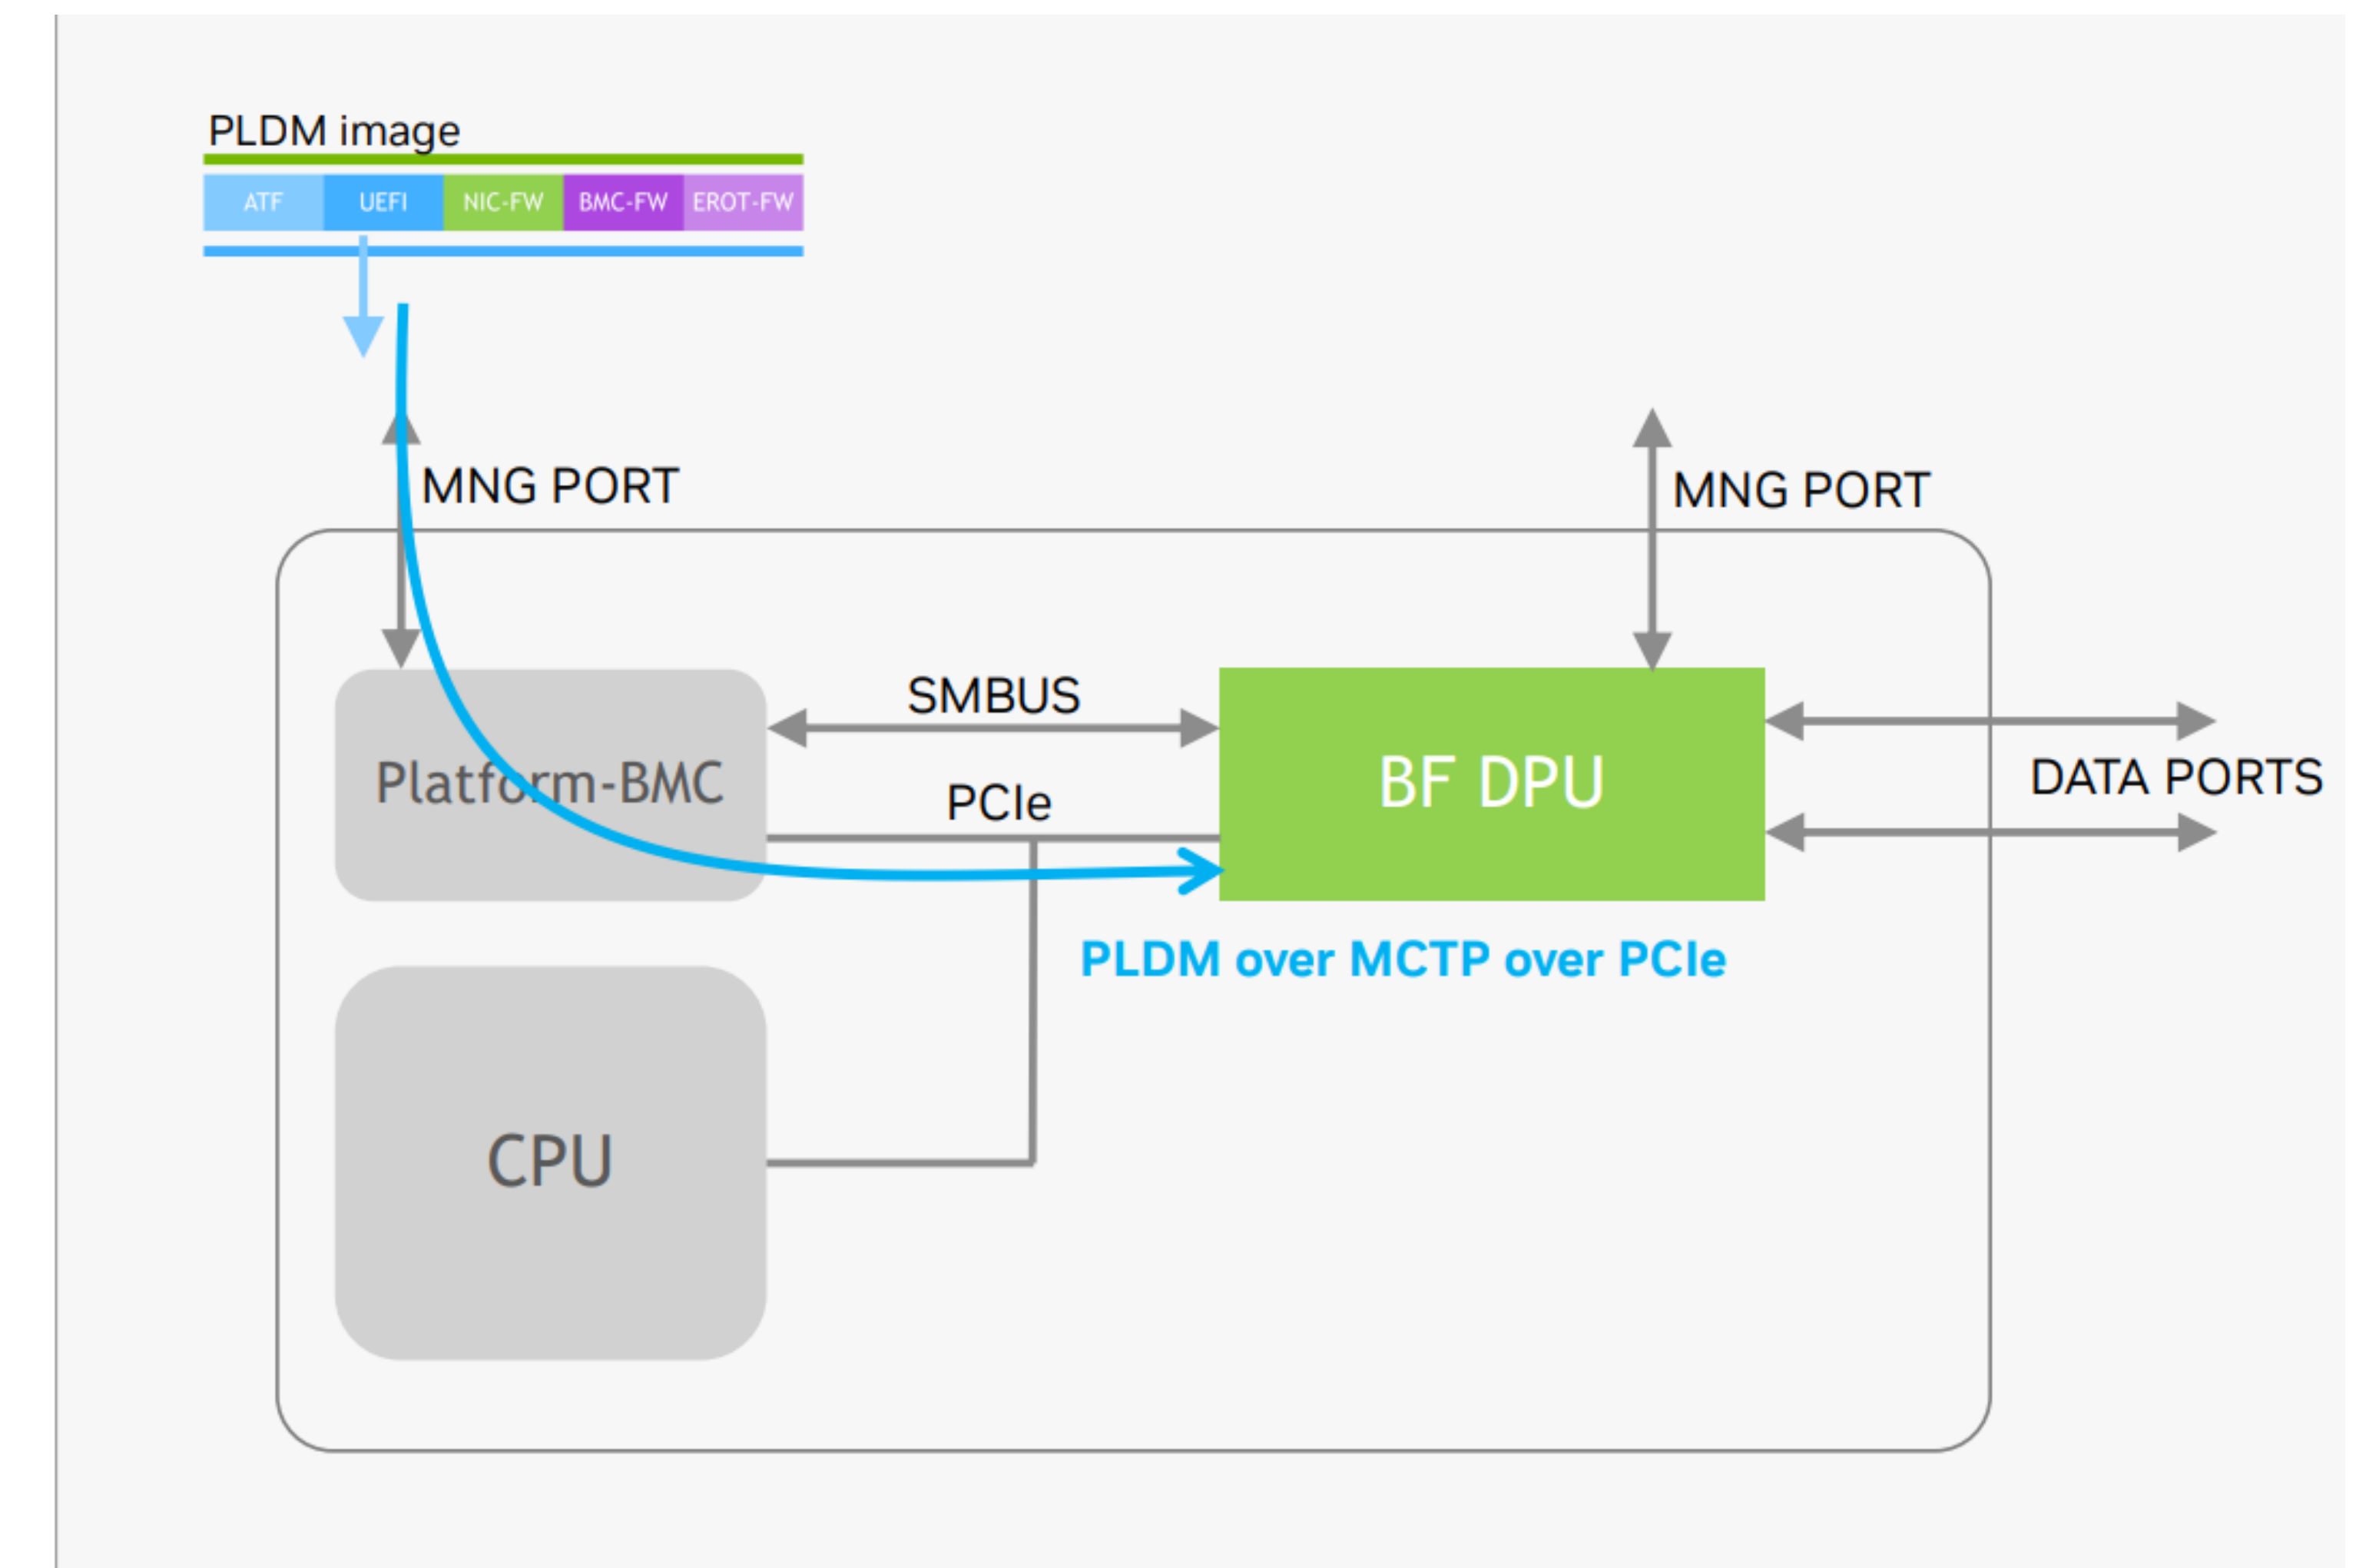
BFB – PLDM Firmware Update

- **PLDM firmware update support for BlueField-3 devices**

Added support for PLDM firmware update – BlueField-3 devices now support firmware updates via the PLDM type-5 protocol over MCTP over PCIe, allowing future updates to be performed through the platform's BMC. This implementation complies with PLDM specification version 1.0. Note that the firmware image size is approximately 100MB.

- With this release, firmware updates using the PLDM flow can only be applied with a full-system power cycle. Support for applying updates via server reboot will be added in a future release.
 - When operating in DPU mode, administrators must manually configure BMC credentials in a local Arm OS config file to enable BMC and CEC updates. Provisioning of credentials will be automated in a future release.
- Enhanced firmware reset flow for Sync1 utilizing community-accepted hot reset kernel flow
- Added logging of NVMe/eMMC wipe operations to RShim log
- Bug fixes

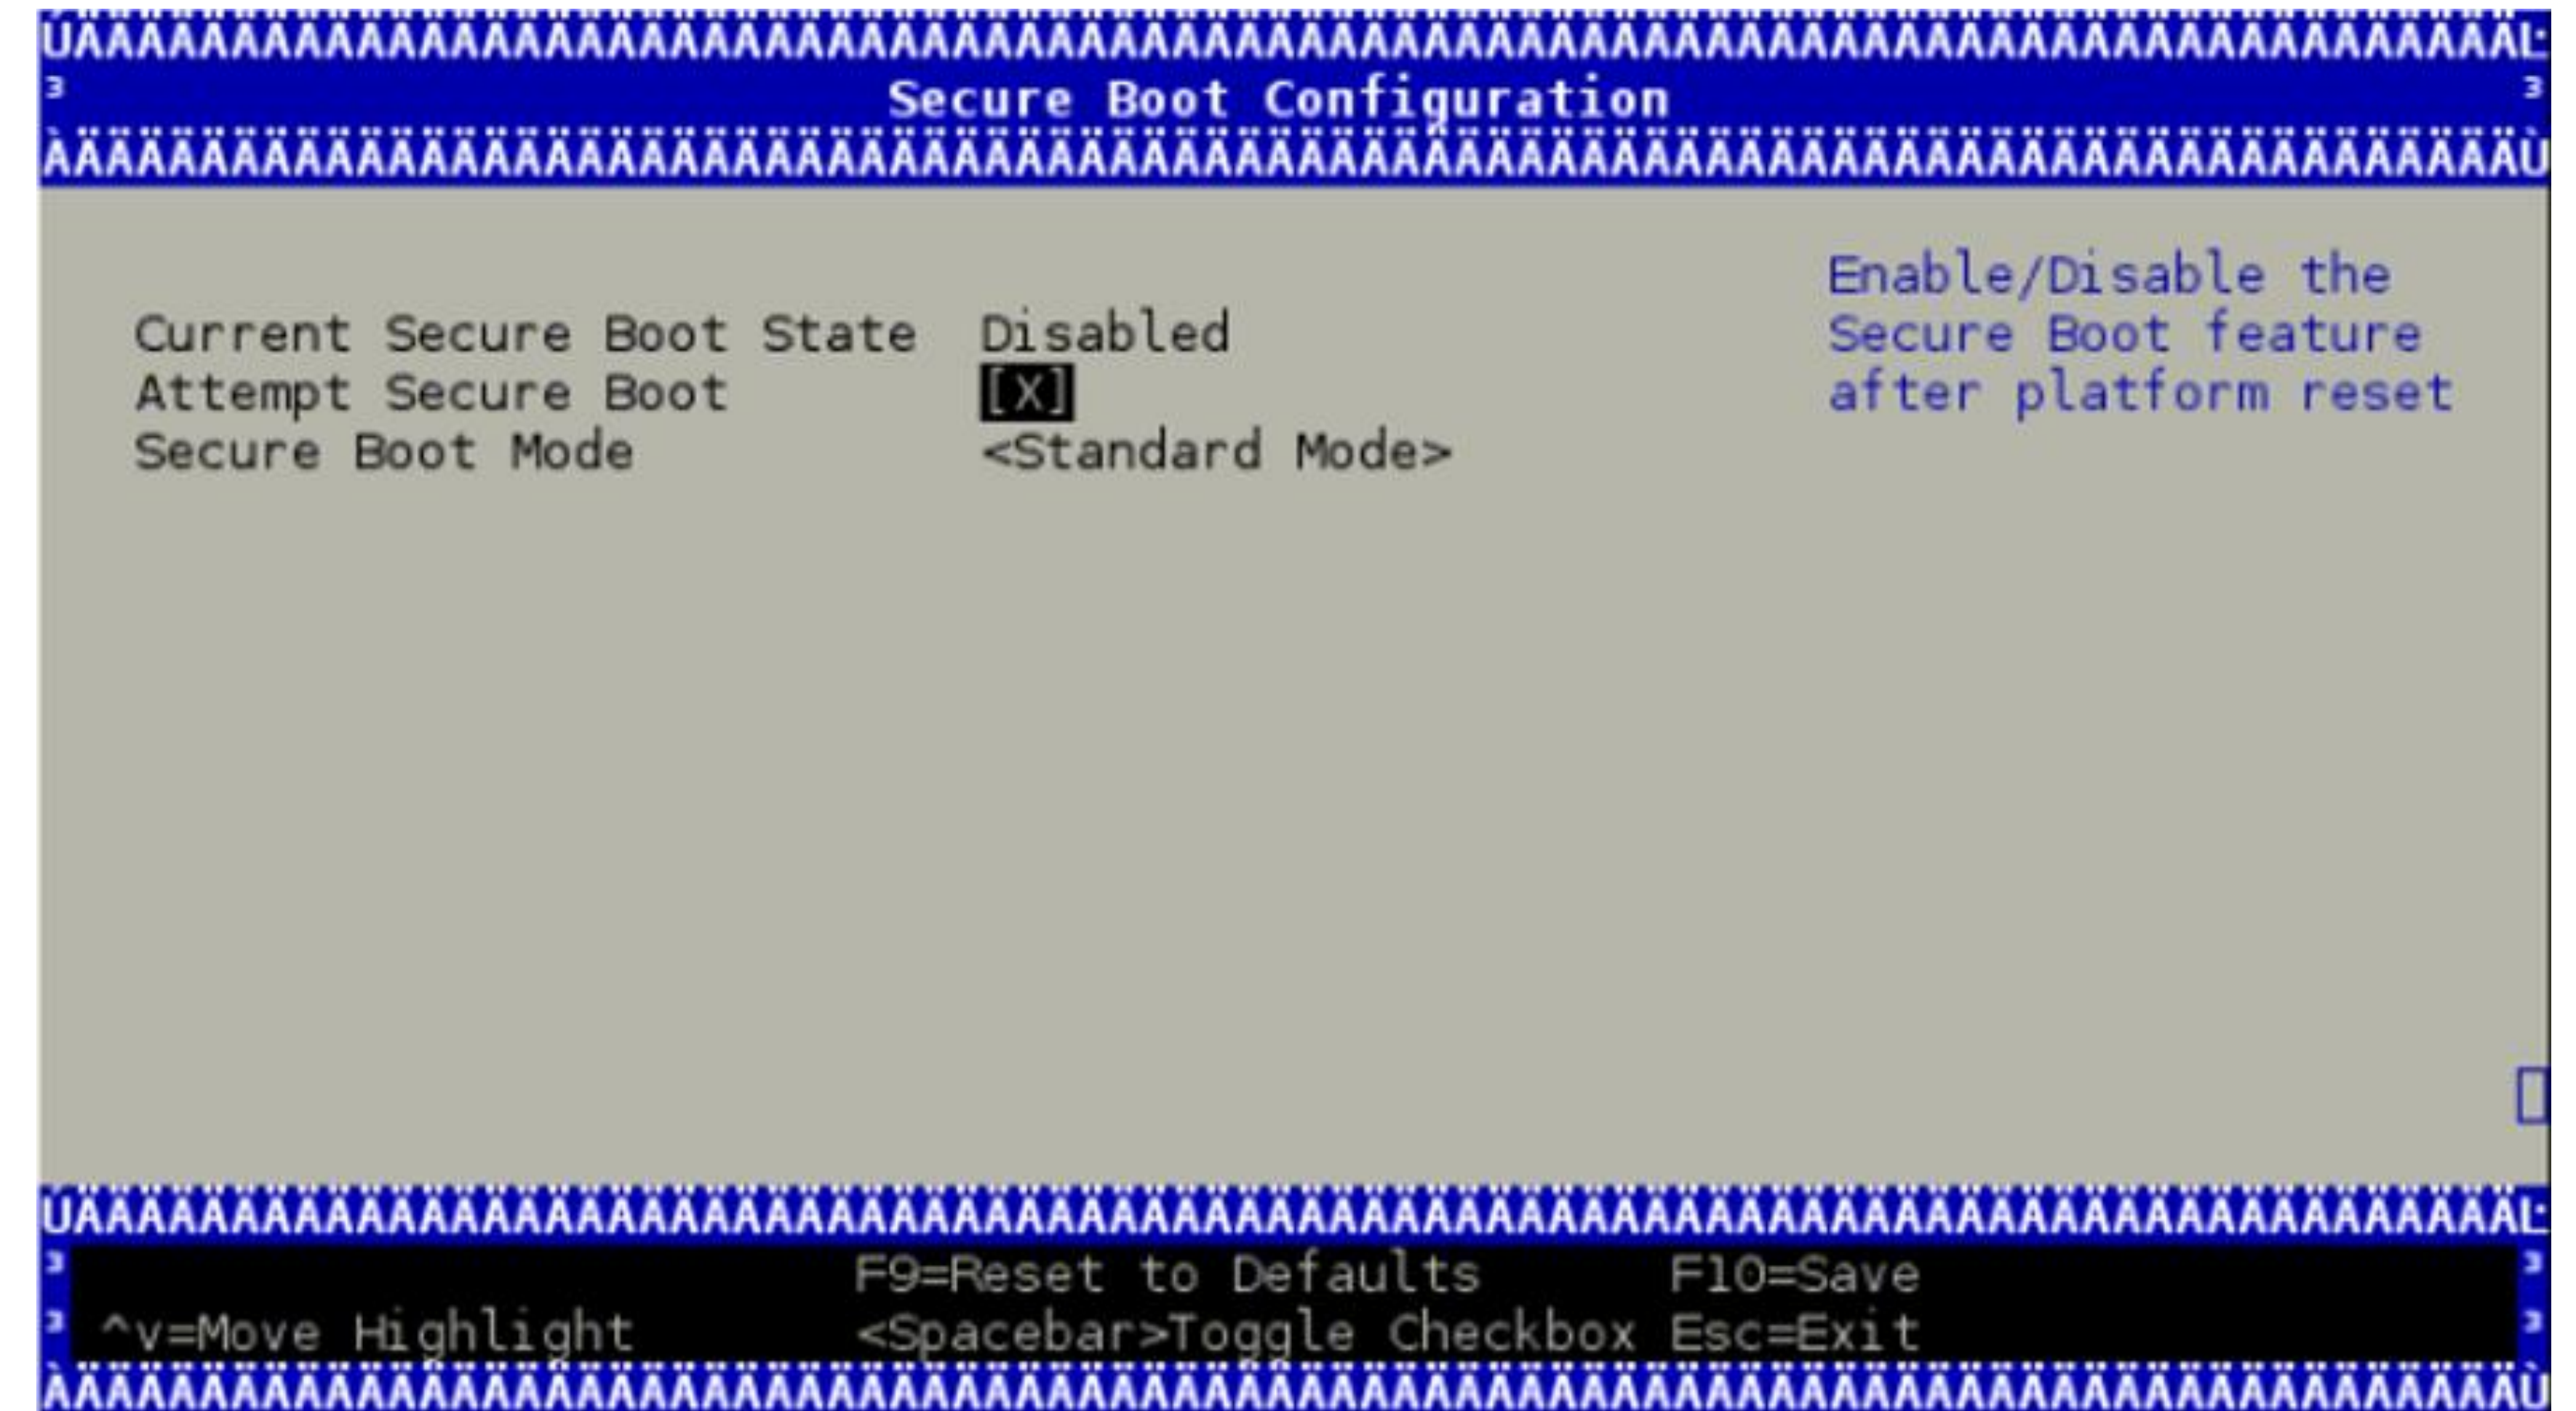
BFB – Disable Secure Boot

- Disable Secure Boot
- [UEFI Secure Boot - NVIDIA Docs](#)
 - Method#1 – UEFI menu
 - Method#2 – Redfish API by on-board BMC

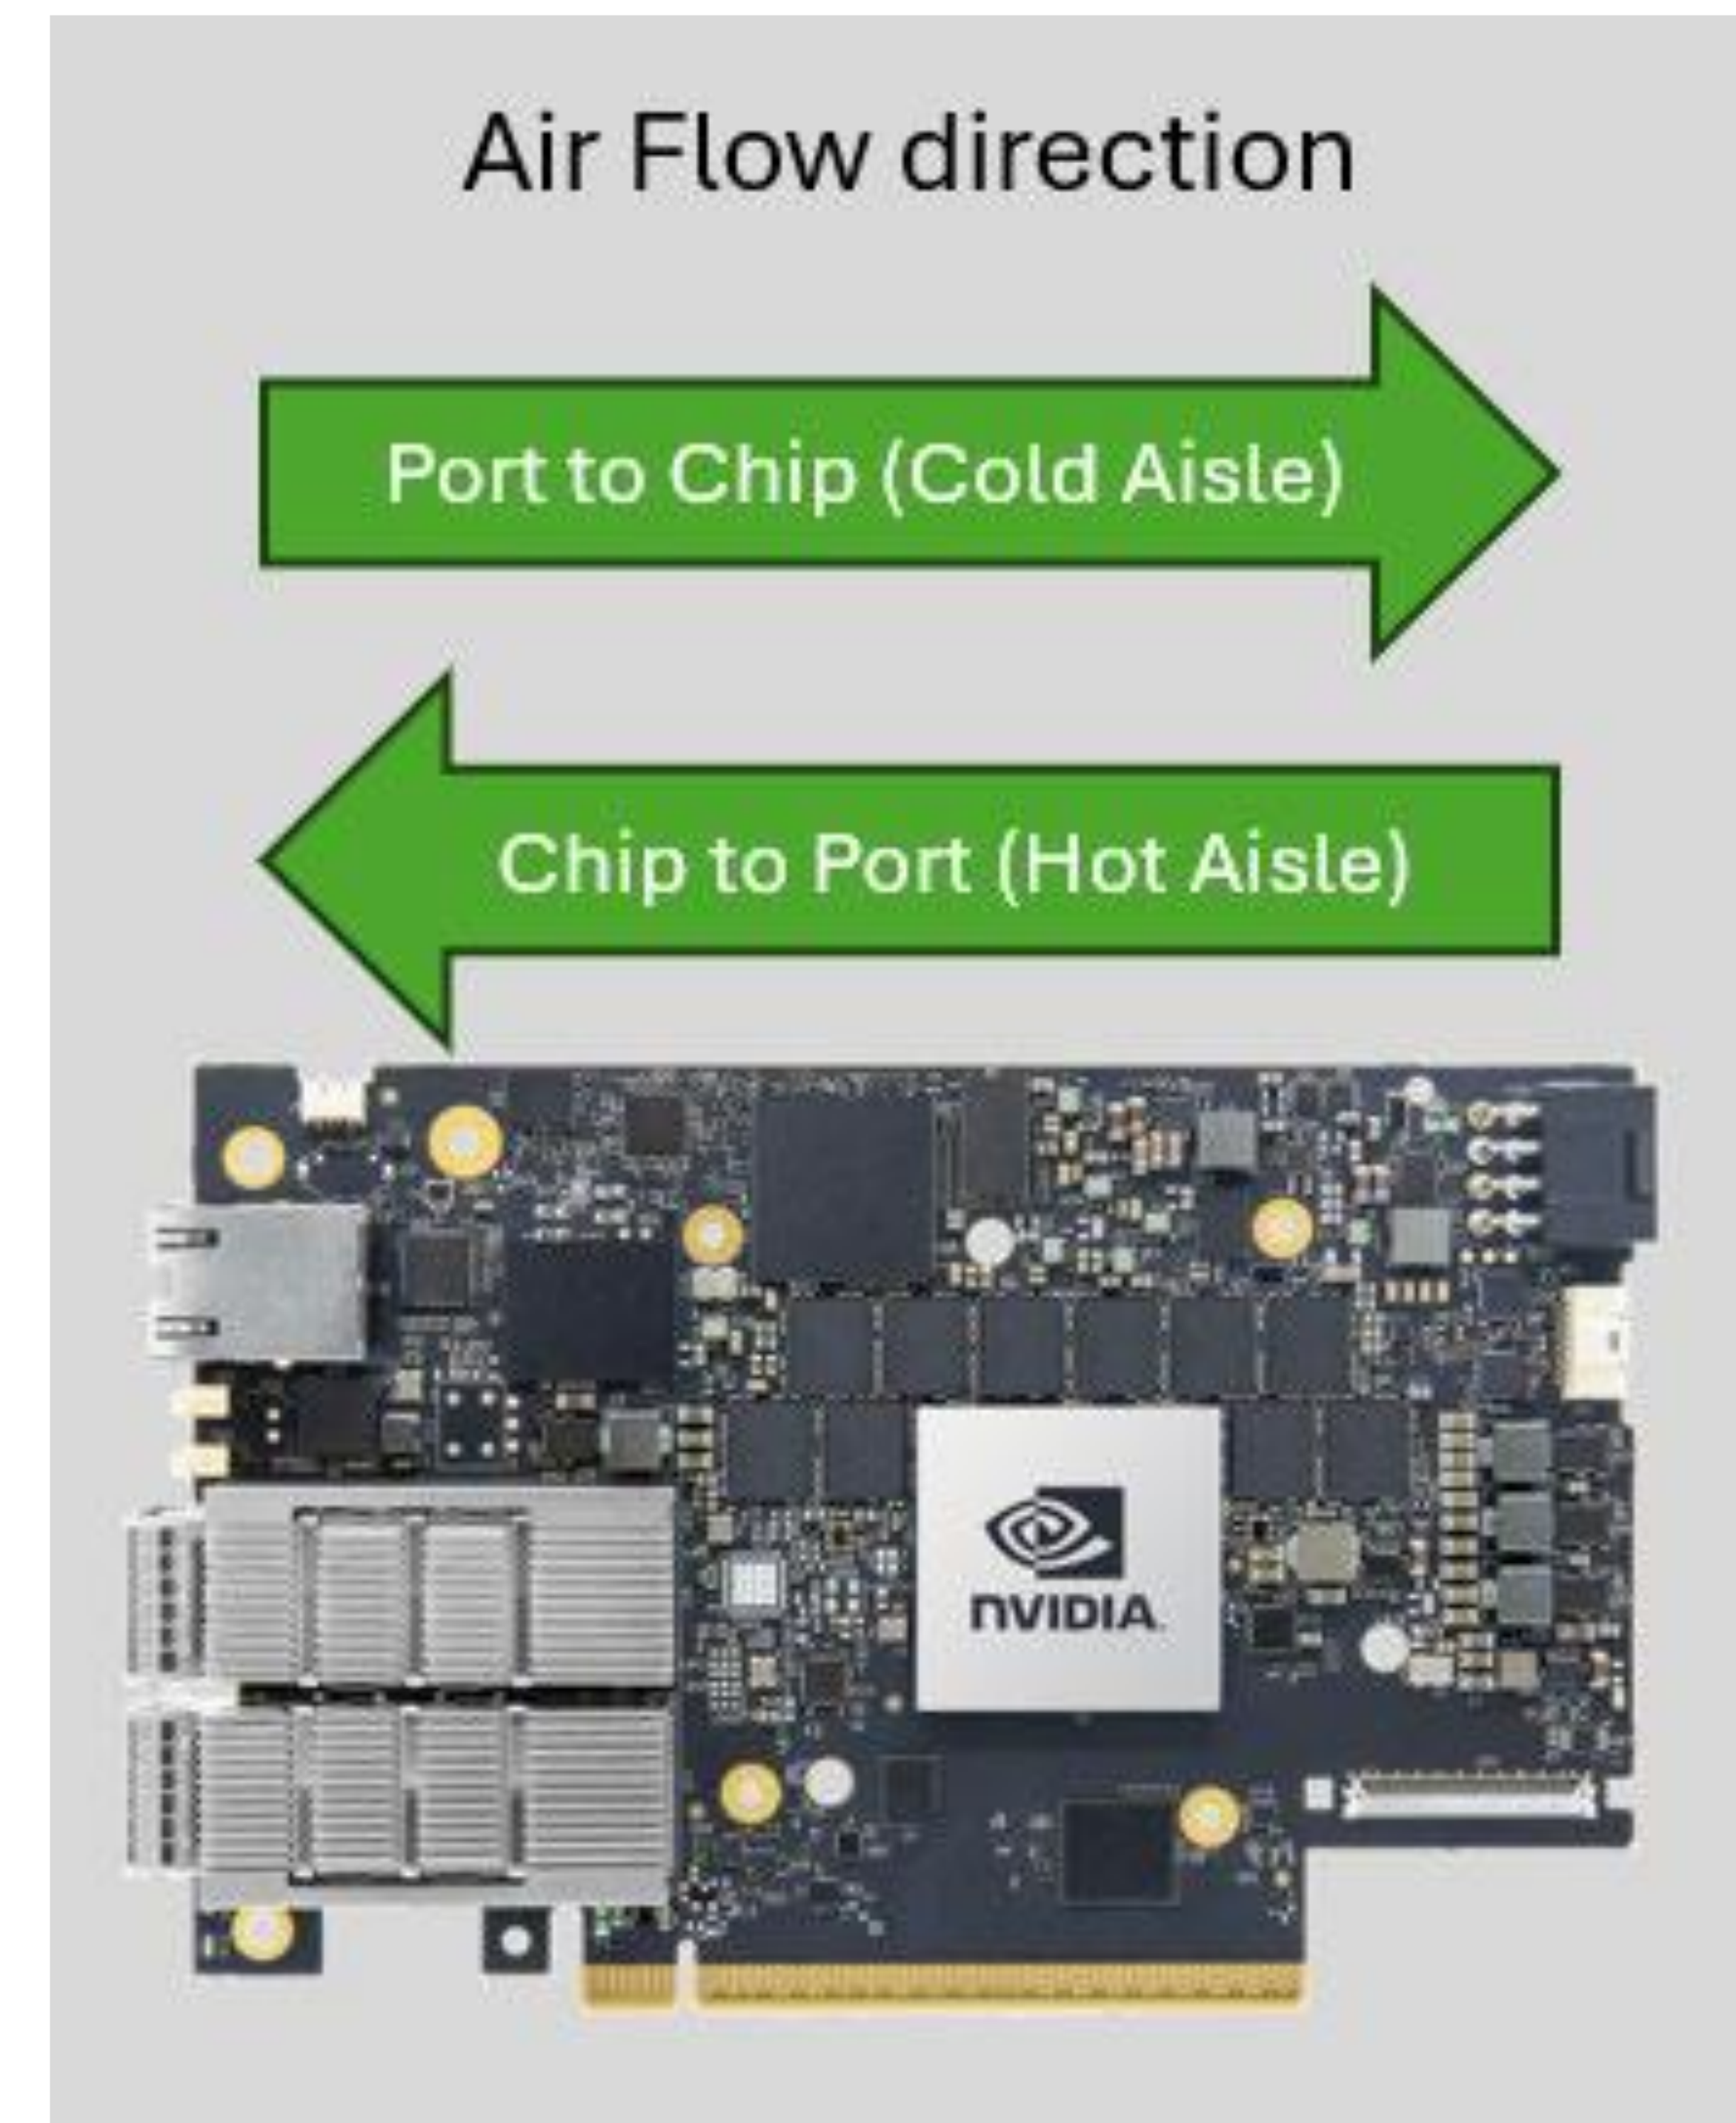
Cold Aisle Consideration

- Consult with NVIDIA Field Applications Engineering before starting Network NVQual thermal testing on BlueField-3 platforms in a cold aisle cooling environment.
- Some cases require additional measurement
- **1103274 NVIDIA BlueField-3 Networking Platform Product Specifications**
- B3240 Cold Aisle – OPN 900-9D3B6-00CN-PA0
Prototype now

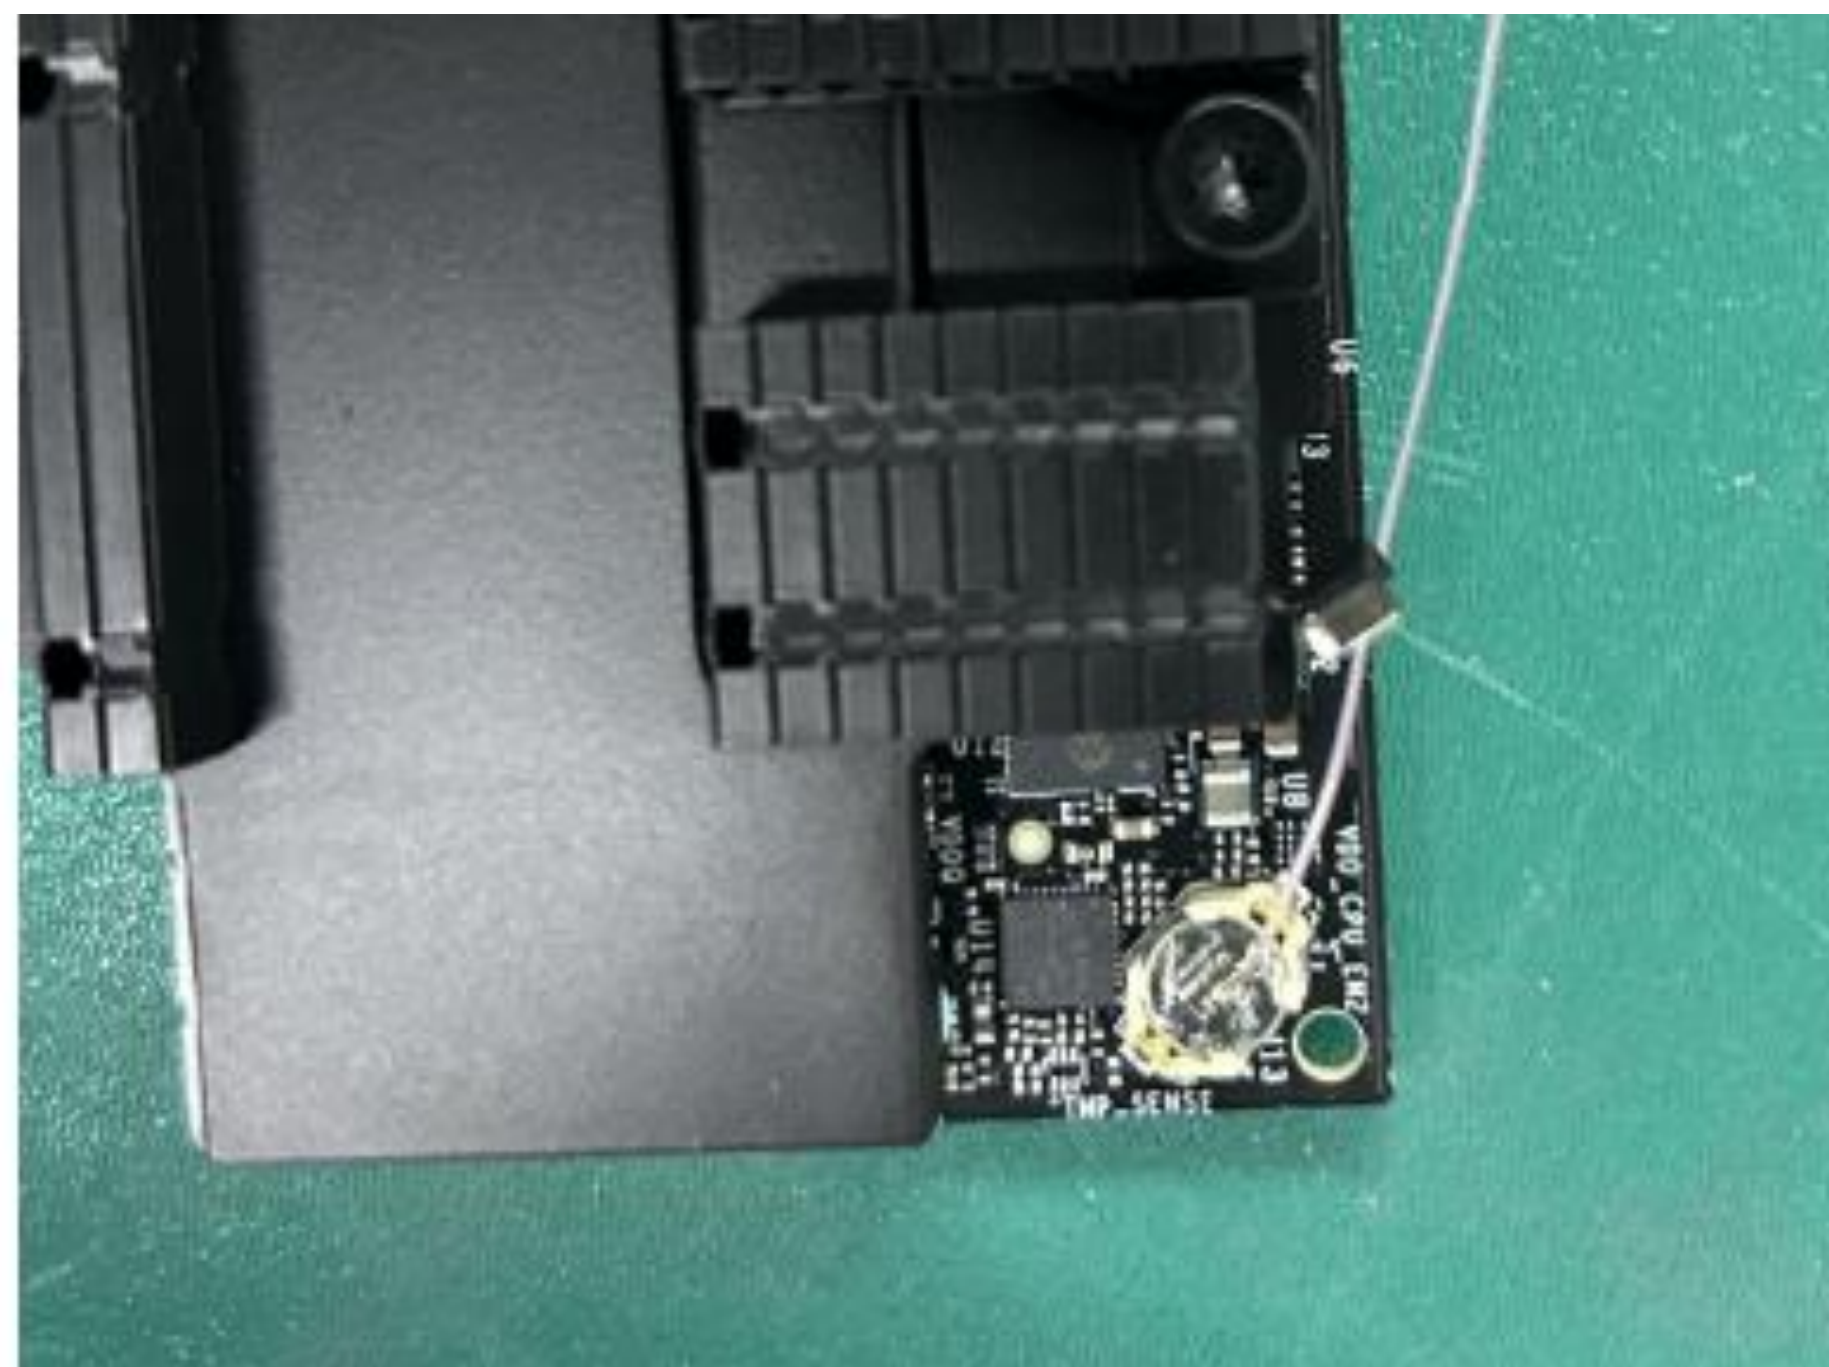
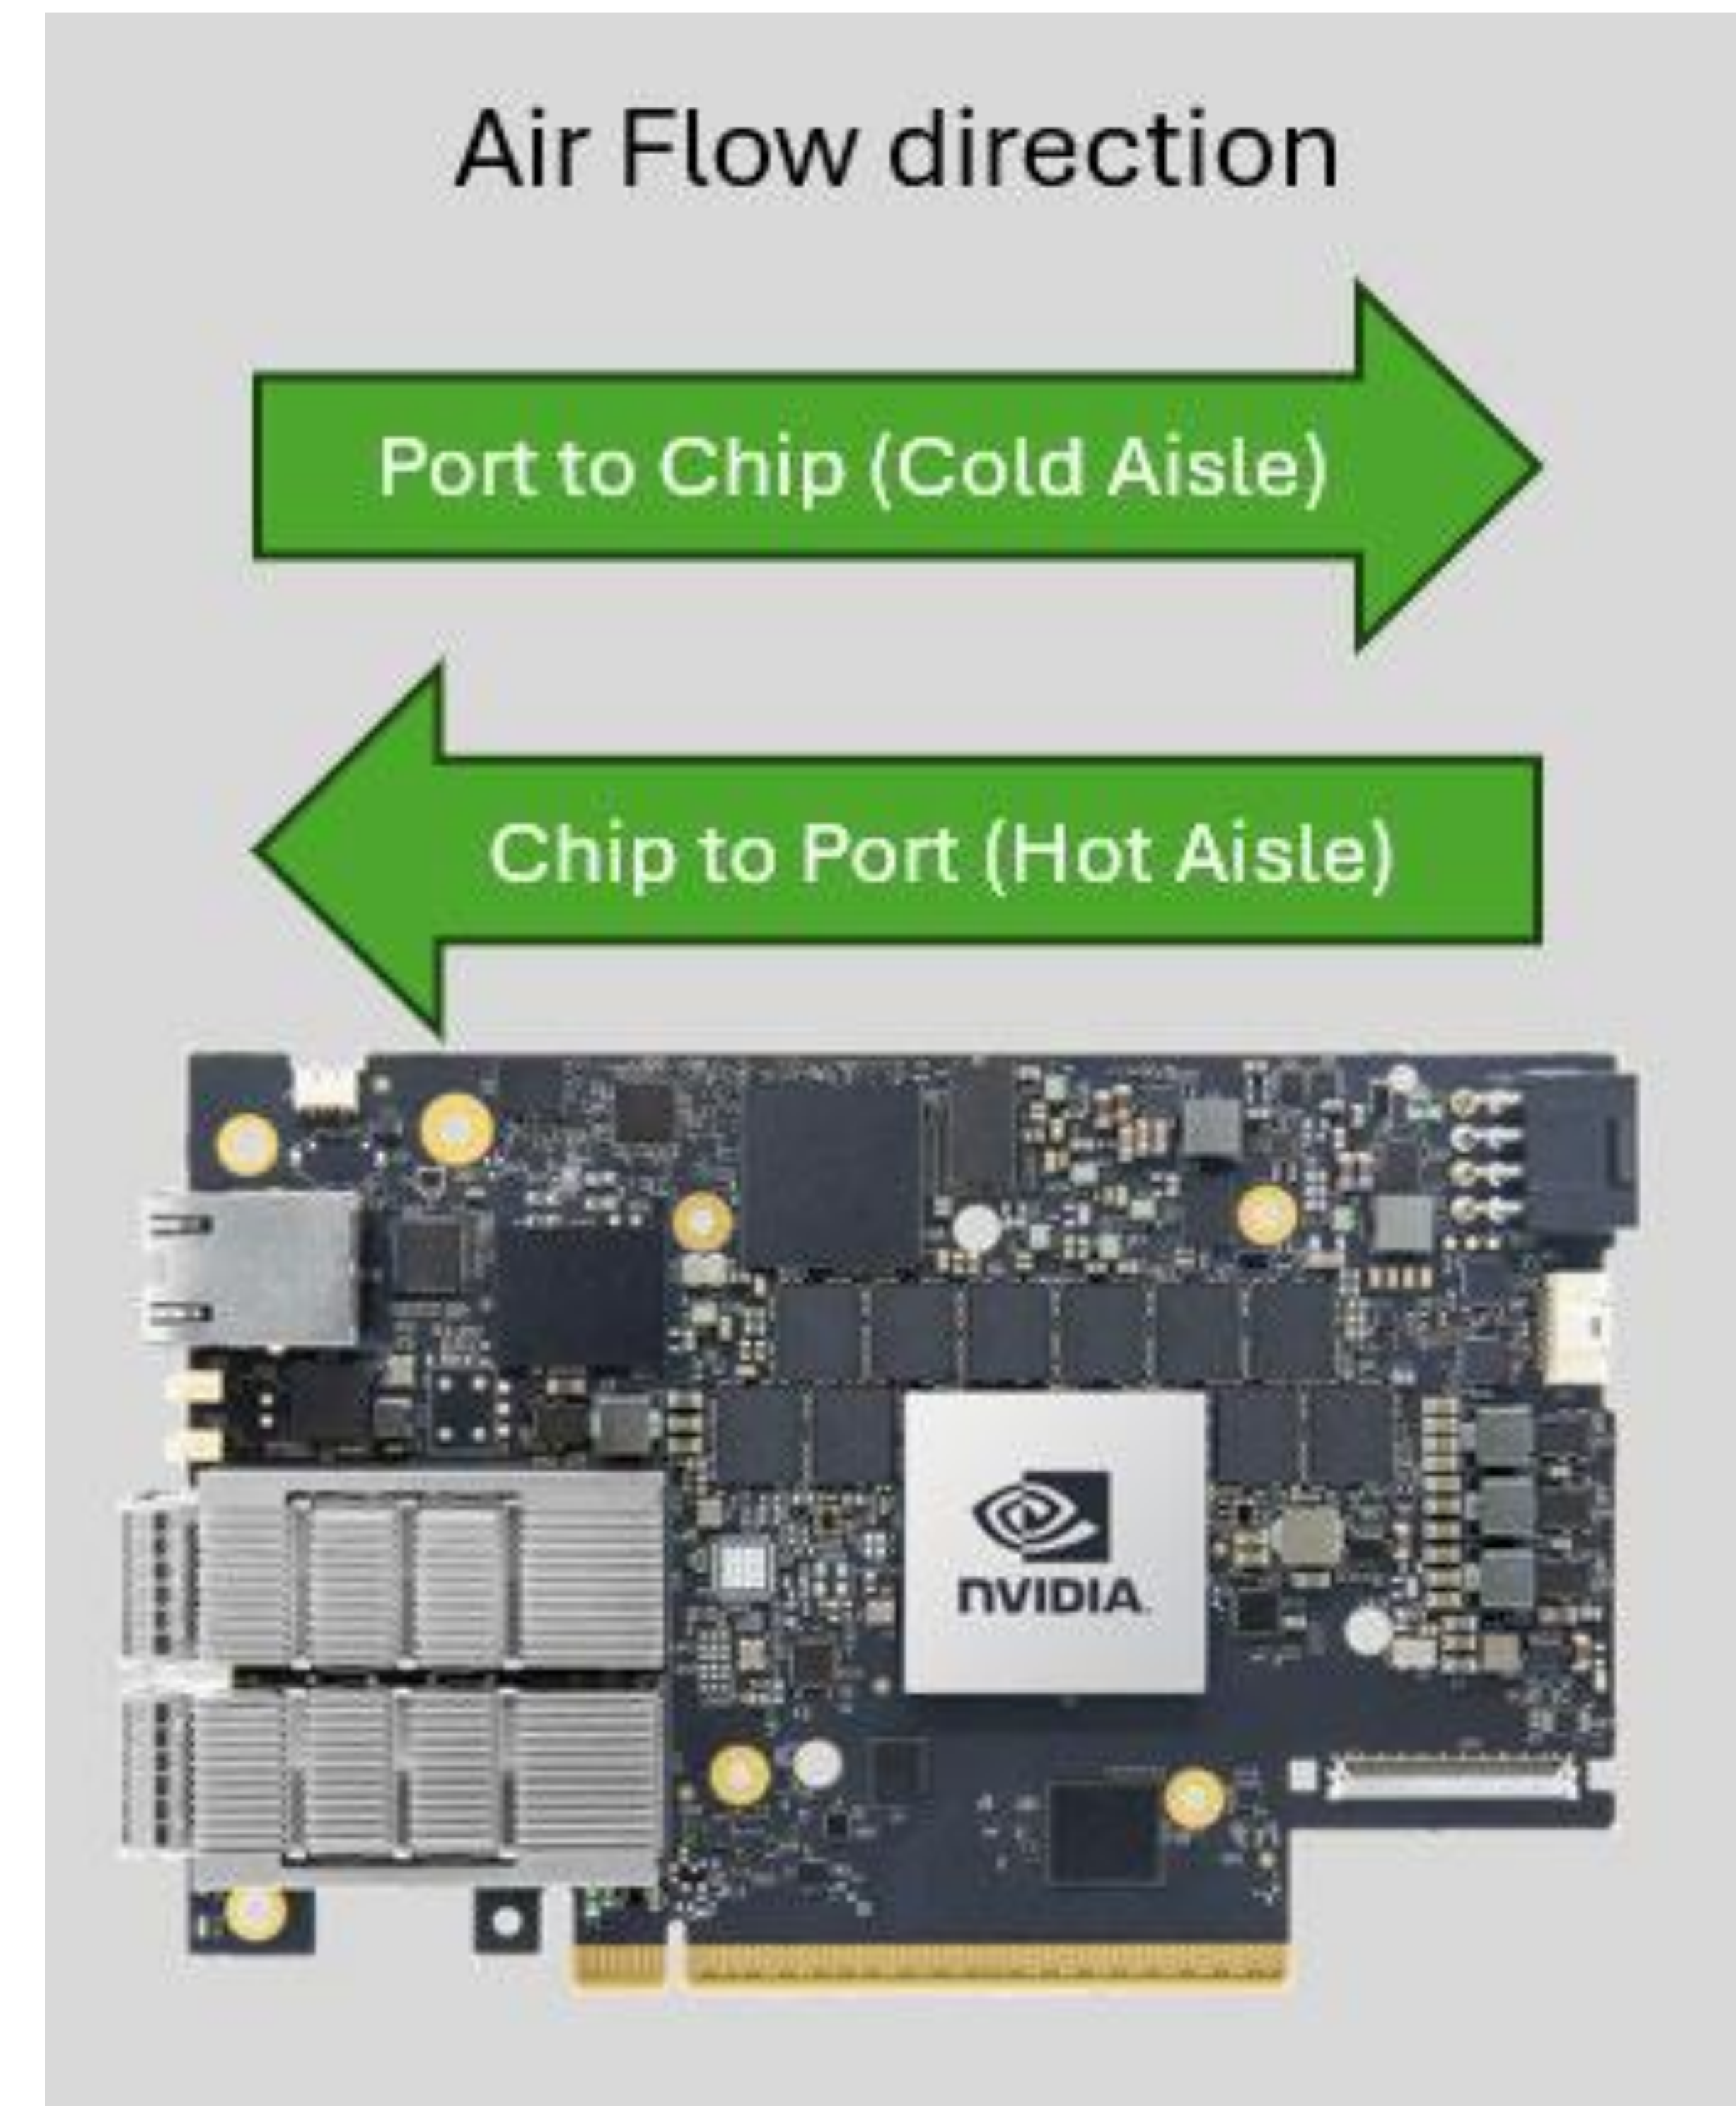
Cold Aisle Consideration

- 确定BF3是否是在server的冷通道(Cold Aisle)位置, 如果是需要在BF3的电池上贴上热电偶, 测试电池的温度, 记录整个运行nvqual过程中的温度值, 并摘取最大值, 和nvqual log 和report时一起提交。
- BF3的电池温度不能超过60度
