Nvidia OEM Network Product Update

2025 Q1

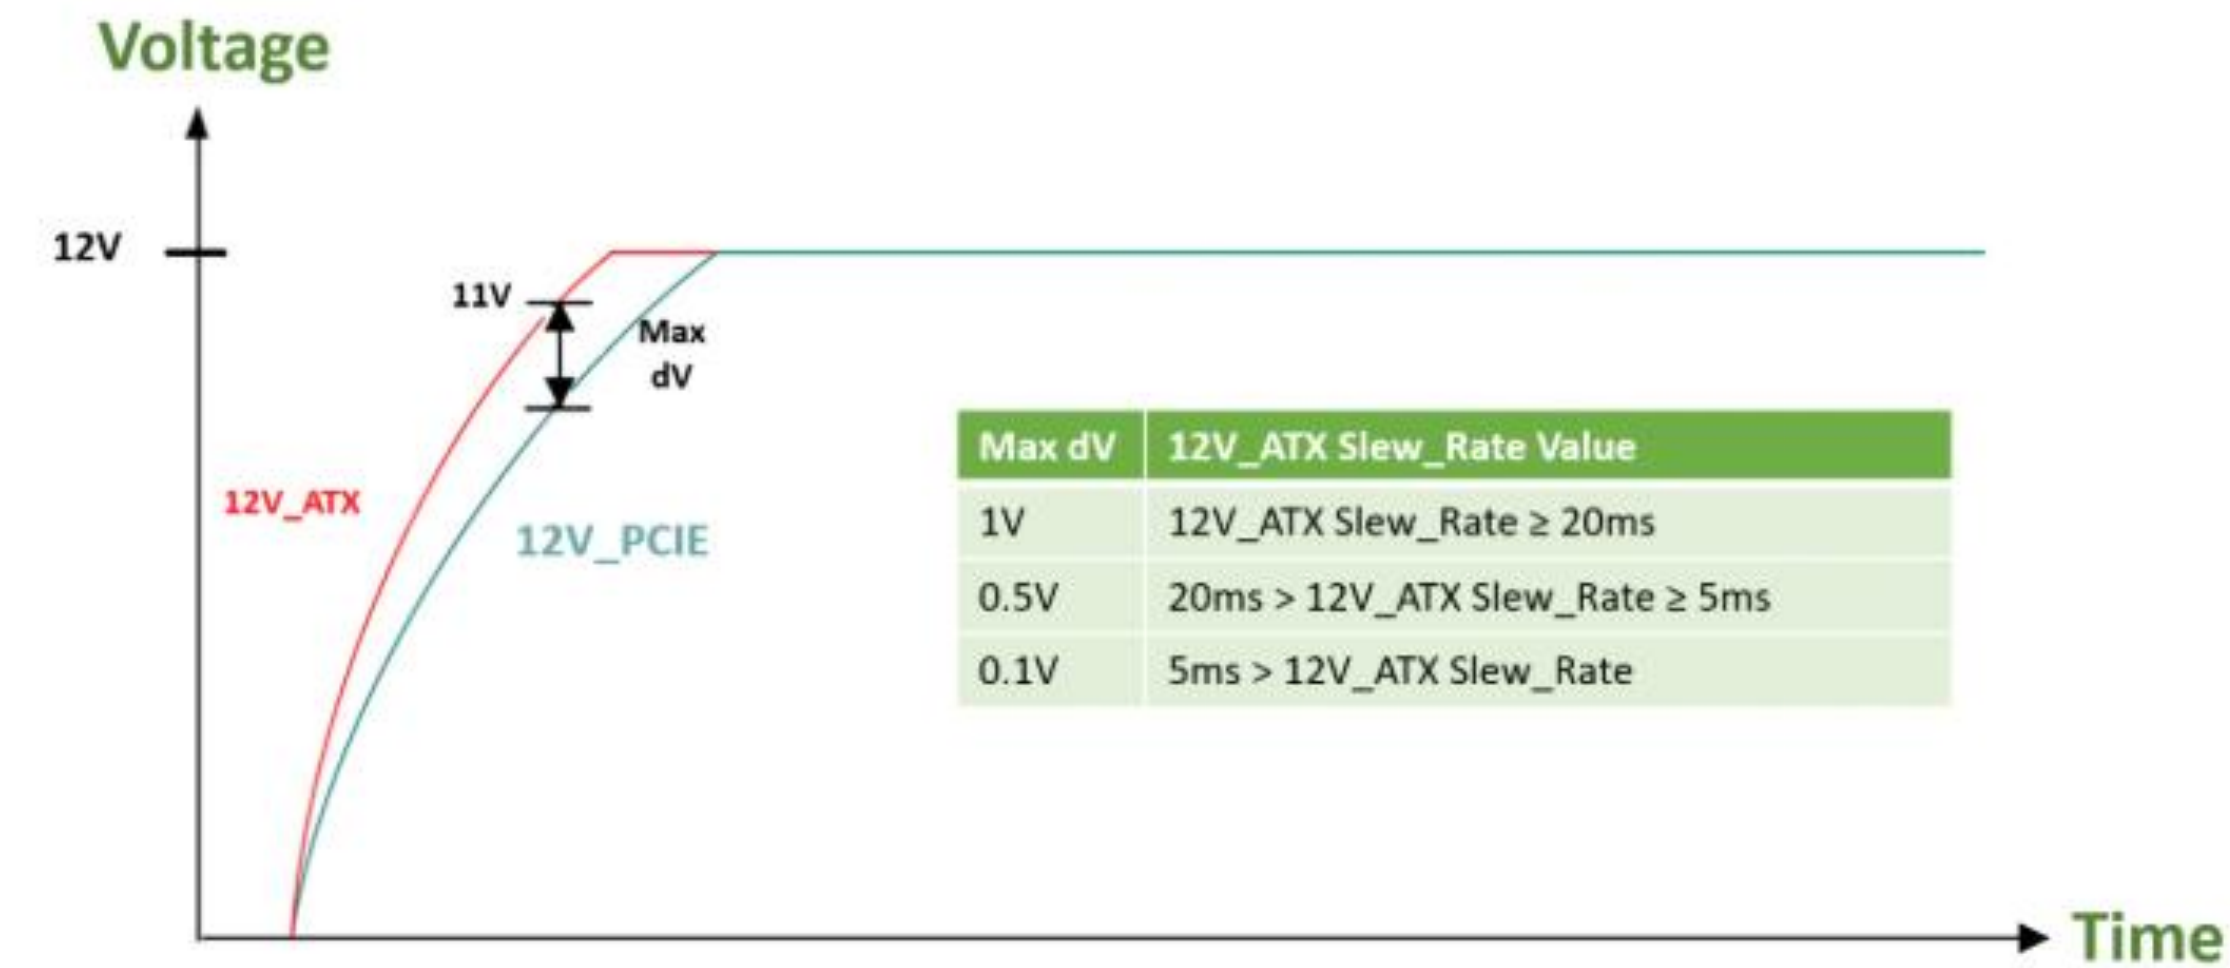
1. The 12V_ATX voltage can exceed the 12V_PCIE voltage by a maximum allowable voltage difference (dV) when the 12V_ATX reaches 11V. See below graph and table describing the dV between the 12V_ATX and 12V_PCIE voltages.

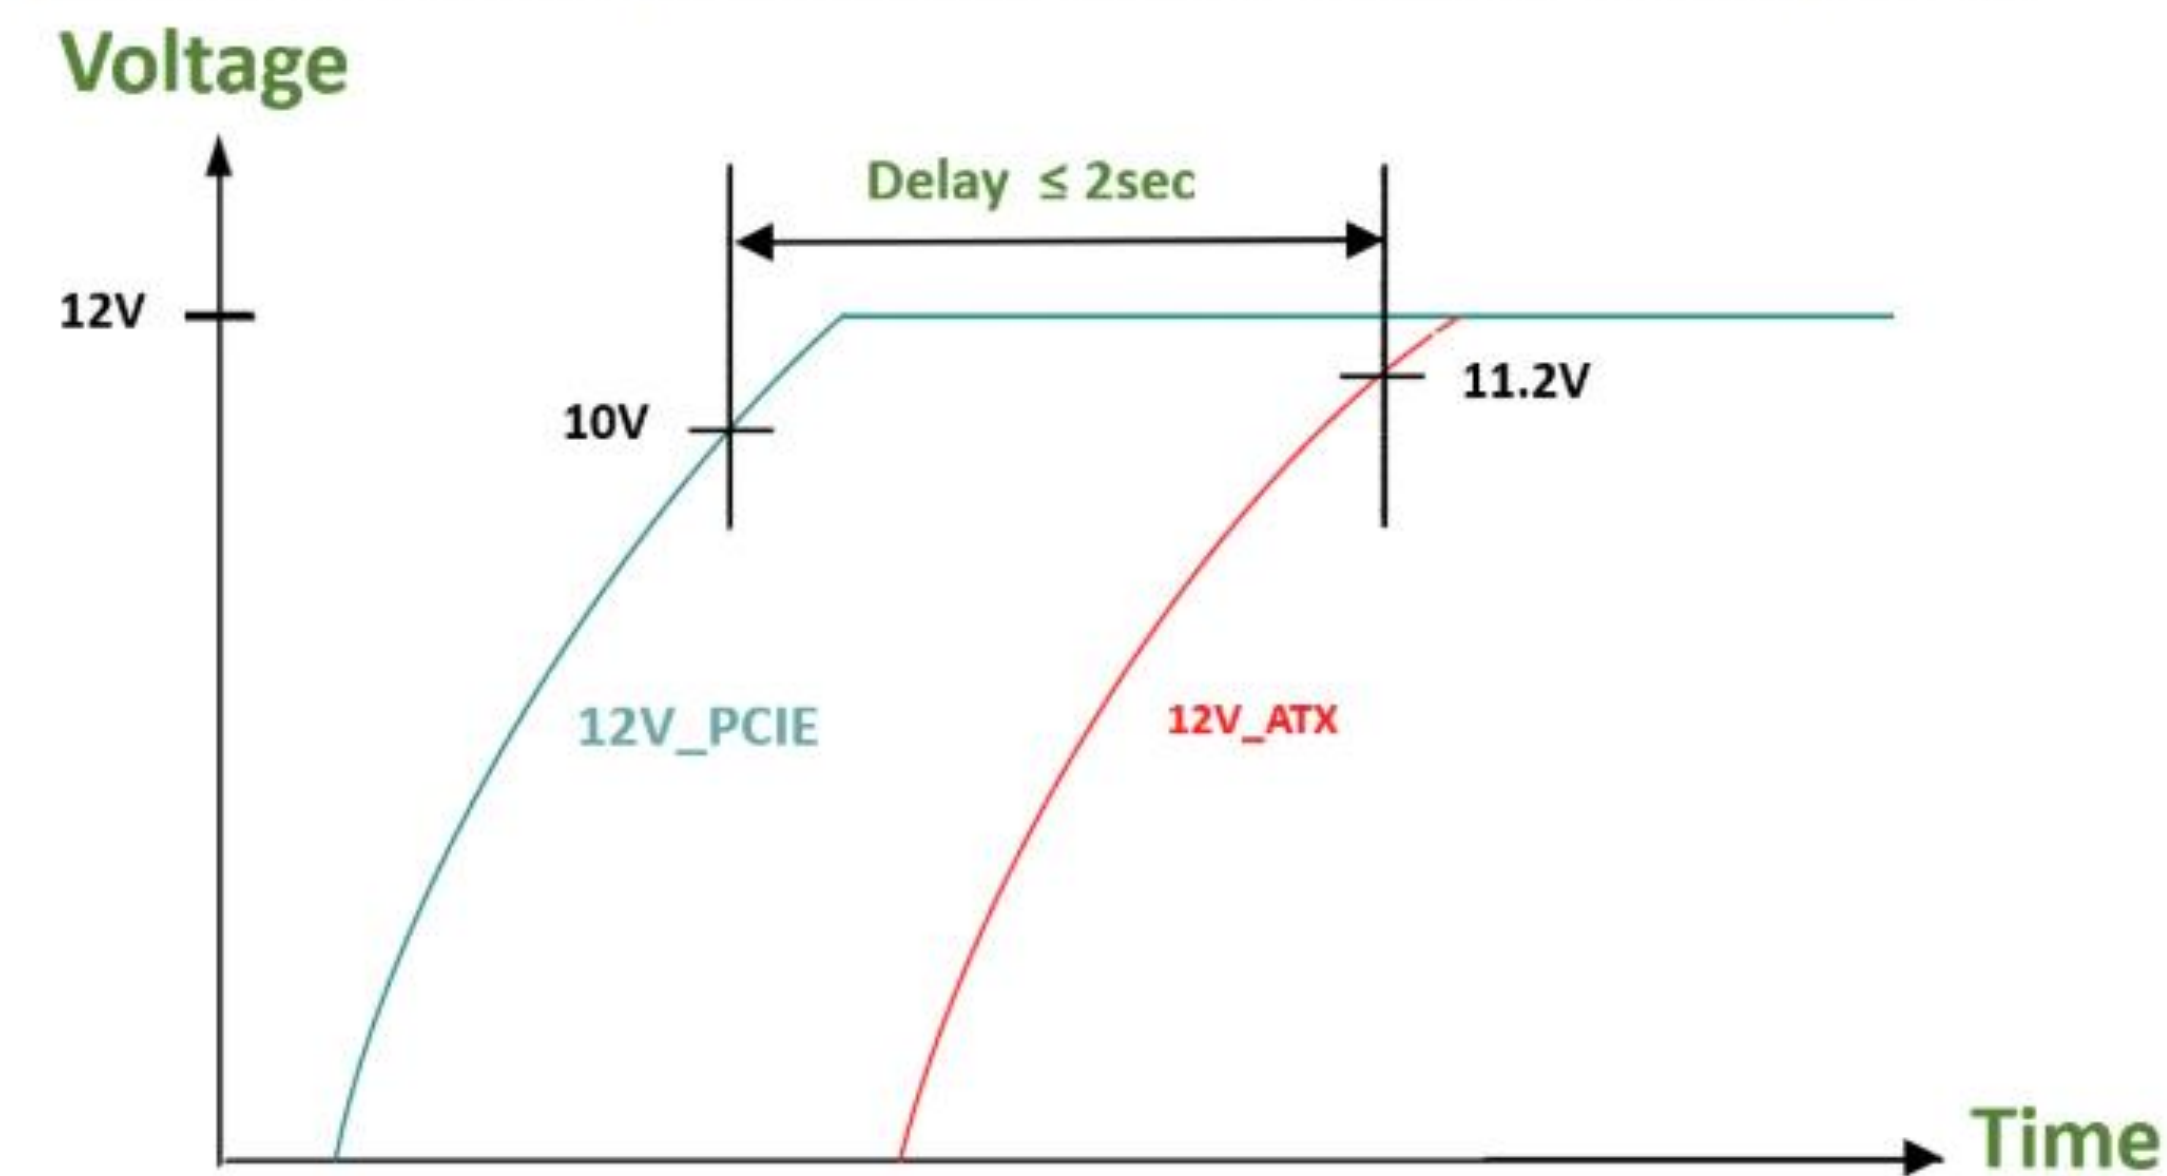
2. The 12V_ATX can be powered up after the 12V_PCIE, with a maximum delay of 2 seconds. The below graph illustrates the delay between the 12V_ATX and 12V_PCIE voltages at power-up.

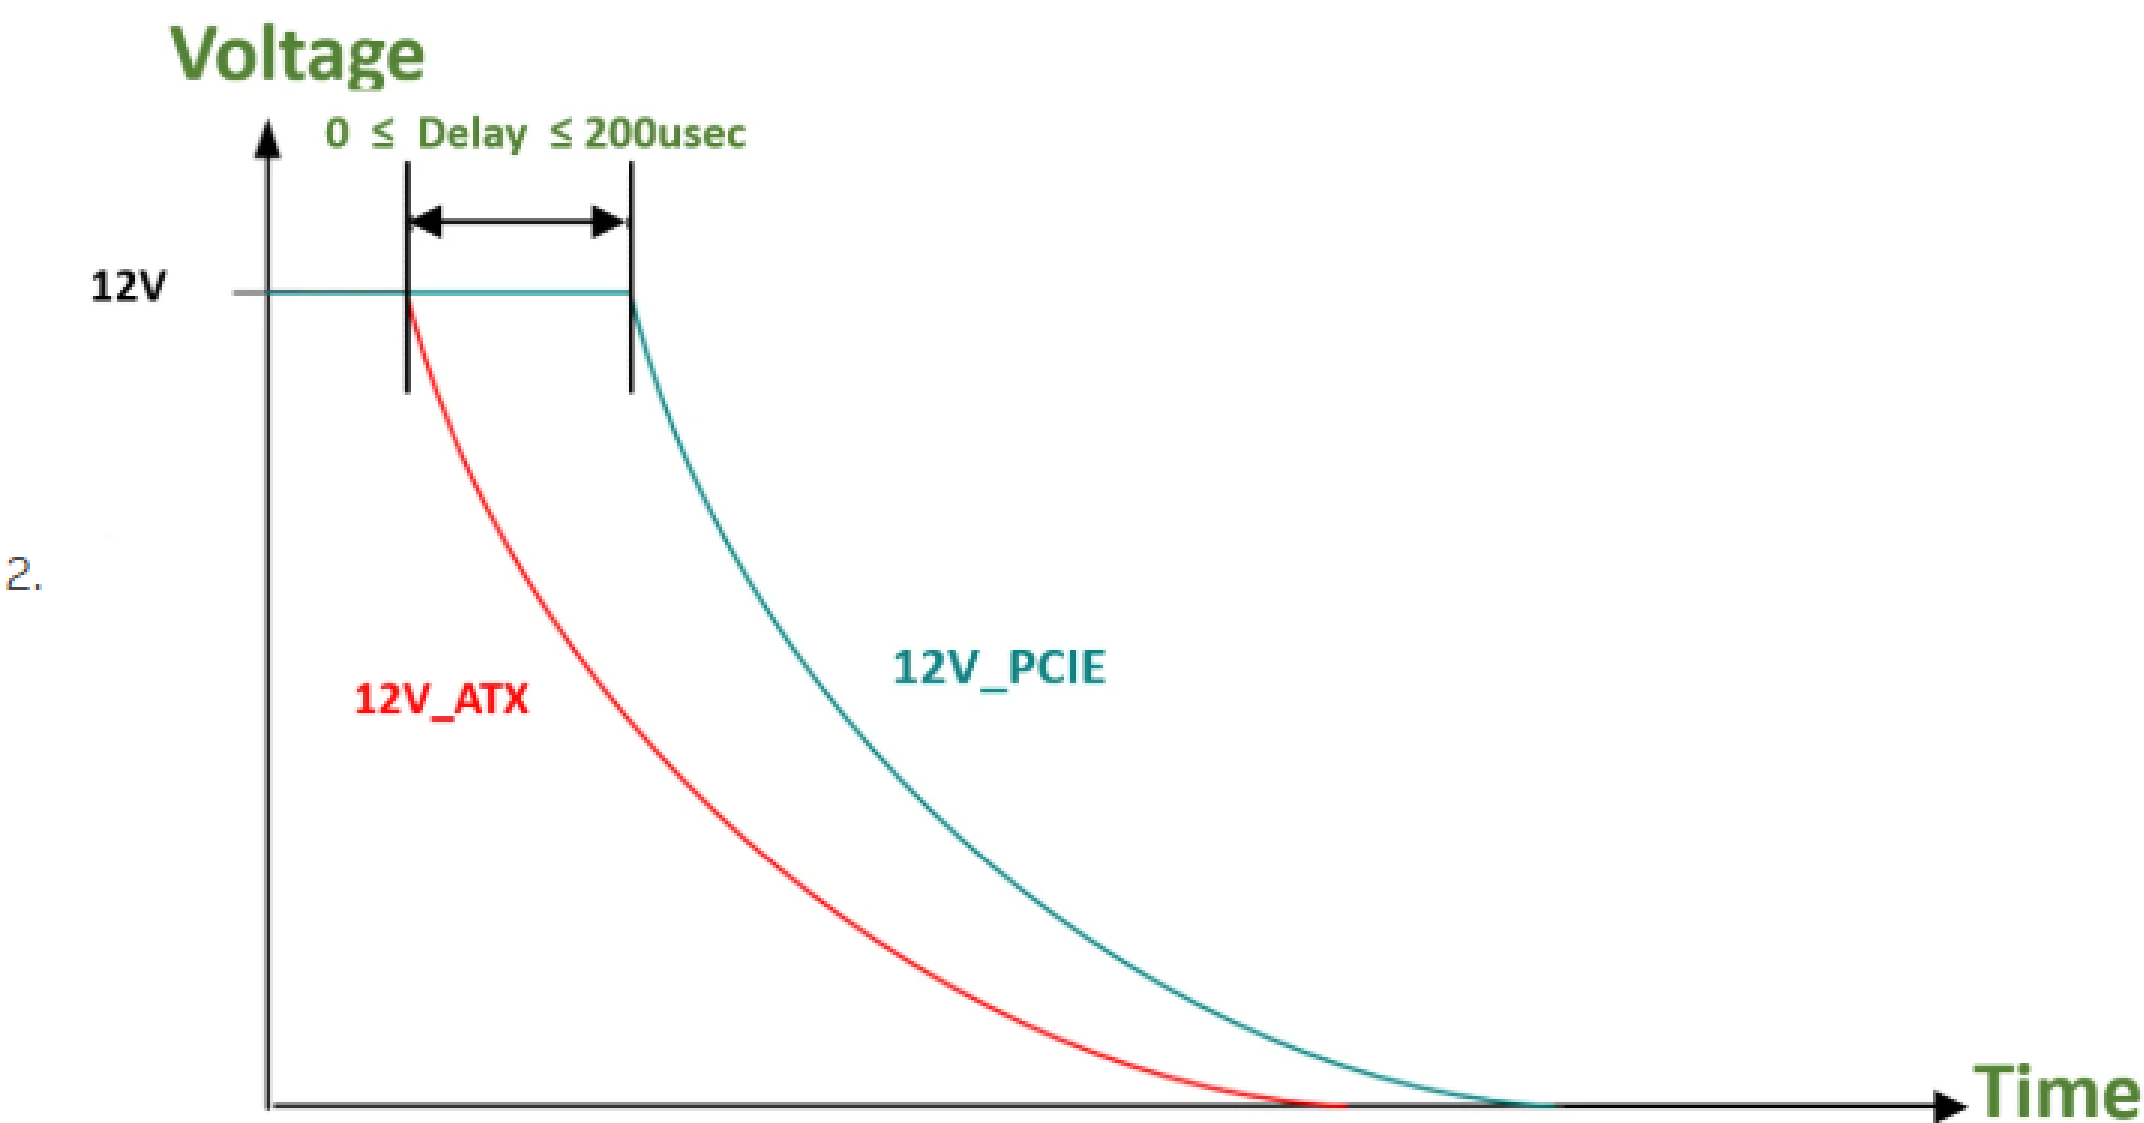
1. The 12V_PCIE voltage can be powered down simultaneously with the 12V_ATX voltage, or within a maximum delay of 200usec. The below graph illustrates the delay between the 12V_ATX and 12V_PCIE voltages at power-down.

3. The 12V_PCIE voltage must not be powered down while the 12V_ATX voltage is powered up.

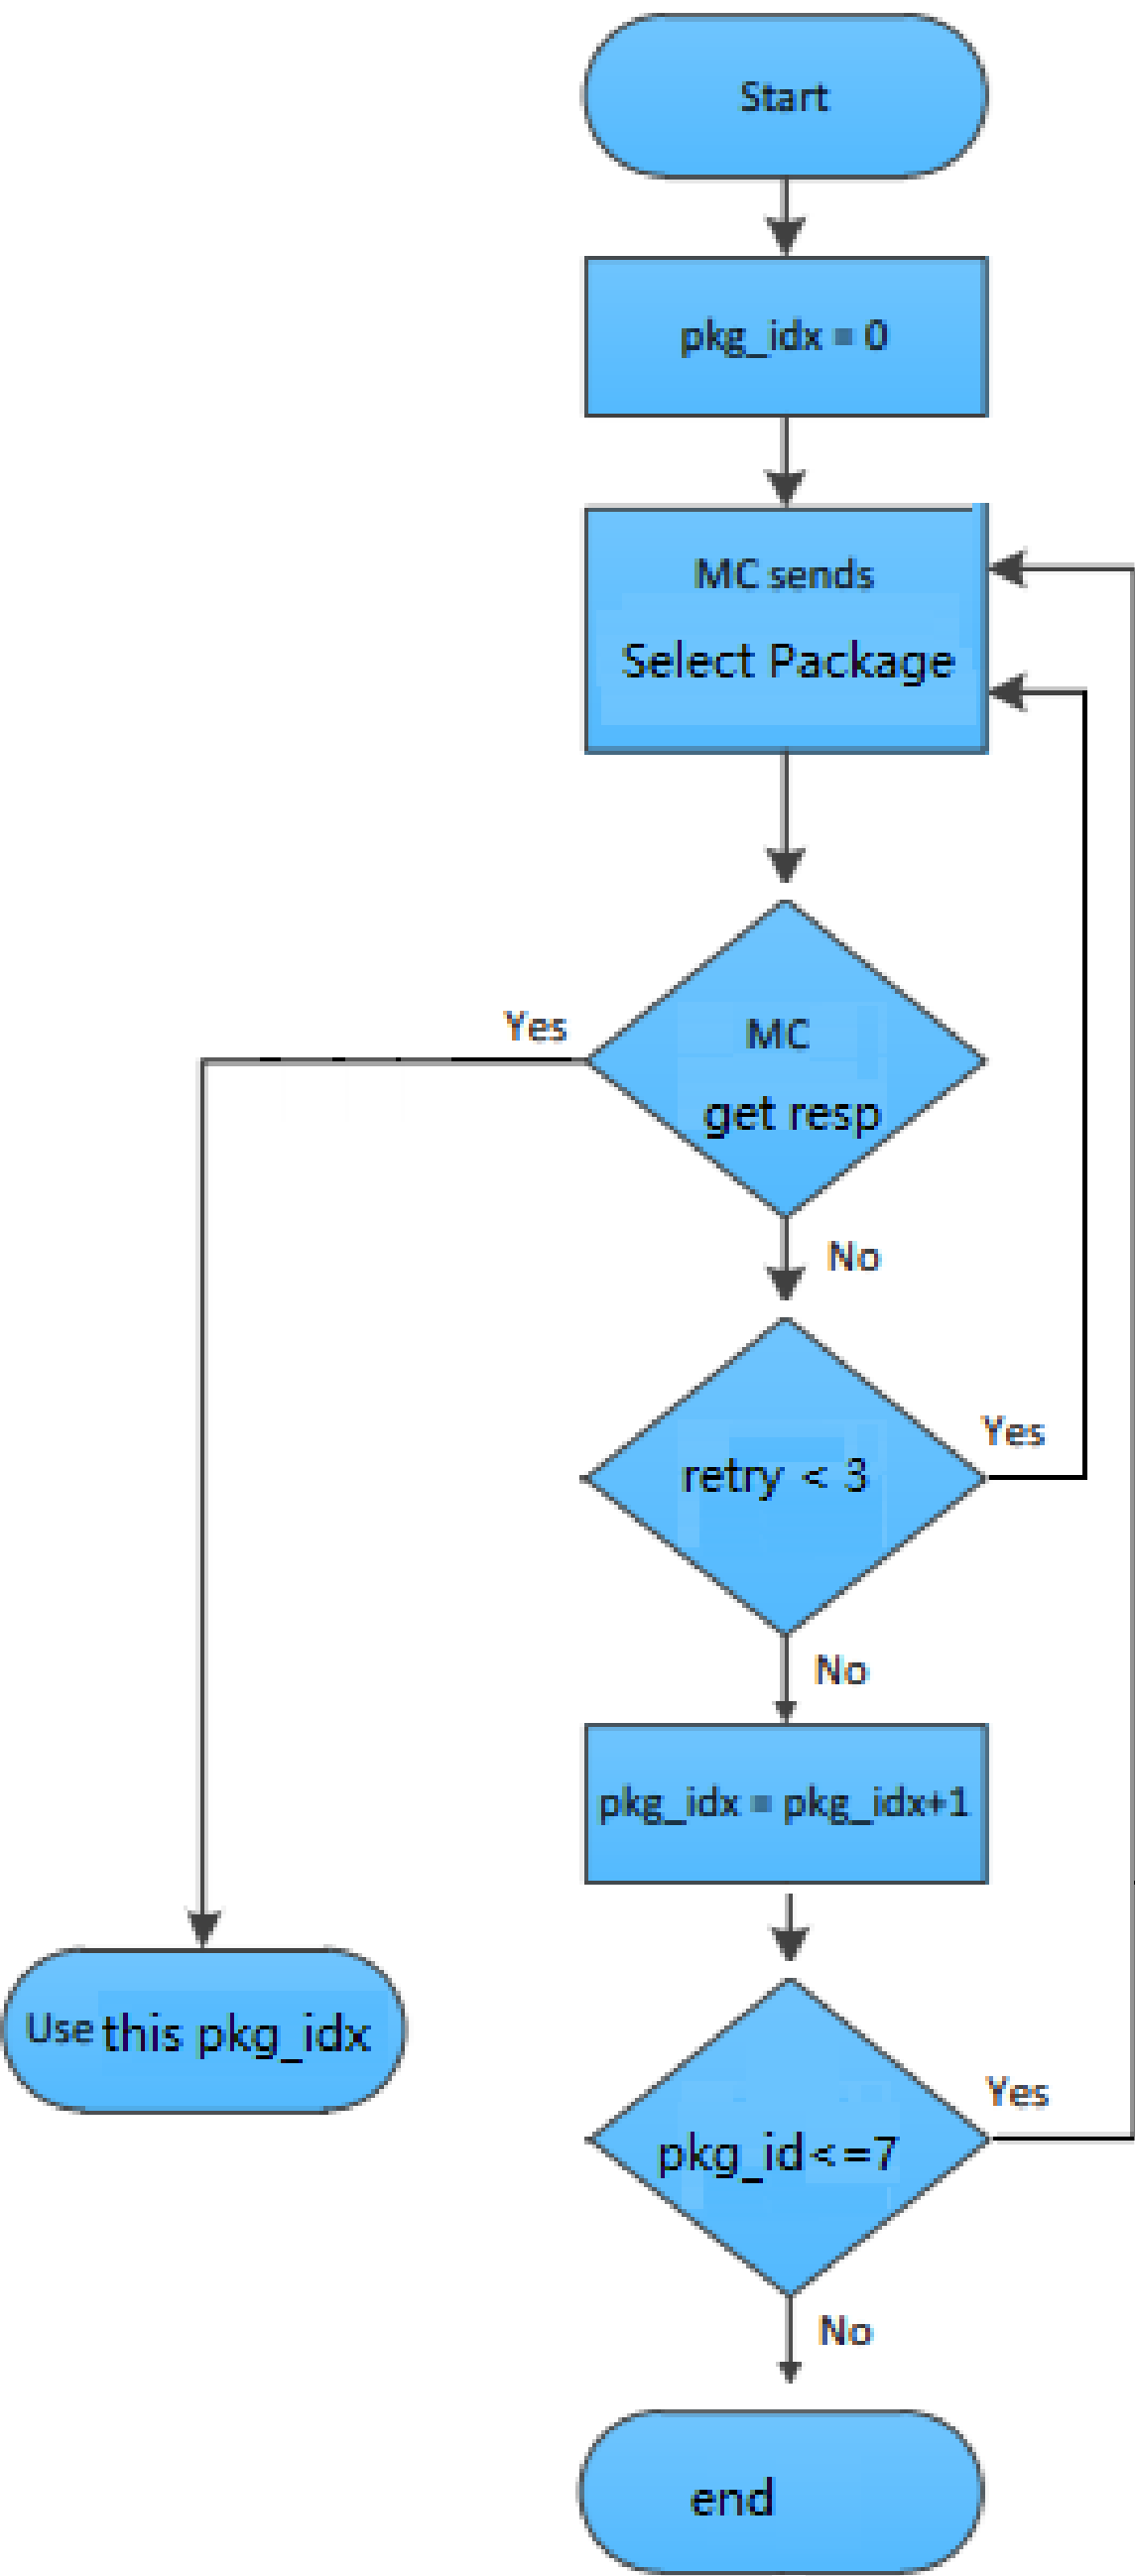
Network Controller Sideband Interface (NC-SI) Specification DSP0222

If the Management Controller receives a response within the specified response time, it can record that it detected a package at that ID. If the Management Controller does not receive a response, it is recommended that the Management Controller retry sending the command. Three total tries is typical. (This same retry process should be used when sending all commands to the Network Controller and will be left out of the descriptions in the following steps.) If the retries fail, the Management Controller can assume that no Network Controller is at that Package ID and can immediately repeat this step 2) for the next Package ID in the sequence.

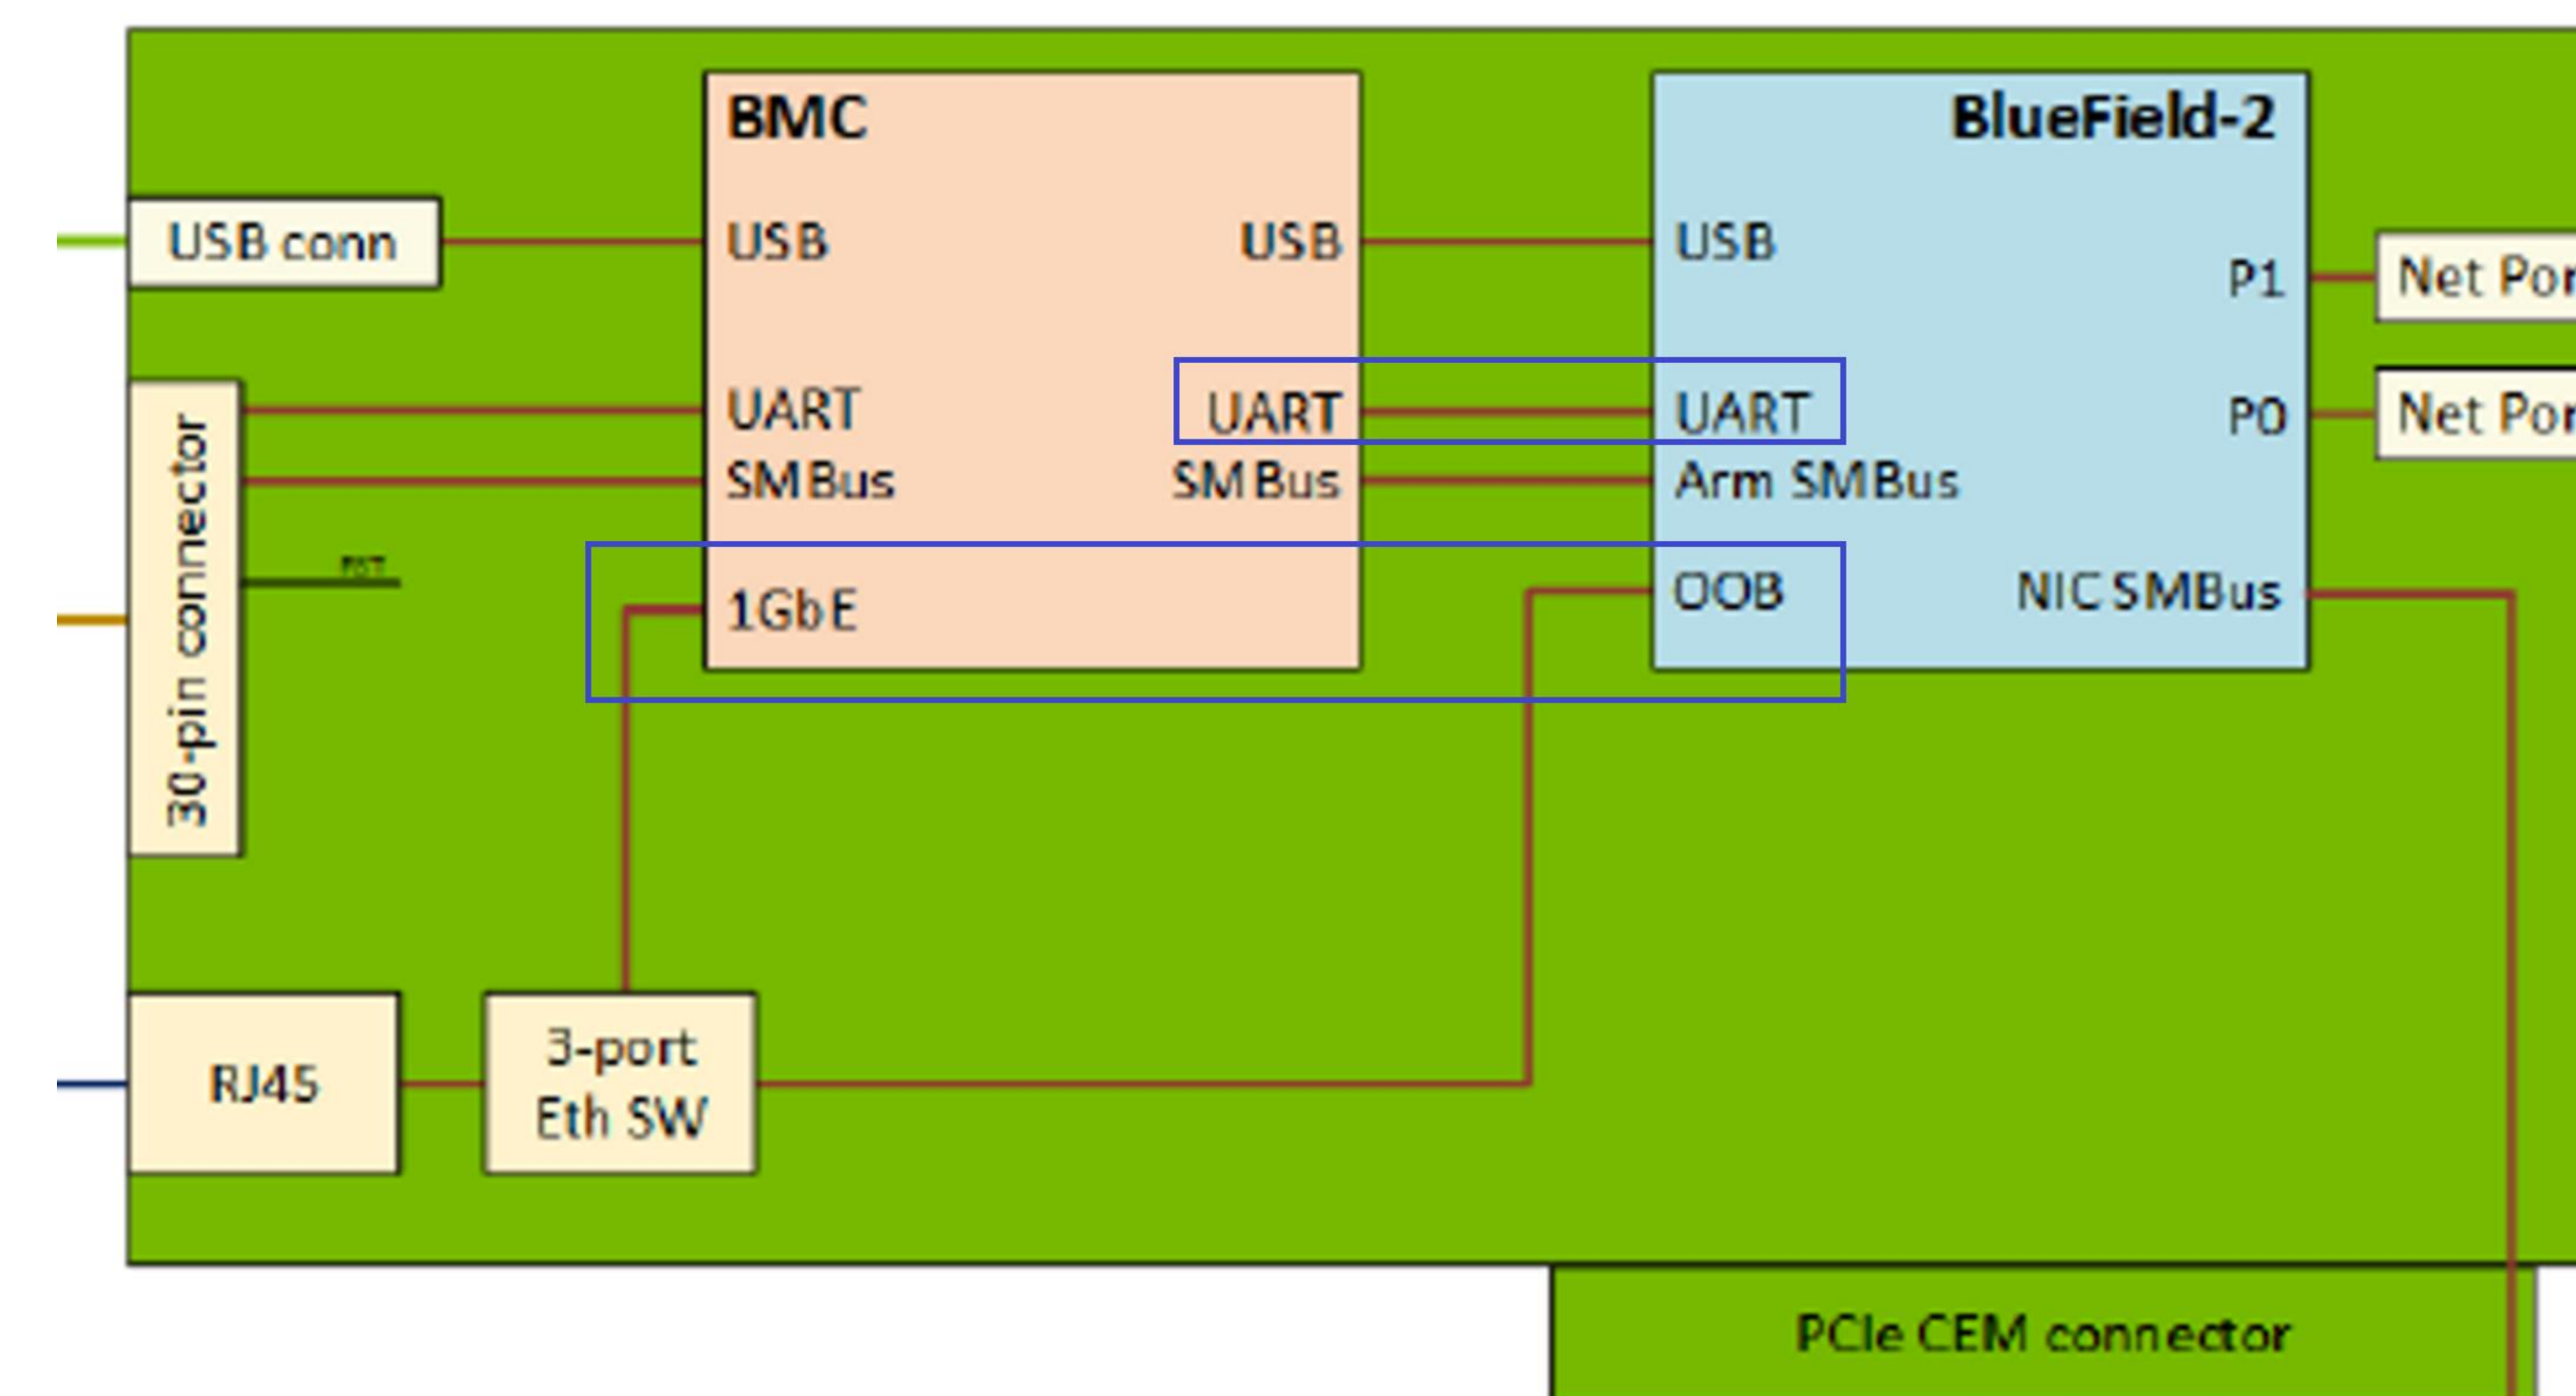
DPU ARM/BMC In-band management(1/4)

- Access DPU BMC without OOB connected.
 - Login DPU ARM from Host through IP/UART over rshim over PCIe
 - minicom -D /dev/rshim0/console
 - ssh root@dpu_tmfifo_net0
 - IPMI to set DPU BMC static IP
 - sudo ipmitool lan set 1 ipsrc static
 - sudo ipmitool lan set 1 ipaddr 11.11.11.2
 - sudo ipmitool lan set 1 defgw ipaddr 11.11.11.1
 - sudo ipmitool lan set 1 netmask 255.255.255.0
 - sudo ifconfig oob_net0 11.11.11.1/24 up
 - SSH BMC from DPU ARM
