# SURFACE EFFECTS ON LOW CYCLE FATIGUE BEHAVIOR IN IN718 ALLOY

Prabir R. Bhowal<sup>1</sup>, Darryl Stolz<sup>1</sup>, Agnieszka M. Wusatowska-Sarnek<sup>1</sup>, Rick Montero<sup>1</sup>

<sup>1</sup>Pratt & Whitney; 400 Main Str.; M/S 114-40; East Hartford, CT 06108, USA

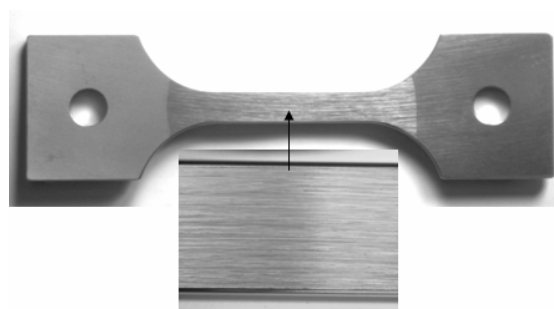
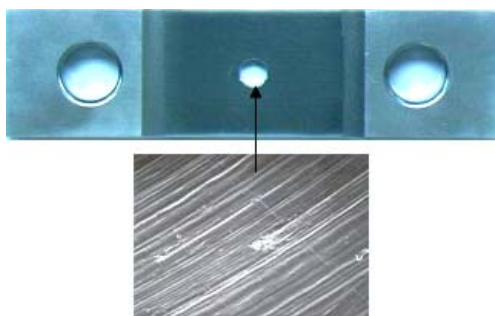
Figure 1. Example of smooth and notched LCF specimens with (A) lathe-turned gage section, (B) polished gage section, and (C) notched gage section with central hole (shown are machining marks left after single-point boring).

Both flat and cylindrical test specimens were used for smooth LCF tests. The flat specimens had a rectangular gage section of nominal dimensions 50 mm x 12 mm x 5 mm, and the flat surfaces represented the lathe-turned surface of conventional IN718 disk machining. The edges of the specimen were polished and the grips shot-peened. An example of the flat specimen with lathe-turned surface is shown in Fig. 1A. Cylindrical specimens

were used for reference LCF test with polished surface (per ASTM E606). An example of the specimen is shown in Fig. 1B. Approximately, 25 micron of surface material was removed using 400 and 600 grit SiC polishing. The nominal gage dimensions of the specimen were 25 mm long x 9.4 mm diameter. For notched LCF, the specimen was flat with a central and through thickness hole. The gage section was rectangular with nominal dimensions of 38 mm x 37 mm x 3.7 mm. The central hole produced a stress concentration ( $K_t$ ) of about 2.5 during axial LCF loading of the specimen. An example of the specimen is shown in Fig. 1C. The hole was machined by single-point boring (SPB) that left machining marks parallel to the stress axis. For reference tests, the same notched specimen was used but the central hole was ‘media-finished’. For media finishing, medium-sized-fused-cast  $Al_2O_3$  granules were used.

arrow to the right in Fig. 14 to indicate that these flat LCF specimens (see Fig. 1A) fractured at the specimen shoulder and outside the gage section. The two groups of test data, A and B, were due to failures from surface carbides or internal grain facets, respectively, at the shoulder location.

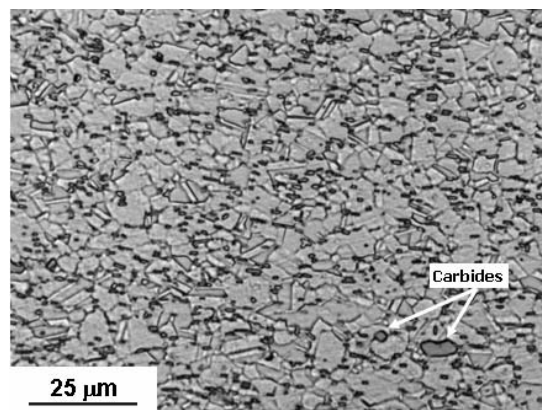
Figure 2. Example of microstructure. The carbides shown in the micrograph is of MC type.

The microstructure of the forged and direct aged disk is shown in Fig. 2. The average gamma ( $\gamma$ ) grain size was 11  $\mu m$  (ASTM 10) with grain size varying from 5.6  $\mu m$  to 16  $\mu m$  (ASTM 9-12) depending on the location in the disk. Occasional grains with sizes as large as 20 to 30  $\mu m$  (ASTM 7-8) were also observed but they represented a small area fraction (<2%) in the microstructure. Further, the microstructure contained Nb/Ti-rich MC carbides, spheroidized delta-phase ( $\delta$ :  $Ni_3Nb$ ), and two strengthening phases:  $\gamma'$  and  $\gamma''$  precipitates [14]. The MC carbides were the most important constituents that reacted severely to tool tip cutting edges and produced surface damages. Therefore, maximum carbide size, the frequency of their occurrence and their clustering tendency are critical to the understanding of LCF capability. In the DA718 material studied here, the largest carbides were typically 20-25  $\mu m$  in equivalent diameter.

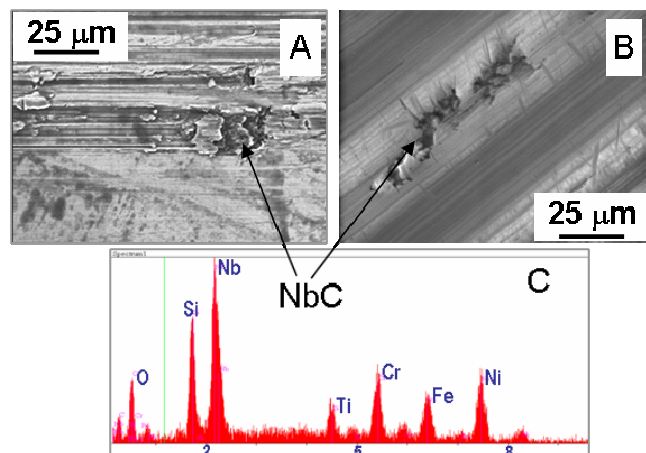
Figure 3. Examples of surface NbC carbide and surface damage during (A) lathe-turning (LT) of flat surface, and (B) single point boring (SPB) of round hole.

As noted earlier, two types of conventional machining (lathe-turning and single point boring) were initially studied in terms of surface effects of LCF life. Fig. 3A and 3B show examples of surface appearances following lathe-turning of flat surfaces and single point boring of round holes, respectively. The critical damages on the surface, as shown in Fig. 3, were produced by the tool tip interacting with the MC carbides. The NbC was the most numerous of the MC carbides followed by Nb(Ti)C, and these carbides were cracked by the tool tip, and sometimes pulled out of the surface in fragments, and dragged along the surface in the direction of the tool tip motion.

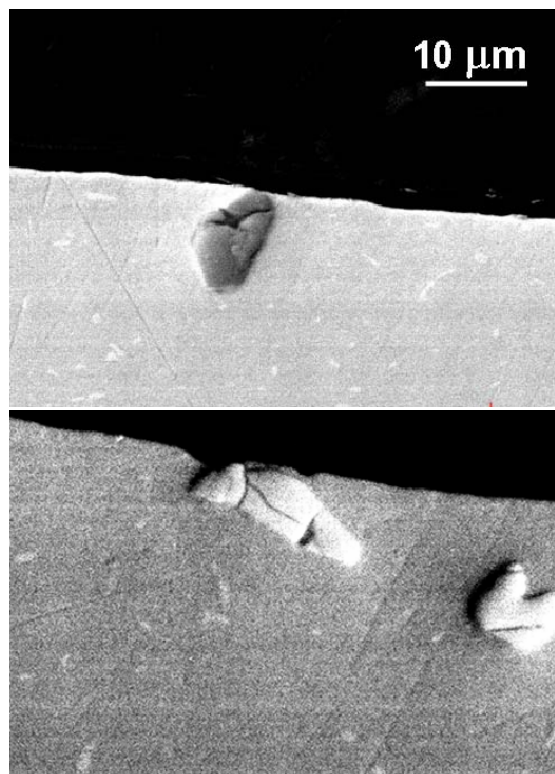
Figure 4. Unetched micrograph from section through machined surface illustrating cracked carbides at surface and subsurface locations.

Cracking of MC carbides at the surface was further examined on unetched polished cross sections. Figure 4 shows evidence of carbide cracking at surface and subsurface locations typically within 25 μm of the machined surfaces. On the other hand, the post-machine polishing showed that the MC carbides generally remained uncracked, and only rare evidence of large carbides with light traces of cracking was observed. Examples of unetched cross sections through polished surfaces are shown in Figure 5.

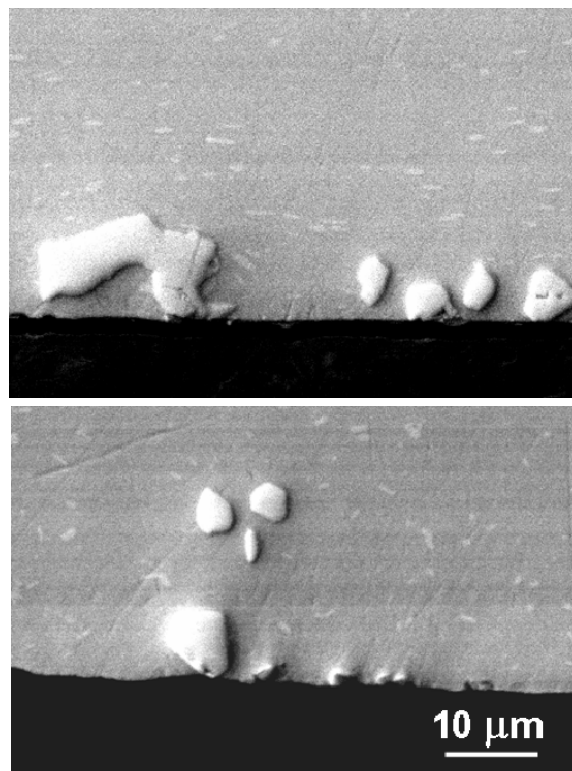
Figure 5. Unetched micrograph from section through post-machine polished surface illustrating predominantly undamaged carbides at surface and subsurface locations.

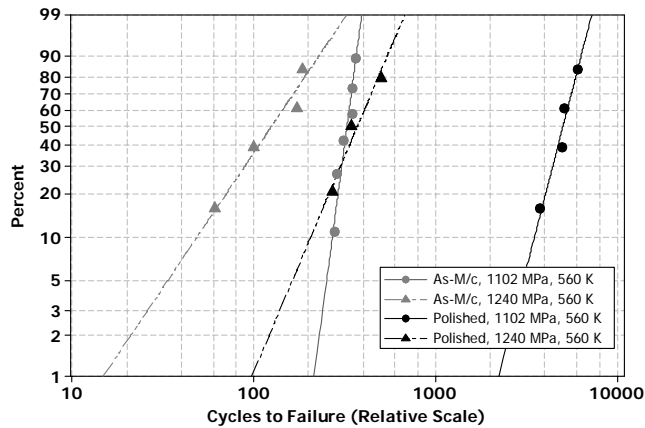
Figure 6. Weibull plot showing effect of as-machined surface on smooth LCF life relative to polished surface. Test temperature 560 K, and applied stresses 1102 and 1240 MPa.

As-Machined Surface Effect on LCF. The effect of the as-machined surface on smooth LCF life is shown in Fig. 6 in relation to reference LCF specimens that had a polished surface. The abscissa axis is a relative scale for LCF lives, and data are shown for tests at low and high stresses (1102 and 1240 MPa) for a test temperature of 560 K. A significant drop in LCF life, approximately, 15X at 1102 MPa and 3X at 1240 MPa, was evident from the machined surfaces relative to the polished surfaces. Similar observations were also made with the notched LCF specimens for tests at the same temperature, and nominal stresses of 595 and 650 MPa. Figure 7 shows test results, and a drop in LCF life by about 6X at 595 MPa and 4X at 650 MPa was evident due to the machined surfaces relative to the polished surfaces. Methods of removing stock material (i.e. polishing) without damaging the surface carbides were demonstrated to be effective at improving the LCF life compared to conventionally machined surfaces.

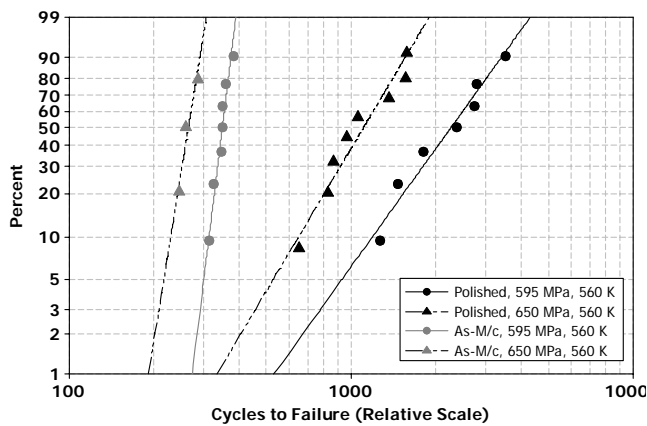
Figure 7. Weibull plot showing effect of as-machined surface (SPB) on notched LCF life relative to media-polished surface. Test temperature 560 K, and applied nominal stresses 595 and 650 MPa.

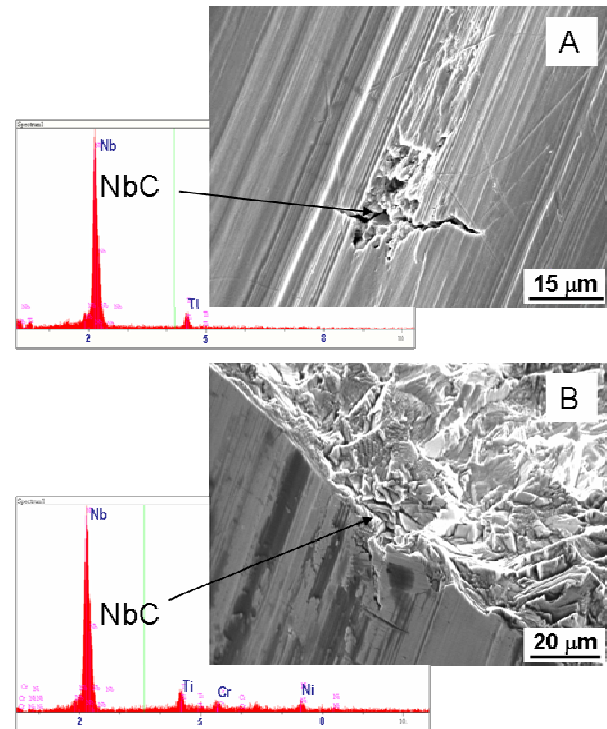
Figure 8. SEM of as-machined smooth LCF failure: (A) Example of secondary crack initiation, (B) Typical fracture initiation from NbC (560 K/1102 MPa).

**LCF Initiation Sites.** The carbides were most life limiting for the 560 K tests. The LCF failure in the as-machined specimens always initiated from surface MC carbides (primarily NbC) due to frequent cracking of these carbides from the machining operation. Figure 8 shows SEM micrographs illustrating a damaged NbC on the machined surface, and the LCF initiation from such carbides in smooth LCF specimens. The typical size of the carbide at the initiation site ranged from 15 to 25  $\mu\text{m}$  and corresponded to the large carbides in the size distribution. Many secondary cracks were present on the specimen surface, and were always associated with carbides as shown in Fig. 8A. These micro-cracks formed early in life [6] especially under conditions of high stress amplitude. Their presence suggests that the carbides, when damaged or cracked by the insert tip during machining, caused early LCF initiation and led to significant life reduction relative to polished specimens. In the polished LCF specimens, the 560 K tests included both carbide and grain initiations, which were located at both surface and subsurface locations. Figure 9 shows SEM fractographs of LCF initiation from an as-machined (SPB) notched LCF specimen. LCF failure always initiated from surface carbide that was damaged or cracked by the tool tip. In the notched specimen, the highest stress occurred only at the notch

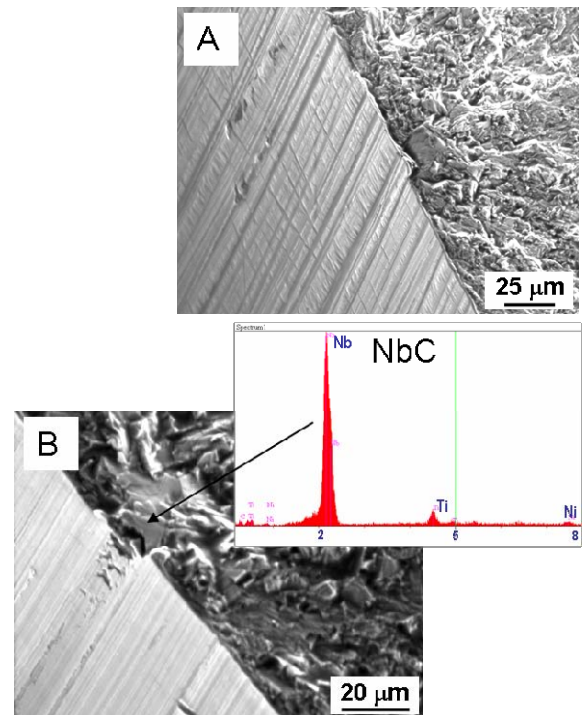
Figure 9. SEM of as-machined notched LCF failure: (A) Specimen surface near crack initiation site, and (B) Fracture initiation from surface NbC (560 K/595 MPa).

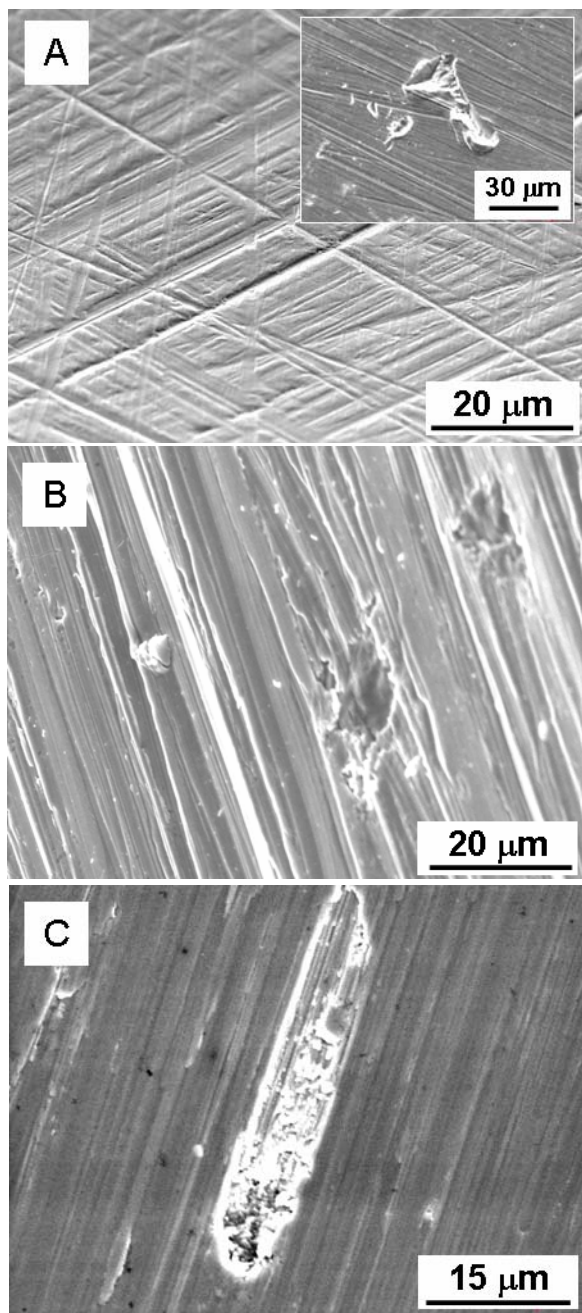
Figure 10. Examples of surface and NbC appearances after post-machine processing of round holes: (A) Mechanical honing, (B) Extrude honing, and (C) Jig grinding.

Post-machine processing was examined, as noted before, for machined round holes only because there were a number of commercially available processes that could be easily utilized to process the SPB surface of the hole. The processes utilized were mechanical honing, extrude-hone, and jig-grinding per conditions stated earlier, and Fig. 10 illustrates the surface appearances from these processes. Note that all these processes removed material by

a minimum amount of 25  $\mu\text{m}$  and thereby, removed the damaged layer on the surface from the SPB operation. Among these processes, the mechanical honing showed the least severe damage to the machined carbide. For example, the carbide in the inset of Fig. 10A was among the largest carbides (about 25  $\mu\text{m}$ ) but it was not as severely damaged or dragged as seen in other processes.

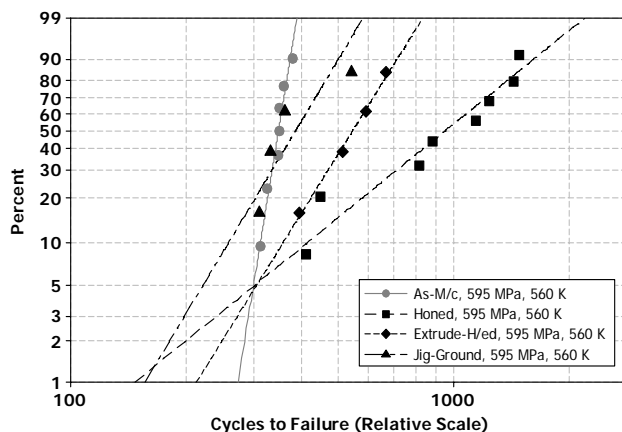
Figure 11. Weibull plot of notched LCF lives after post-machine processing in relation to as-machined (SPB) notched surface.

The notched LCF life with the central hole reconditioned by the above three processes is illustrated in Fig. 11. The LCF lives from the as-machined (SPB) notched specimens are included for comparison. All specimen failures initiated from carbides in these tests, and SEM micrographs illustrating these initiation sites are shown in Fig. 12. Referring to Fig. 11, the mechanical honing showed best LCF lives and all mechanically honed LCF tests exceeded SPB life. On a typical basis live improved by roughly 3X. This was consistent with above surface observations in that mechanical honing probably caused least carbide damage and reduced the probability of badly damaged carbide. Nevertheless, this possibly resulted in the high scatter in data as seen in Fig. 11. The extrude-hone process showed improvement over SPB on a typical basis, and the jig grinding was essentially the same as SPB in terms of LCF life. It should be noted that the SPB machining yields the best LCF capability on a probabilistic approach because of the tight scatter in the data, despite its lower typical life. However, the data in Fig. 11 clearly illustrated the potential of mechanical honing and extrude-hone processes in removing SPB damaged surface layer. Further effort is required to optimize the process parameters (such as feed rate and depth of cut) to reduce the scatter in the data. No such investigation was made in the present study.

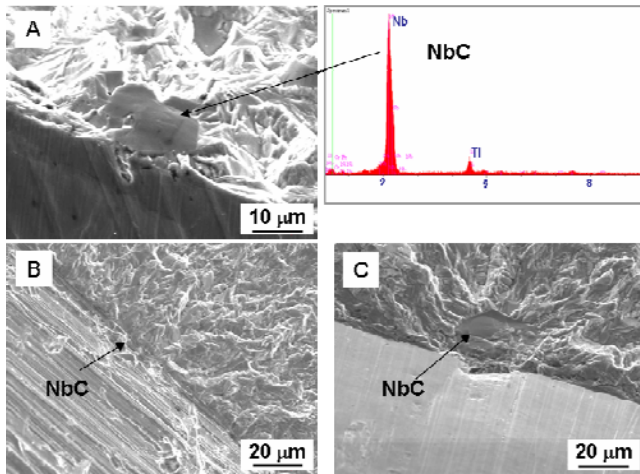
Figure 12. SEM of Notched LCF specimens following post-machine processing: (A) Mechanical honing, (B) Extrude honing, (C) Jig-grinding.

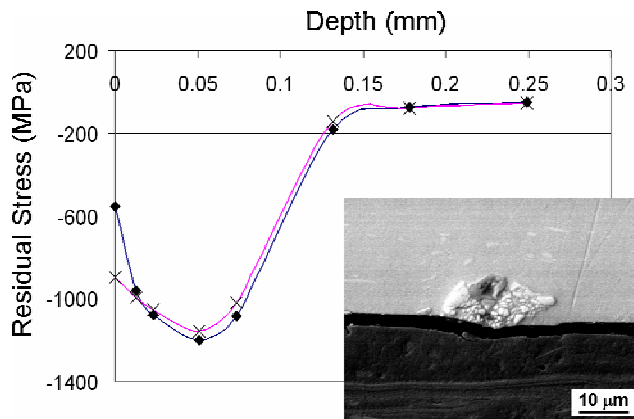
Figure 13. Residual stress pattern introduced by shot-peening and example of large carbide appearance at the surface following shot-peening.

Surface residual stresses were introduced through shot-peening to an intensity of 4A on the as-machined (i.e., lathe-turned) flat surfaces of smooth LCF specimens. Figure 13 shows the residual stress profile with depth in the LCF specimen. A cross-section through the peened surface is also included in this figure. The shot peened surface essentially retained all surface carbides, including those previously cracked or damaged by the lathe turning operation. Following shot peening, the large carbides, as shown in Fig. 13, appeared highly fragmented.

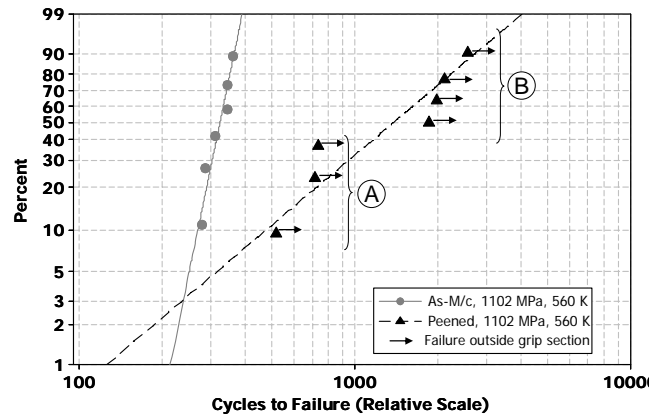
Figure 14. Weibull plot of smooth LCF lives after shot peening (4A) in relation to as-machined (lathe-turned) smooth surface. 'A' and 'B' refer to failures outside the specimen gage section, and from carbide and internal grain, respectively.

Figure 14 shows smooth LCF life after shot-peening in relation to the as-machined specimens. The LCF life was recovered in these shot-peened specimens, and this can be attributed to the compressive residual stress at the surface that extended to 100  $\mu\text{m}$  with -600 MPa or more in magnitude. The compressive residual stress, therefore, protected the specimen from the machine-damaged layer. All shot peened LCF lives were shown with an
