## Scanning Electron Microscopy

Name	Xerxes Chong Xian	CID Number	01389744
Lab Group	Group 8	Date of Lab	08/11/18

### **Specimen 1 - Dragonfly Wing**

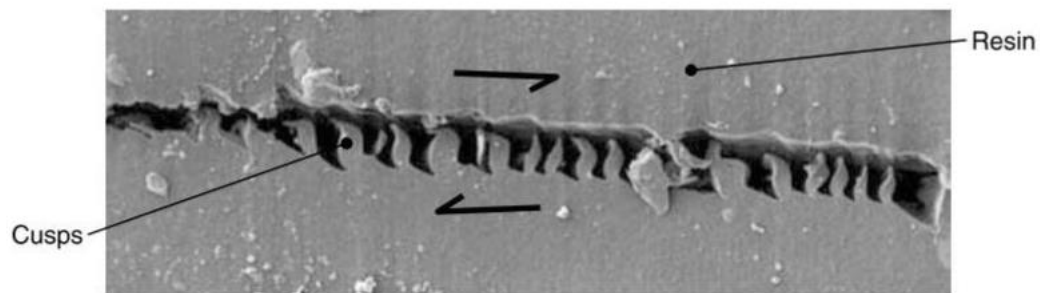
the top-right indicated by the blue arrow. An example of how the shear directions would have resulted in the surface shown in seen in Figure 14.

Figure 14. How shear directions influence the directions of cusps (5)

From Figure 13, the cusps are tilted to the bottom-left due to the direction of shear. Referencing Figure 14 and Figure 15, it can be concluded that the direction of shear would be opposite to the direction of tilt of the cusps, towards the top-right.

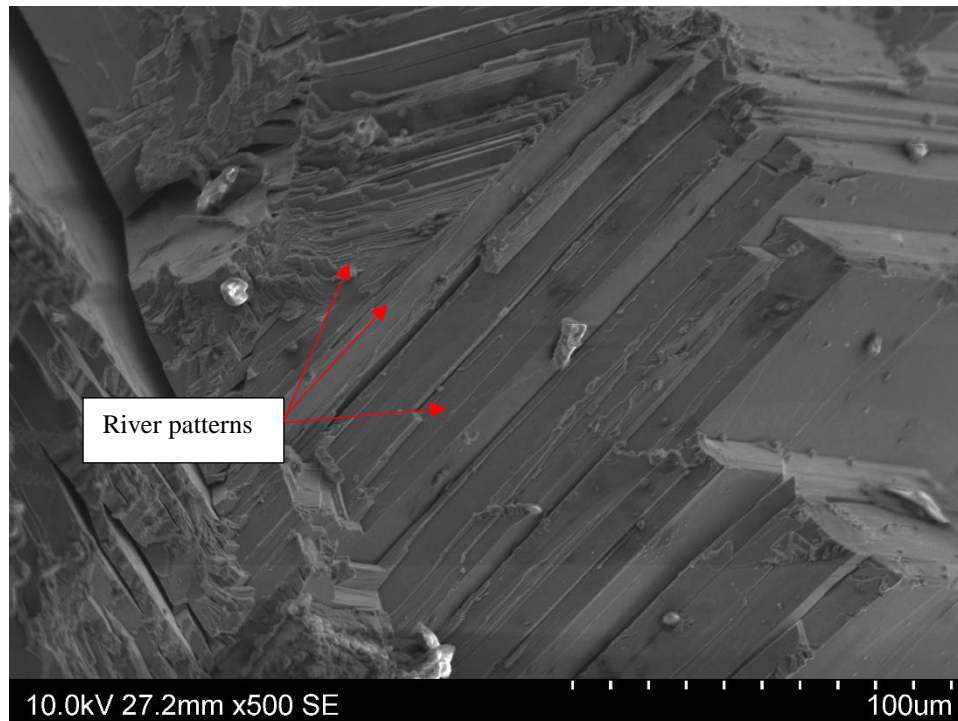
Figure 16. Fracture surface at the zinc specimen at 500X magnification

From Figure 16, the surface on the fracture consists of many smooth angular planes, many of them parallel to each other. There is little sign of major plastic deformation. As the impact test temperature was conducted at 10% of the specimen's melting temperature, the specimen had a reduced ductility. Based on this, it is deduced the failure happened due to a brittle fracture.

Brittle fractures are sudden, and the crack propagation occurs by a process known as cleavage. The smooth angular surfaces are known as cleavage facets and are marked by river patterns along them, which are the characteristic feature of brittle fractures (6). Cleavage facets indicate parallel planes of weak chemical bonding between the layers of atoms. The crack propagates along these planes by breaking the atomic bonds through planar sectioning. The crack changes direction as it travels between crystals as each crystal has a unique orientation of these planes. This results in the different orientations of cleavage facets seen. Local river lines indicate the direction of crack propagation and of the local crack origin. Cleavage initiate from tiny defects such as crack and inclusions.
