In this section, calculation results by numerical simulation would be presented. Discussion was presented based on each of applied configurations. Several responses on the struck ship was described and evaluated regarding influence degree of proposed parameters to the results.

A. Double hull size

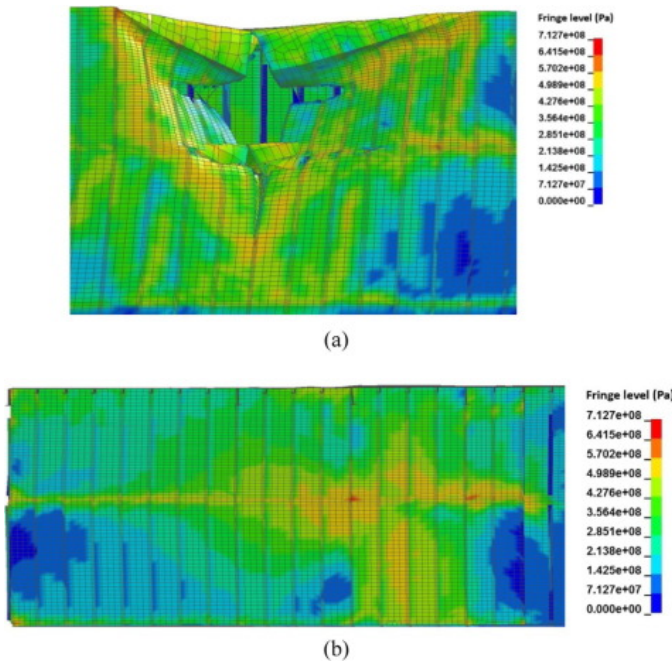
Figure 5: Damage pattern on the double hull structure with space 3.50 m: (a) outer hull, and (b) inner hull.

3.5 m in width. Contrast with this situation, the narrower double hull (1.5 m in width) showed rising trend line as penetration went further. This situation addressed the situation of the inner hull of this hull was slowly deformed plastically. Illustration of this phenomenon is presented in Figure 7 and Figure 8 for both hulls. The presented contours in these figures are von Mises stress which represent failure stress. In 1.5 m double hull, stress on the inner hull was found distributed on the area of penetrated hulls. Stress concentration was clearly indicating failure if penetration was continued on this location. Stress on inner was widely distributed on the inner hull for the larger double hull. This hull size provided adequate time during penetration to deliver the stress to other structural components. Initial conclusion based on this discussion that narrower double hull space more susceptible to failure during collision. Therefore, double hull with space 1.5 m would be used in further analyses and simulations accounting for material configurations.

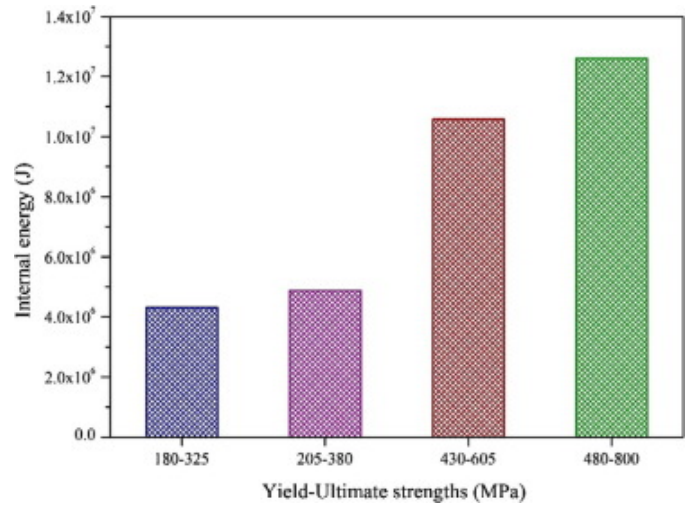
Figure 6: Internal energy for different applied material strength on the double hull structure.

Material is inseparable element in structural analysis. In this work, this parameter is taken into consideration with deploying material with different strength magnitude. The energy results of this study indicated that the internal energy was equally perpendicular with magnitude of yield and ultimate strength. Material with higher strength needed more energy to be destroyed during penetration. Difference in yield strength between the first and second materials was found 12% and internal energy introduced 12% distinction. The third and fourth material showed difference 50 MPa in term of yield strength with energy comparison between both materials indicated 27% discrepancy. Between the first and second materials,

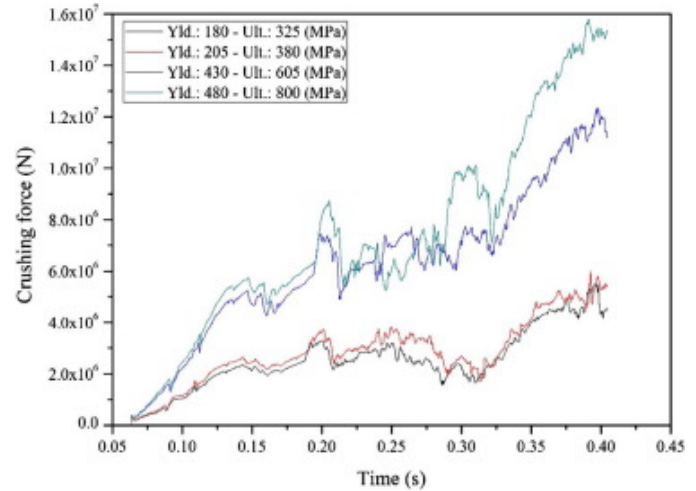
Figure 7: Characteristic of crushing force on the double hull structure with different strengths.

Difference was relative lower than the third and fourth materials, that contribution of tensile strength was taken into consideration as the third and fourth materials had bigger disparity. Behaviour of crushing force also provided good correlation since higher material strength, higher stress that would be experienced. These results are presented in Figure 9 and Figure 10, consecutively. Damage extents in Figure 11 were presented by Tresca stress indicated that the higher strength would reduce casualties on the inner hull after collision process. This material was proven provide better resistance for side hull against collision by the striking ship. However, attention should be paid in term of material treatment. Higher strength tends to need more costly treatment in building and repairing processes which lead to increase of maintenance cost.

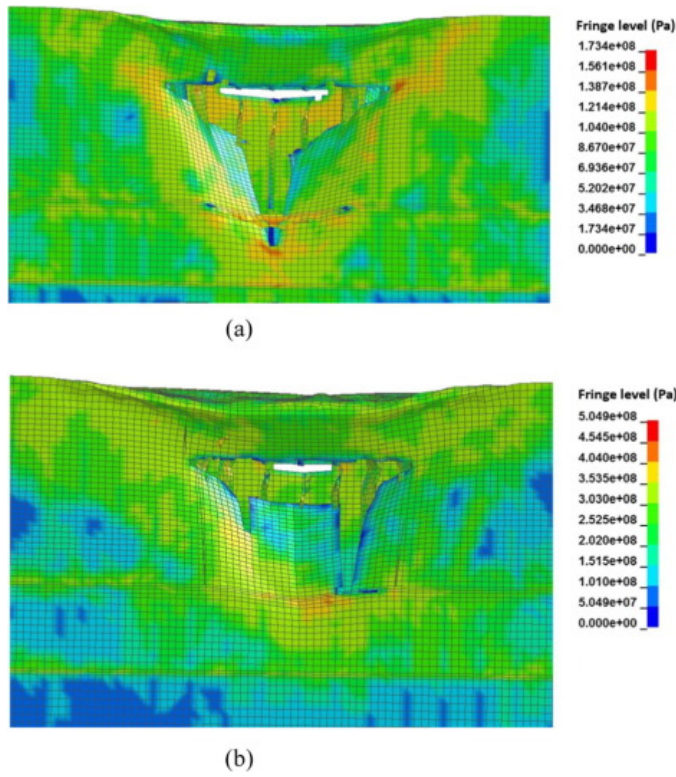
Figure 8: Damage pattern on the outer and inner hulls: (a) yield 180 MPa, and (b) yield 480 MPa.

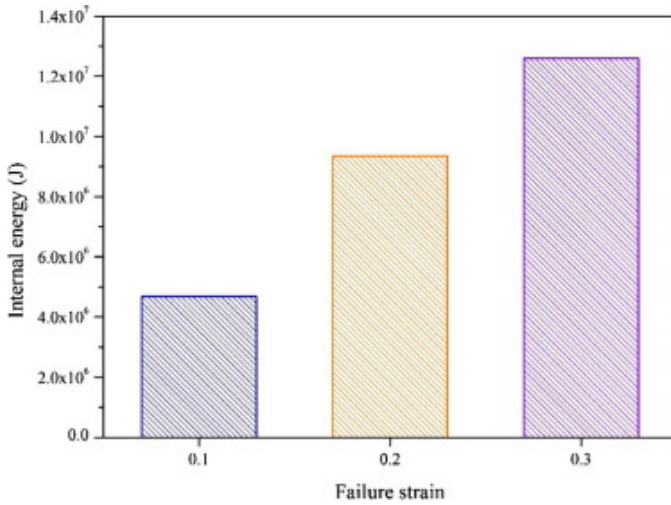
Figure 9: Effect of failure strain constant to internal energy during ship collision.

to evaluate how far failure strain affected calculation results. Three different strain constants were applied on the deformable structure. Calculation results in Figure 12 indicated that the internal energy was gradually increasing for the proposed strain constants. The target structure was shown better strain capability during penetration and made the structure was harder to experience failure. Illustration in Figure 13 was presented wide area with was wrinkled as effect of collision load in structure with strain constant 0.3. Compared with the smallest constant which the inner hull was successfully breached and tearing was found that the striking ship cleanly tore the both hulls, the strain constant 0.3 delivered better capability to resist penetration by the striking ship. Benchmarking study can be considered as good method to estimate reasonable strain constant for applied material properties in analysis.

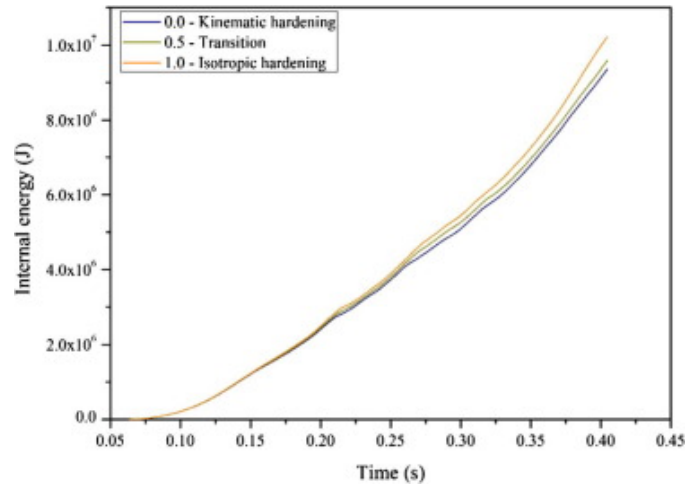
Figure 10: Internal energy for proposed assumption of yield surface. Significance is not found on the results.

function of the plastic strain, this definition is called isotropic hardening with constant 1. The transition constant 0.5 was considered in the analysis to provide intermediary comparison for kinematic and isotropic results. In term of internal energy (Figure 14), significant difference was unlikely found for all proposed assumptions. Trend line and value were also showing similarity in term of crushing force as presented in Figure 15. Both responses indicated that isotropic hardening produced higher results than kinematic hardening with no remarkable characteristic. Results of the transition value 0.5 was found between kinematic and isotropic magnitudes.

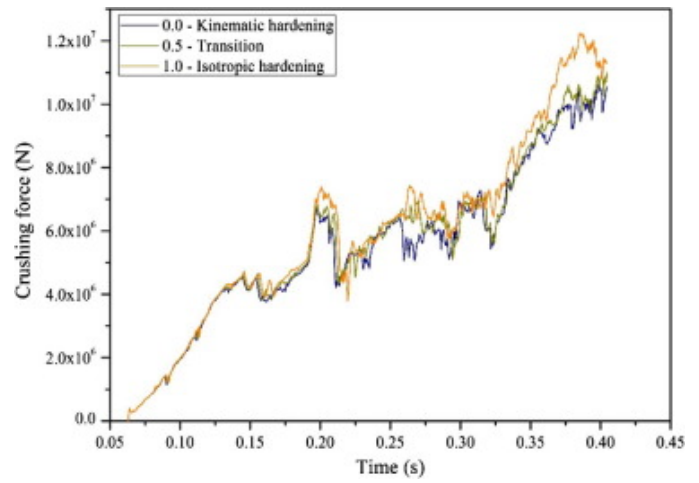
Figure 11: Crushing force during penetration by the striking ship with different assumed yield surfaces.
