In this section, calculation results by numerical simulation would be presented. Discussion was presented based on each of applied configurations. Several responses on the struck ship was described and evaluated regarding influence degree of proposed parameters to the results.

A. Double hull size

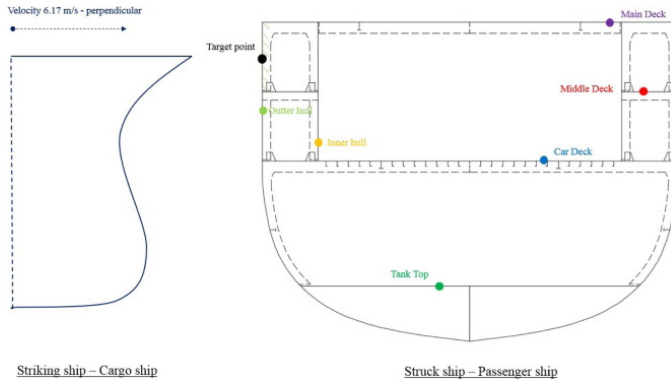
Figure 1: Illustration of side collision. Bullets highlight location of pointed components.

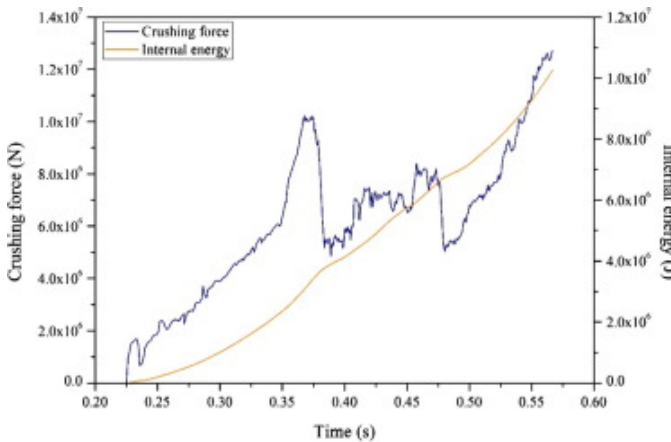
Figure 2: Crushing force and internal energy for double hull configuration 1.50m.

Safety standard of a ship against various forms of impact load (e.g. collision and grounding) can be evaluated from condition of the inner hull after resisting such damage. Breach of the inner hull can be considered fatal since damage occurs not only on ship structure, but also already reach ship cargo. Calculation results based on different hull configurations are presented in Fig. 5 and Fig. 6. Internal energy in these graphs are defined as energy that is needed to plastically deform or even destroy the involved structures in impact. In this case, the struck ship as the deformable object is observed. Energy to deform side hull with narrower space was indicated higher as both hulls (outer and inner) were significantly damaged by the striking ship during penetration. Indication of higher internal energy is not solely dictated a structural configuration

has better resistance against impact load. Crushing force in the figures is defined as force fluctuation during destruction of the involved objects take place by certain impact load. The force for wider space on the struck ship was observed go down in the end of collision process as the destruction was focussed on the outer hull. Major deformation or even hole on the inner hull could be avoided as large space was provided by double hull with size

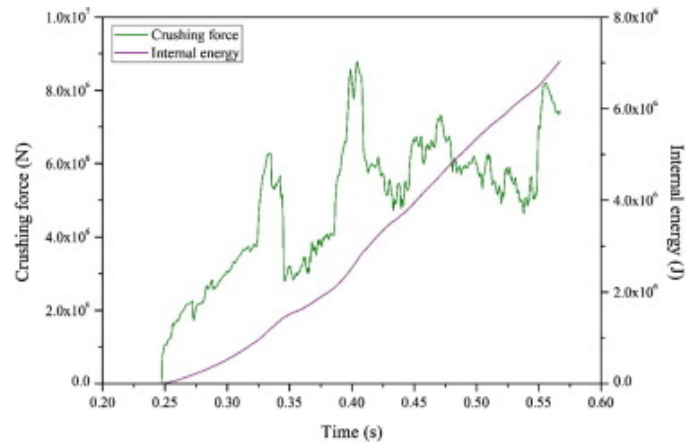
Figure 3: Crushing force and internal energy for double hull configuration 3.50m.

3.5 m in width. Contrast with this situation, the narrower double hull (1.5 m in width) showed rising trend line as penetration went further. This situation addressed the situation of the inner hull of this hull was slowly deformed plastically. Illustration of this phenomenon is presented in Fig. 7 and Fig. 8 for both hulls. The presented contours in these figures are von Mises stress which represent failure stress. In 1.5 m double hull, stress on the inner hull was found distributed on the area of penetrated hulls. Stress concentration was clearly indicating failure if penetration was continued on this location. Stress on inner was widely distributed on the inner hull for the larger double hull. This hull size provided adequate time during penetration to deliver the stress to other structural components. Initial conclusion based on this discussion that narrower double hull space more susceptible to failure during collision. Therefore, double hull with space 1.5 m would be used in further analyses and simulations accounting for material configurations.

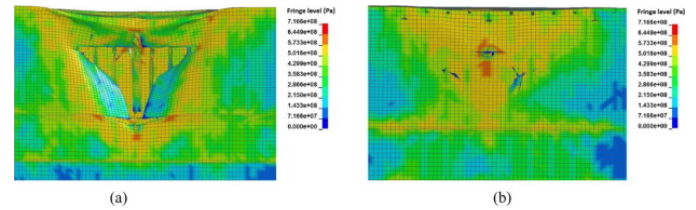
Figure 4: Damage pattern on the double hull structure with space 1.50 m: (a) outer hull, and (b) inner hull.

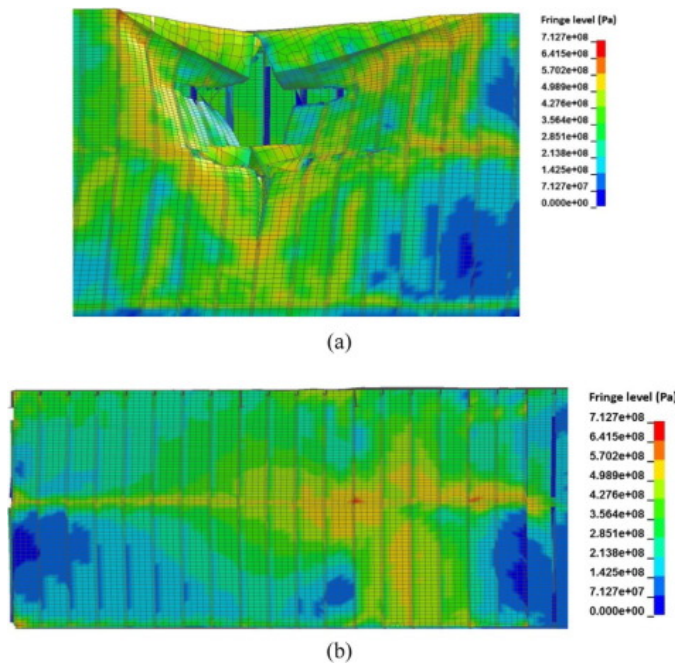
Figure 5: Damage pattern on the double hull structure with space 3.50 m: (a) outer hull, and (b) inner hull.

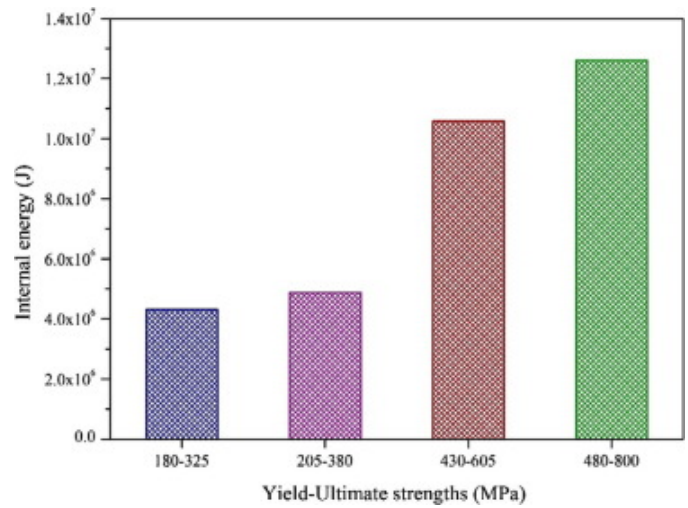
Figure 6: Internal energy for different applied material strength on the double hull structure.

Material is inseparable element in structural analysis. In this work, this parameter is taken into consideration with deploying material with different strength magnitude. The energy results of this study indicated that the internal energy was equally perpendicular with magnitude of yield and ultimate strength. Material with higher strength needed more energy to be destroyed during penetration. Difference in yield strength between the first and second materials was found 12% and internal energy introduced 12% distinction. The third and fourth material showed difference 50 MPa in term of yield strength with energy comparison between both materials indicated 27% discrepancy. Between the first and second materials,

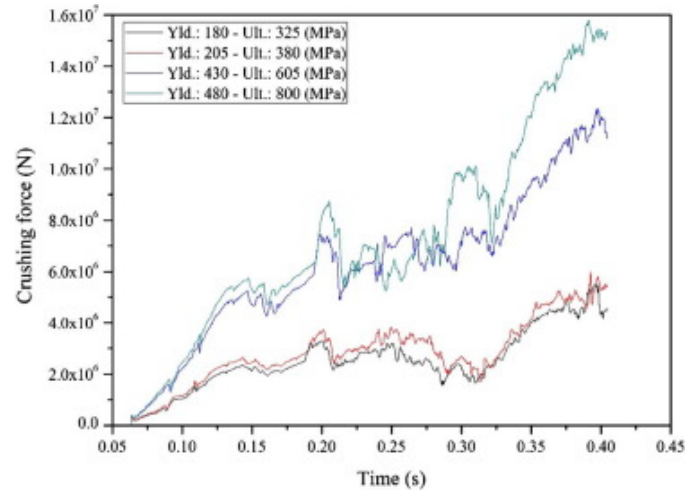
Figure 7: Characteristic of crushing force on the double hull structure with different strengths.

Difference was relative lower than the third and fourth materials, that contribution of tensile strength was taken into consideration as the third and fourth materials had bigger disparity. Behaviour of crushing force also provided good correlation since higher material strength, higher stress that would be experienced. These results are presented in Fig. 9 and Fig. 10, consecutively. Damage extents in Fig. 11 were presented by Tresca stress indicated that the higher strength would reduce casualties on the inner hull after collision process. This material was proven provide better resistance for side hull against collision by the striking ship. However, attention should be paid in term of material treatment. Higher strength tends to need more costly treatment in building and repairing processes which lead to increase of maintenance cost.

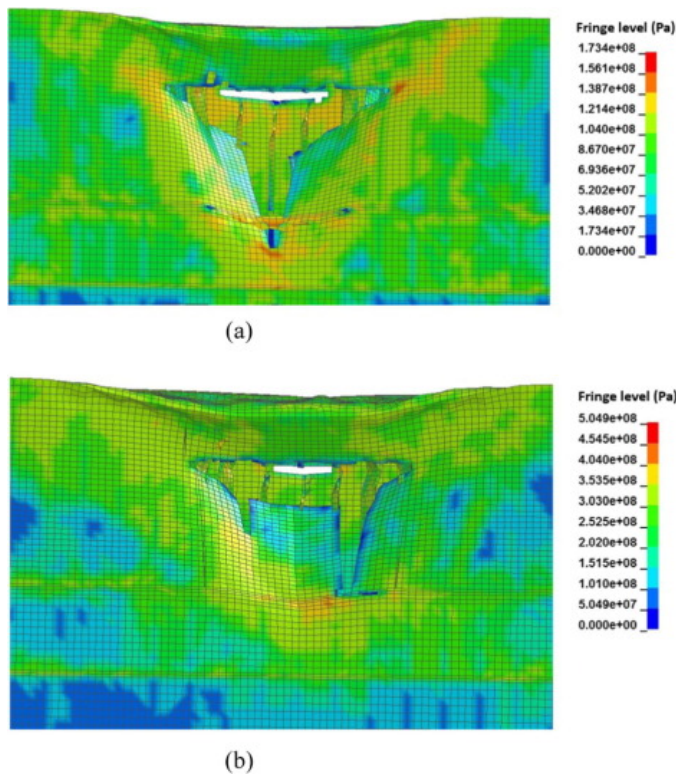
Figure 8: Damage pattern on the outer and inner hulls: (a) yield 180 MPa, and (b) yield 480 MPa.

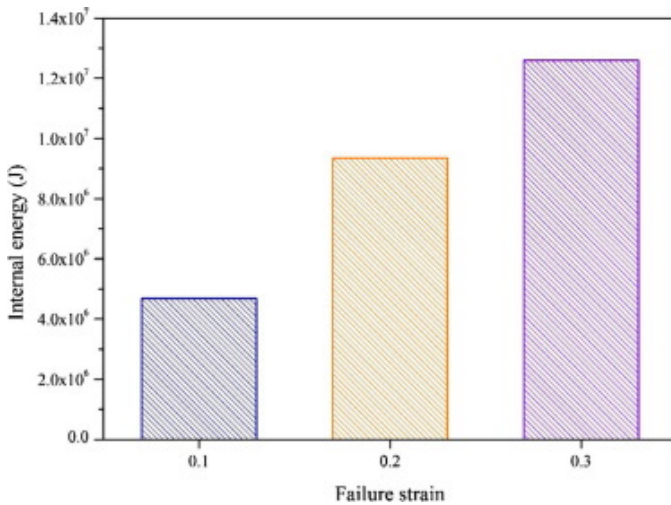
Figure 9: Effect of failure strain constant to internal energy during ship collision.

to evaluate how far failure strain affected calculation results. Three different strain constants were applied on the deformable structure. Calculation results in Fig. 12 indicated that the internal energy was gradually increasing for the proposed strain constants. The target structure was shown better strain capability during penetration and made the structure was harder to experience failure. Illustration in Fig. 13 was presented wide area with was wrinkled as effect of collision load in structure with strain constant 0.3. Compared with the smallest constant which the inner hull was successfully breached and tearing was found that the striking ship cleanly tore the both hulls, the strain constant 0.3 delivered better capability to resist penetration by the striking ship. Benchmarking study can be considered as good method to estimate reasonable strain constant for applied material properties in analysis.

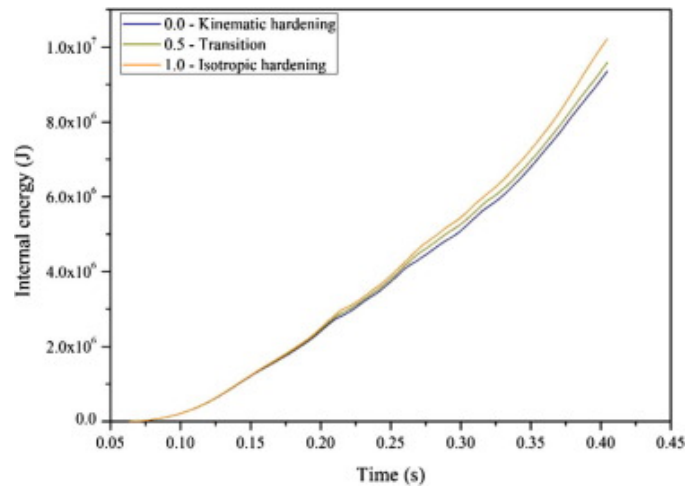
Figure 10: Internal energy for proposed assumption of yield surface. Significance is not found on the results.

Hardening was taken into consideration to observe different assumption in position of yield surface during penetration. Kinematic hardening with constant 0 indicates that the radius of the yield surface is fixed but the center translates in the direction of the plastic strain, which means it can be move as translated direction of plastic strain. In opposite of the first assumption, if the yield surface is fixed and works as

function of the plastic strain, this definition is called isotropic hardening with constant 1. The transition constant 0.5 was considered in the analysis to provide intermediary comparison for kinematic and isotropic results. In term of internal energy (Fig. 14), significant difference was unlikely found for all proposed assumptions. Trend line and value were also showing similarity in term of crushing force as presented in Fig. 15. Both responses indicated that isotropic hardening produced higher results than kinematic hardening with no remarkable characteristic. Results of the transition value 0.5 was found between kinematic and isotropic magnitudes.

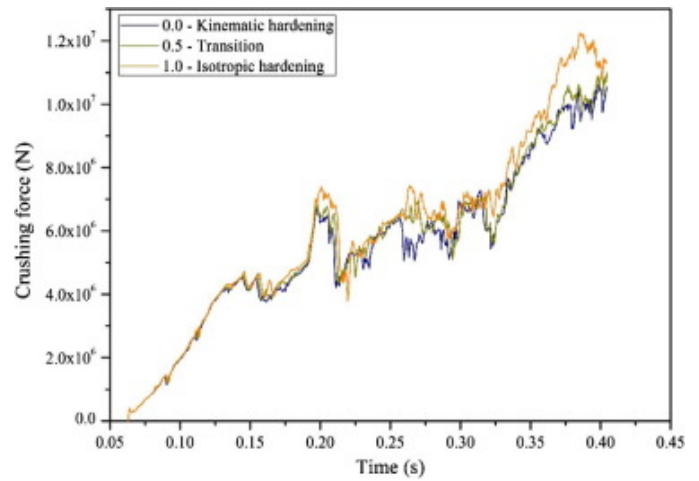
Figure 11: Crushing force during penetration by the striking ship with different assumed yield surfaces.
