# Intel® Ethernet Controller I350

Specification Update

Revision 3.2  
333066-006

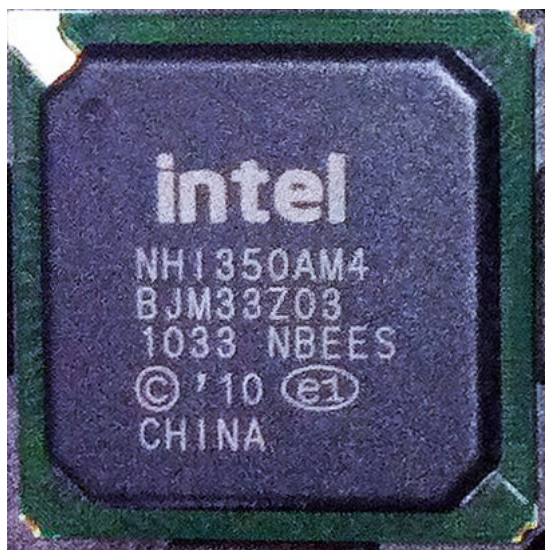
**Figure 1-1. Example Component with Identifying Marks**

## 1.2 Marking Diagrams
