Corrosion Protection for Metal Connectors in Coastal Areas

for Structures Located in Special Flood Hazard Areas in accordance with the National Flood Insurance Program

FIA-TB-8 (8/96)

TECHNICAL BULLETIN 8-96

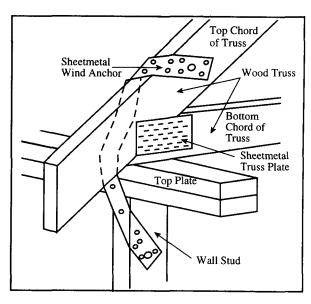
Figure 1. Wind anchor and truss plate

Typical metal connectors that are potentially subject to corrosion include hurricane straps and wind anchors used to connect roofs to walls (see Figure 1); truss plates that connect the separate members of premanufactured roof and floor systems (see Figure 1); joist hangers used on floor joists, beams, and rafters (see Figure 2); and various other metal straps used to connect wood components throughout the building. These include straps that attach the roof to the walls and prevent the aerodynamic lift of high winds from removing the roof or displacement caused by lateral forces during earthquakes.

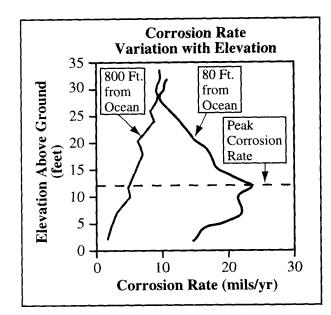
Figure 3. The variation in the corrosion rate of steel with elevation for Kure Beach, NC

Other tests conducted in North Carolina found that corrosion reached a peak at about 12 feet (3.6 meters) above the ground (see Figure 3), approximately equal to the lowest floor elevation of an elevated building with lower level parking. Several rows of buildings farther inland, the overall corrosion rate is lower, but it is highest at an elevation above the roofs of small buildings. Figure 3 also indicates that the worst corrosion nearest the ocean was more than double the worst farther inland.

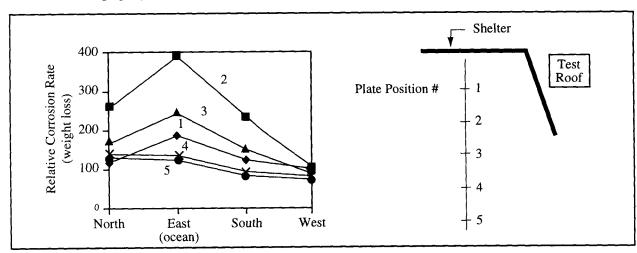
Figure 4. The effect of shelter and orientation under the test roof shown on the right

The study reported that salt spray accumulations on bold exposures are rinsed periodically by rainfall (Positions 4 and 5), reducing the surface salt concentrations. Sheltered exposures receive little salt spray (Position1). Partially sheltered exposures (Positions 2 and 3) receive almost as much incoming spray as bold exposures. However, the surface concentrations remain high,

because of the shelter from cleansing rain. An additional factor is the duration of surface wetness. Accelerated corrosion occurs primarily when a certain level of surface wetness is exceeded, initiating electrochemical reactions among the metal, salts, and air. Bold exposures are more rapidly dried because they are exposed to sunlight. Drying slows the corrosion rate. Partially sheltered exposures stay damp longer and therefore corrode faster. The effect of building orientation on corrosion is also shown in Figure 4. The metals on the side of a building facing the ocean will corrode much faster than those facing away from the ocean.
