# **RVA, Qualitative, and Quantitative Assessment Of a Residential Building**

Vulnerability Assessment & Retrofitting Techniques Assignment Presentation  
IoE Pulchowk Campus | Jan 2026

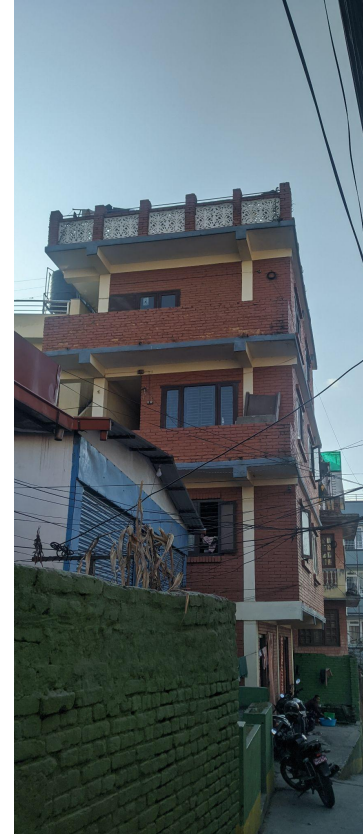
# Selected RC Building

- Age: 44 years
- Bay Width: 12ft, 12ft
- Storey Height: 10ft
- No of bays: 1, 2
- No of Storey: 4
- Material: M20
- Steel: Fe 415
- Beam Reinforcement: 3-12 $\Phi$  + 2-12 $\Phi$
- Beam Size: 13" \* 9"
- Column Reinforcement: 8-12 $\Phi$
- Column Size: 9" \* 9"
- Slab thickness: 4"
- No of residents: 22
- Reinforced concrete frame with unreinforced brick masonry infill in cement mortar (115mm)
- not structurally designed and supervised by engineers during construction.

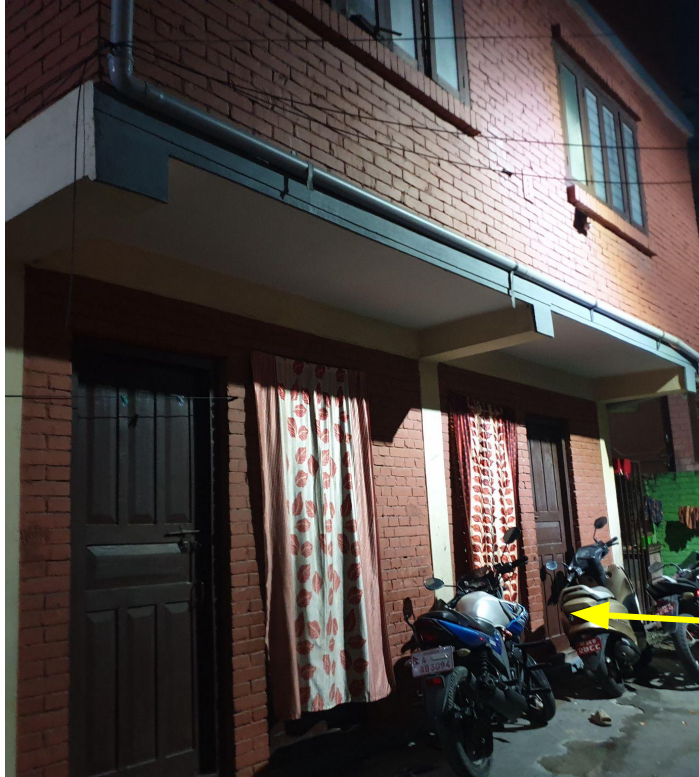
Large Openings  
at Ground Floor,  
Walls over the  
projected slab

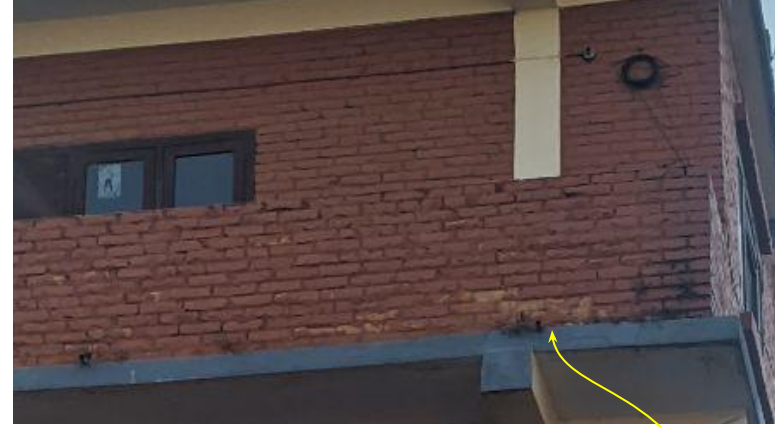
Visual  
Deterioration

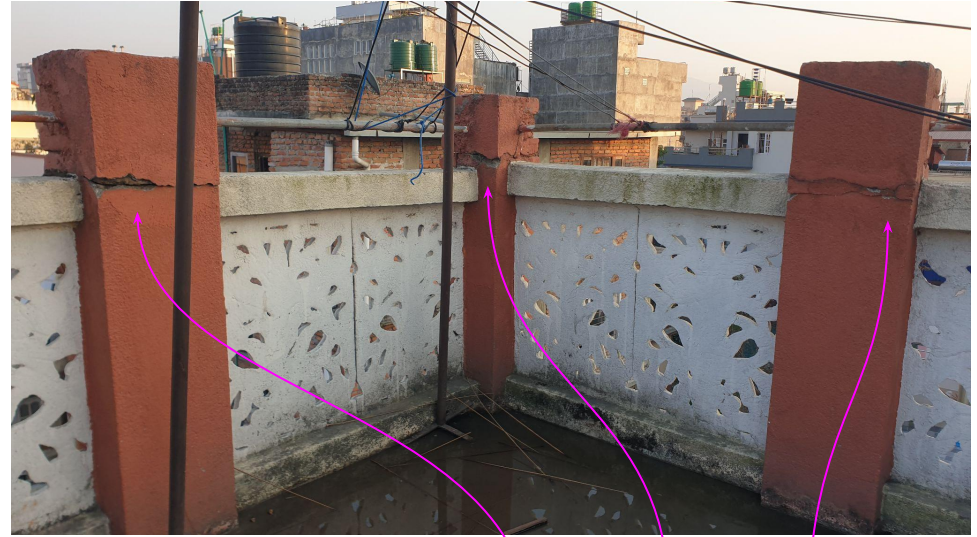
Visual  
Deterioration
