Mooltipass Mini Quality Control

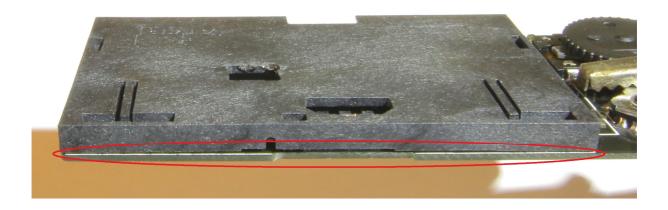
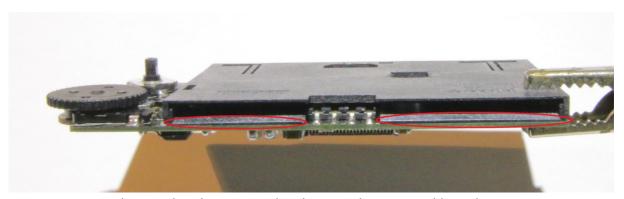
- CORRECT: Smartcard socket close to the PCB

Make sure that the smartcard socket is as close as possible to the PCB

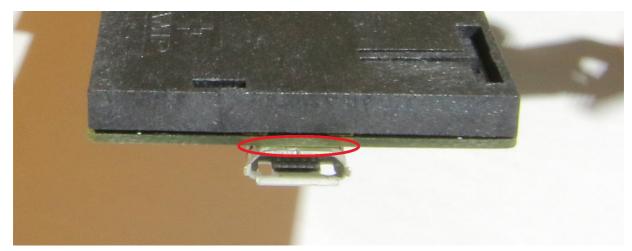
- CORRECT: USB connector close to the PCB

Make sure the USB connector is as close as possible to the PCB $\,$

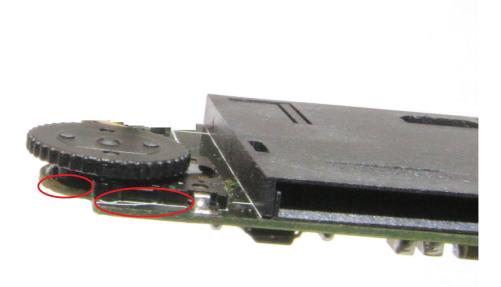
- CORRECT: Clickable wheel close to the PCB

Make sure the wheel is as close as possible to the PCB

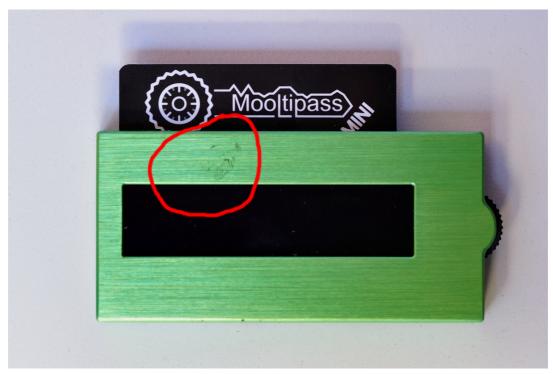
FAIL: black traces on the mini case... please let the glue dry for 24 hours!!!!

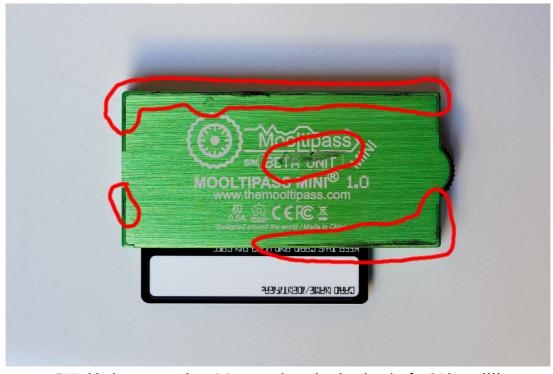
FAIL: black traces on the mini case... please let the glue dry for 24 hours!!!!

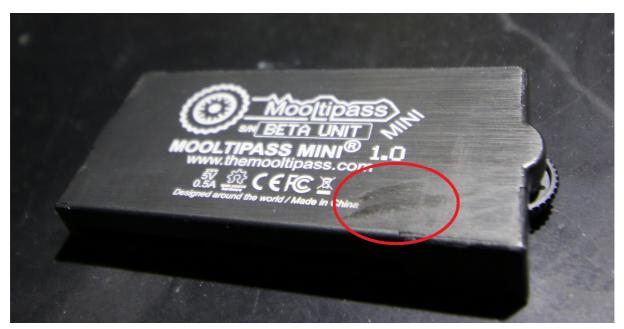
FAIL: black traces on the mini case... please let the glue dry for 24 hours!!!!

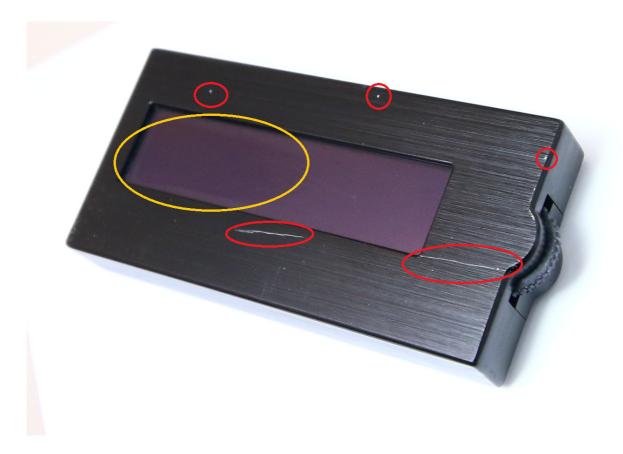
FAIL: dents, scratches on the aluminum case + traces on the screen

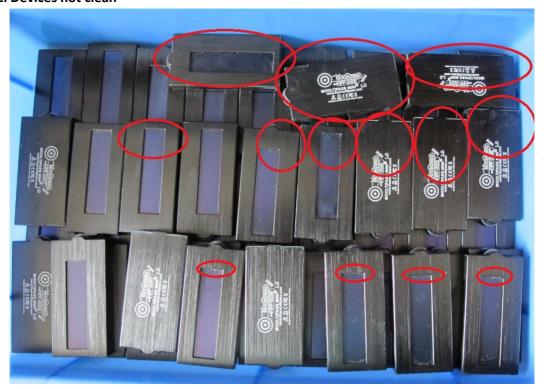
FAIL: residues on the case, device isn't clean!!!!

Acetone may be used to clean the case of residue, but should not be used to clean the screen. Standard computer screen cleaning product with soft cloth may be used to clean the screen.

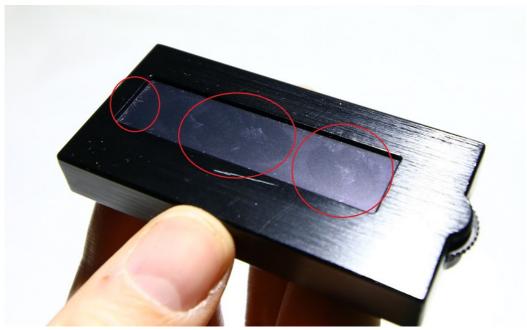
FAIL: traces on the screen, screen is not clean!

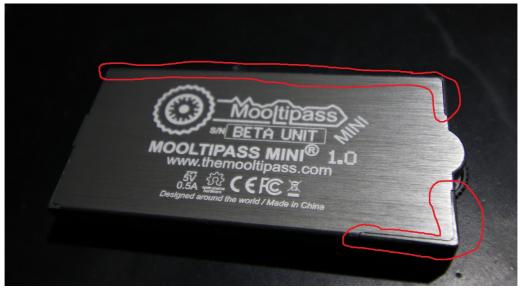
CORRECT: bottom and top case aligned, no traces of glue

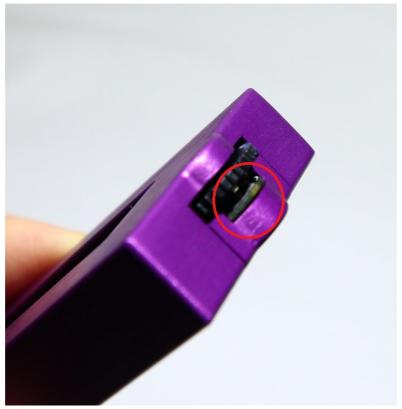
CORRECT: the PCB should be as close as possible to the aluminum case
