J124 TNT- Redfern

Site QA
Penetrations
Core Hole Penetration
Level 1

Site QA - Penetrations - Core Hole Penetration - Level 1 - FP-L1-R

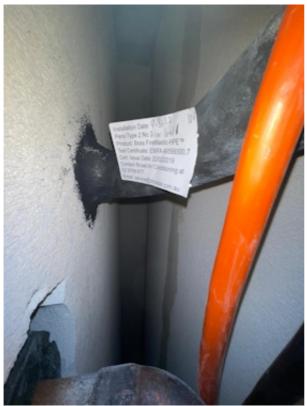
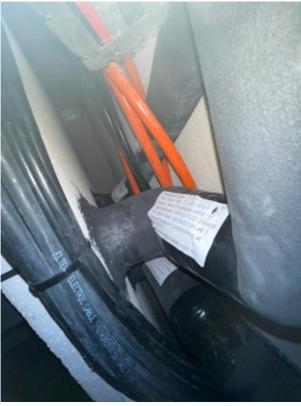
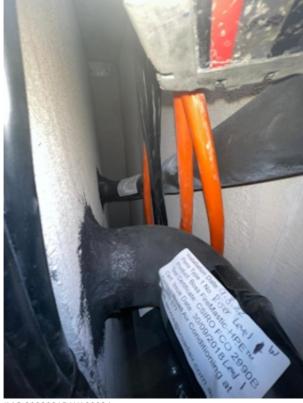
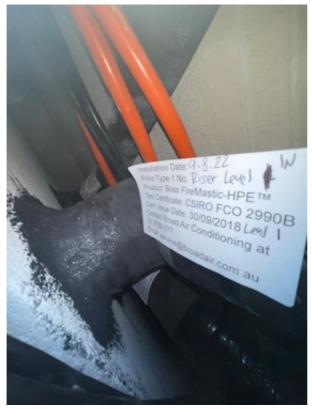
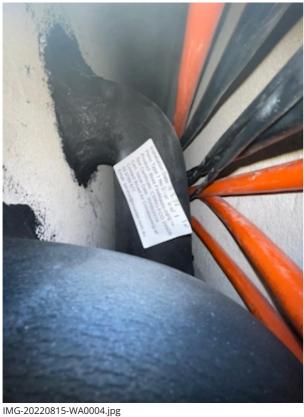
Penetration details have been captured			
Status	Pass	Sebastian Lopez	15 Dec 2022 11:39am
Marine Salara Marine		Sehastian	15 Dec 2022

Penetration details have been captured

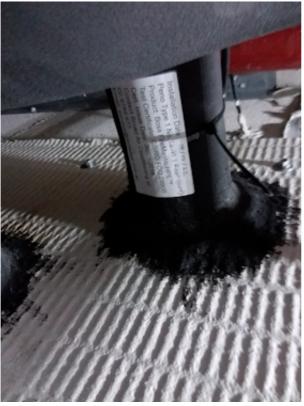
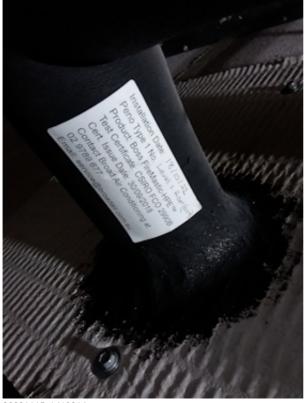
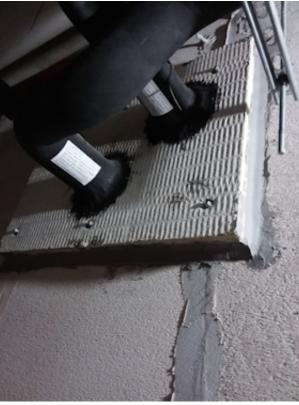
Inside riser

Penetration ID #1:

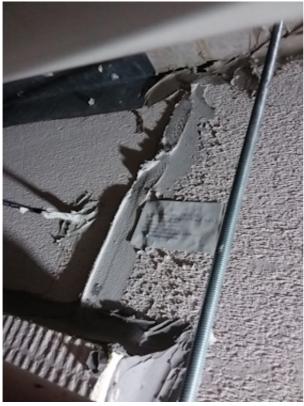
Outside riser		Sebastian Lopez	15 Dec 2022 11:40am	
Number of Penetrations				
Status	Pass	Sebastian Lopez	15 Dec 2022 11:40am	
Core hole max 120mm with Boss Fire FireMastic-HPE sealant (FMHPE-3 / FMHPE-6) filled to a depth of 30mm from either side of wall.				
Status	Pass	Sebastian Lopez	15 Dec 2022 11:40am	
Cables to be tucked between insulation for a minimum of 300mm each side of the penetration				
<u>Status</u>	Pass	Sebastian Lopez	15 Dec 2022 11:40am	
The penetration is labelled and photographic evidence is provided				
<u>Status</u>	Pass	Sebastian Lopez	15 Dec 2022 11:40am	
Maximum services passing the penetration is not exceeding the following				
Status	Pass	Sebastian Lopez	15 Dec 2022 11:40am
