# Vehicle Damage Assessment Report

## Damage Analysis

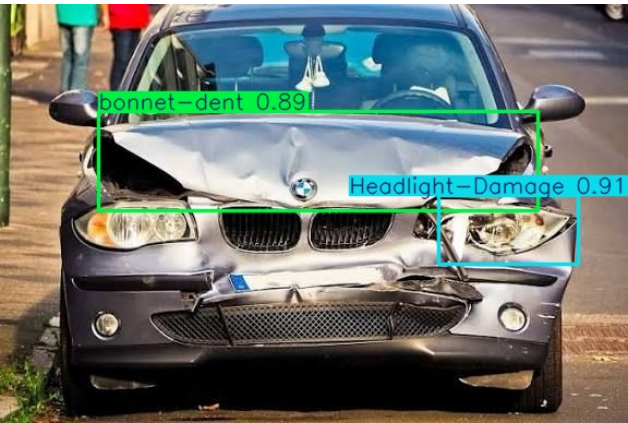
Annotated Image:

| Part | Damage Type | Severity | Recommendation |
|---|---|---|---|
| Vehicle Part | Headlight-Damage | 87% | Replace |
| Vehicle Part | bonnet-dent | 48% | May be repairable |
