# Vehicle Damage Assessment Report

Generated on Friday, 6 February 2026 at 9:18 am

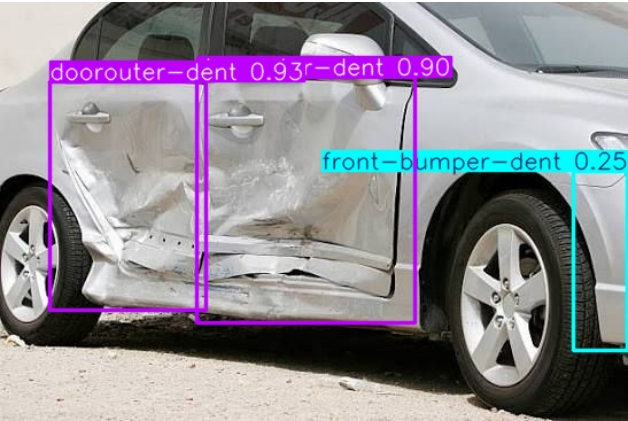
Annotated Image:

| Part | Damage Type | Severity | Recommendation |
|---|---|---|---|
| Vehicle Part | doorrouter-dent | 35% | May be repairable |
| Vehicle Part | doorrouter-dent | 63% | Replace |
| Vehicle Part | front-bumper-dent | 11% | Repairable (repaint) |
