**PROJECT REPORT ON**

# **PROCESS QUALITY MANAGEMENT**

*in making of Aluminium Candle Stand*

# PROBLEM DEFINITION

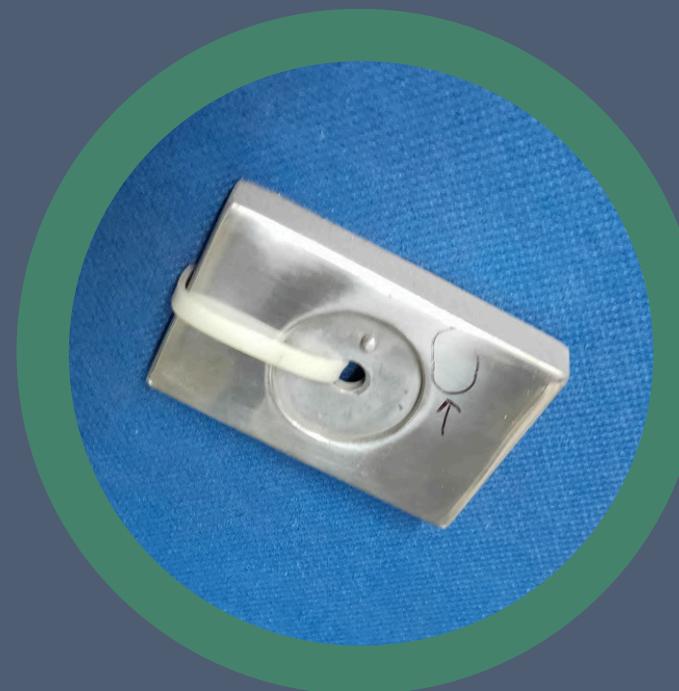
TOOL MARKS

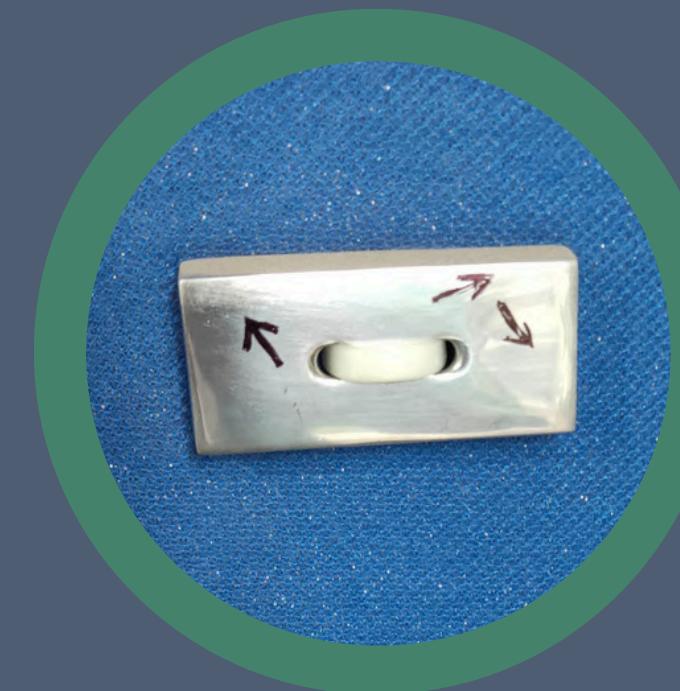
SCRATCH MARKS

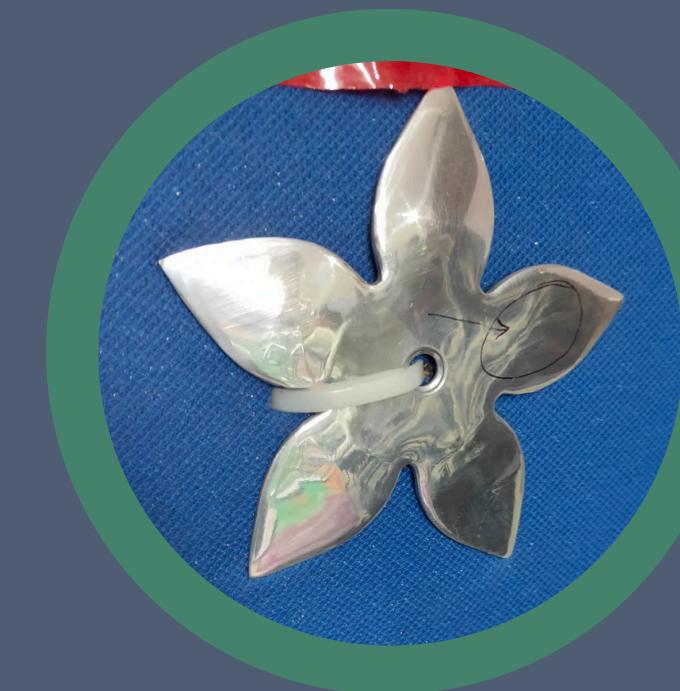
BUFF MARKS

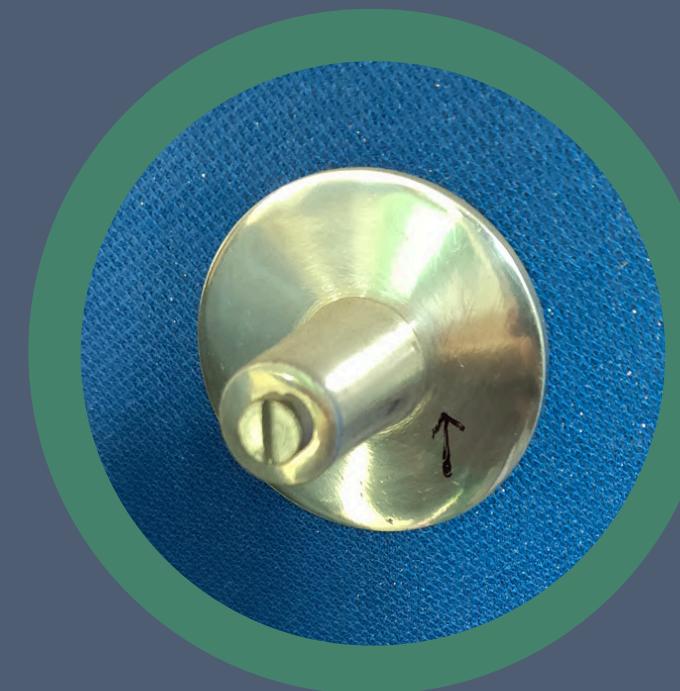
LANCER MARKS

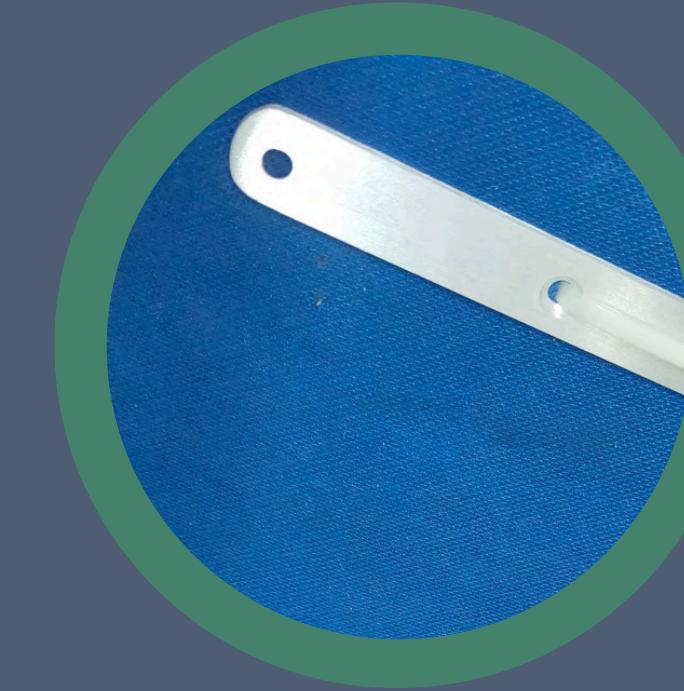
IMPROPER  
POLISHING

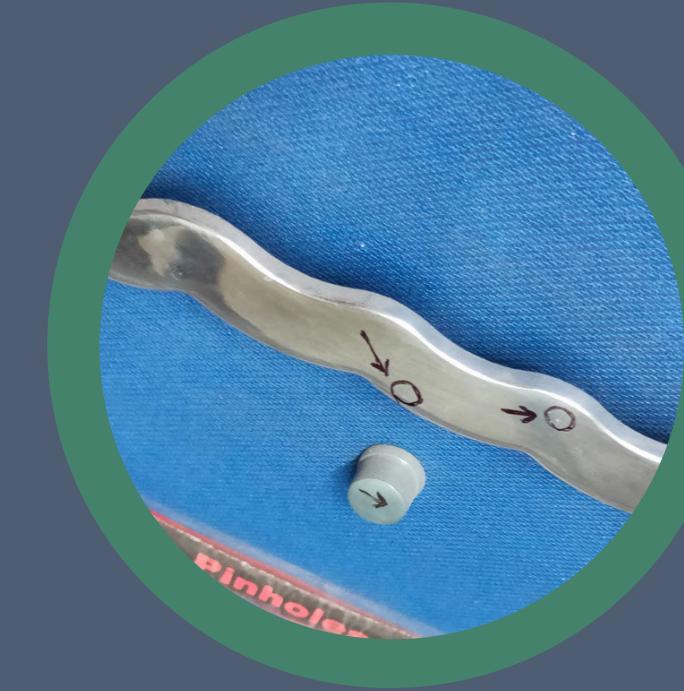
IMPROPER  
TEXTURE

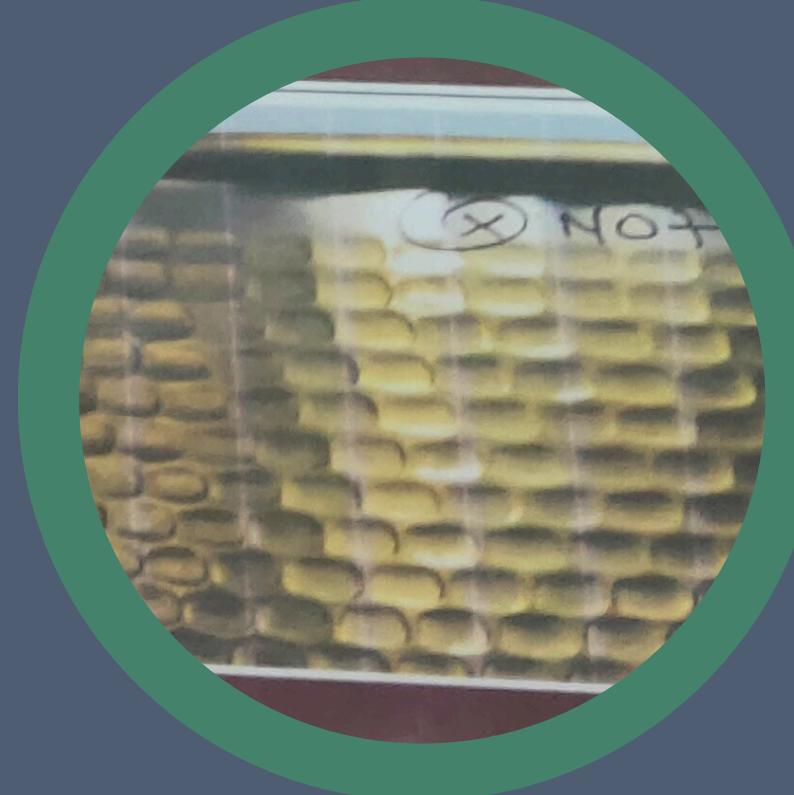
GLOSS / COLOUR  
VARIATION
