# Flood & debris situation report — Rasuwa — Timure to Syabru Bensi (Bhote Koshi)

Event date 26 August 2026 · generated 01 Oct 2026, 17:16 by Baadhi from satellite data · Educational prototype — verify on the ground

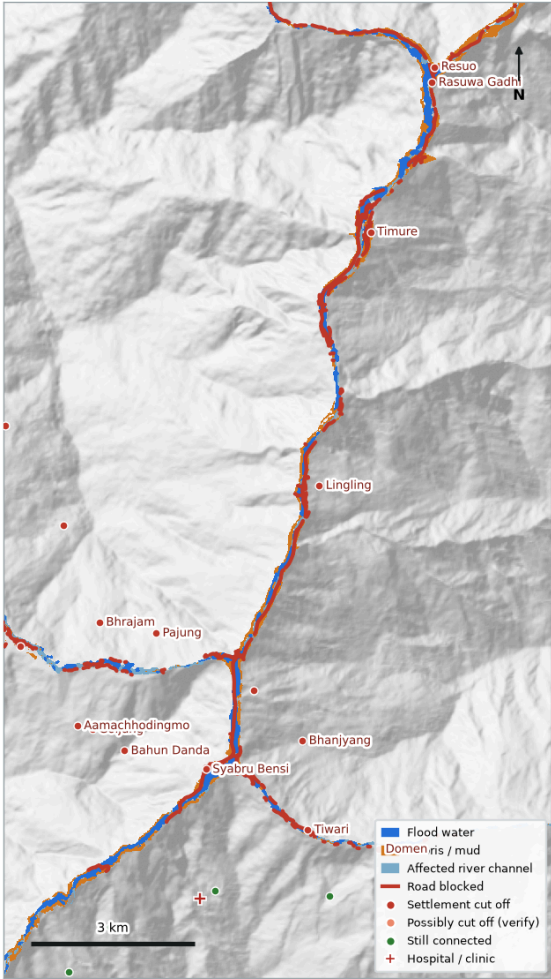
5.11 km<sup>2</sup>

flooded or debris-covered (2.29 km<sup>2</sup> water, 2.04 km<sup>2</sup> debris/mud)
