# Illustrative Construction Drawdown Review

**Fischamend, Lower Austria - Vienna Airport logistics park observation area**

DEMO-EU-AT-FIS-01 | v0.2 TERMINOLOGY REVISION | Large logistics / industrial real-estate development  
Terminology revision of v0.1, 17 Sep 2026. Findings unchanged.

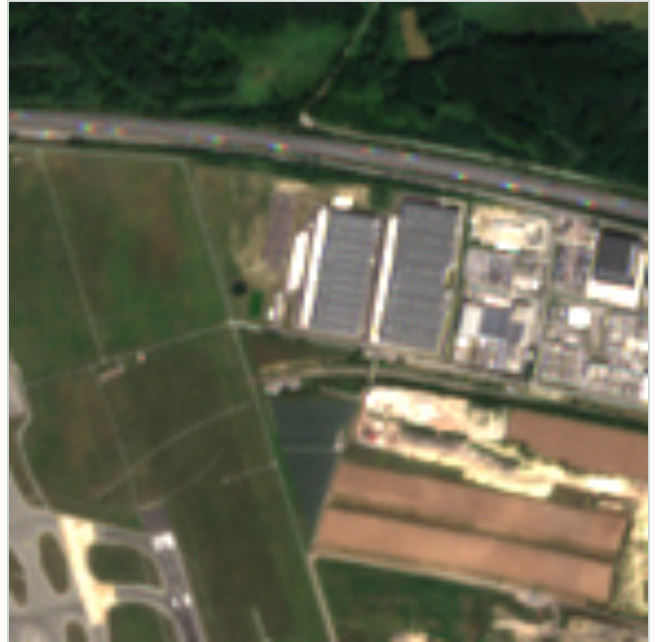
**T1 - 19 AUGUST 2025**

**Between 20 August 2023 and 19 August 2025, two large rectangular roofed structures became visible within the selected observation area, replacing predominantly bare or construction-affected surface.**

The imagery directionally supports the hypothetical review question. It does not establish building completion, quality, fit-out, occupancy, environmental compliance, contractual acceptance or payment eligibility.

**Which dated documentary and engineering records should the responsible reviewer examine to test quantities, acceptance criteria, environmental conditions and any institution-specific payment conditions?**
