# Illustrative Construction Drawdown Review

## Fischamend, Lower Austria - Vienna Airport logistics park observation area

DEMO-EU-AT-FIS-01 | v0.2 TERMINOLOGY REVISION | Large logistics / industrial real-estate development  
Terminology revision of v0.1, 17 Sep 2026. Findings unchanged.

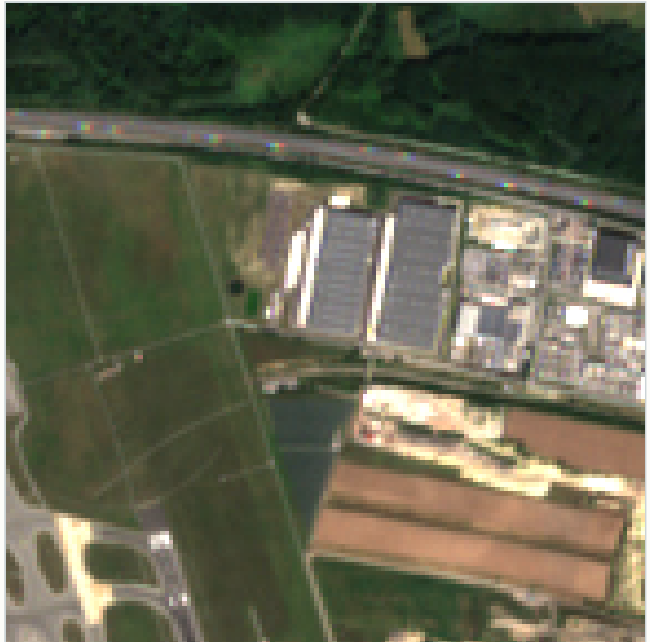
T1 - 19 AUGUST 2025

Between 20 August 2023 and 19 August 2025, two large rectangular roofed structures became visible within the selected observation area, replacing predominantly bare or construction-affected surface.
