# Illustrative Construction Drawdown Review

**Fischamend, Lower Austria - Vienna Airport logistics park observation area**

DEMO-EU-AT-FIS-01 | v0.1 DRAFT | Large logistics / industrial real-estate development

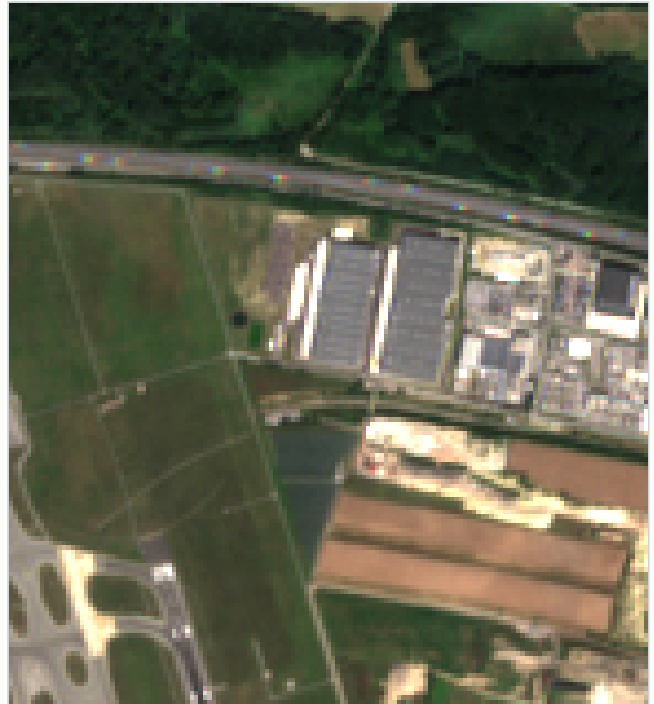
T1 - 19 AUGUST 2025

Between 20 August 2023 and 19 August 2025, two large rectangular roofed structures became visible within the selected observation area, replacing predominantly bare or construction-affected surface.

The imagery directionally supports the synthetic review question. It does not establish building completion, quality, fit-out, occupancy, environmental compliance, contractual acceptance or payment eligibility.

Which dated documentary and engineering records should the responsible reviewer examine to test quantities, acceptance criteria, environmental conditions and any institution-specific payment conditions?
