Vibration Assessment Centrifuges Rev 0
Sunday 25th June, 2023

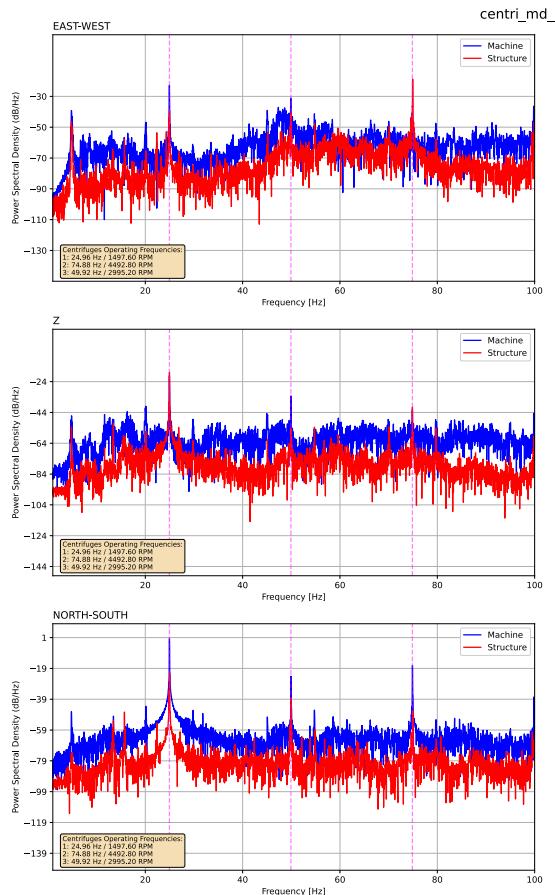
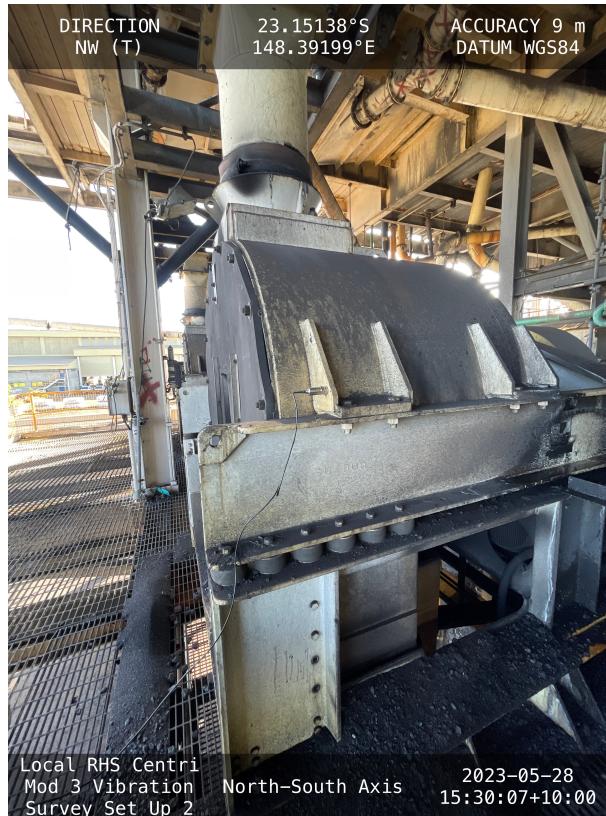
A vibration assessment was carried out in the following centrifuges measuring acceleration above the vibration dampers and in the supporting structure (after the vibration dampers), the following frequencies were identified: [24.96 74.88 49.92] Hz.

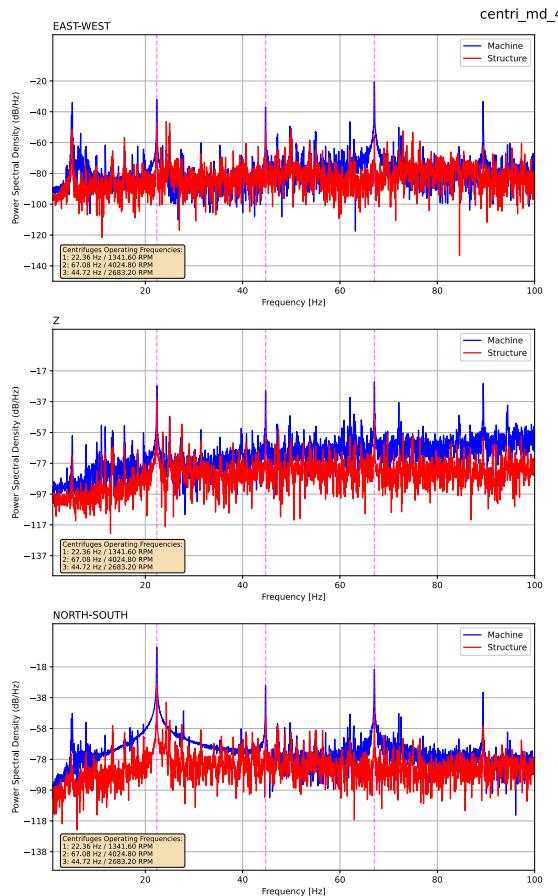
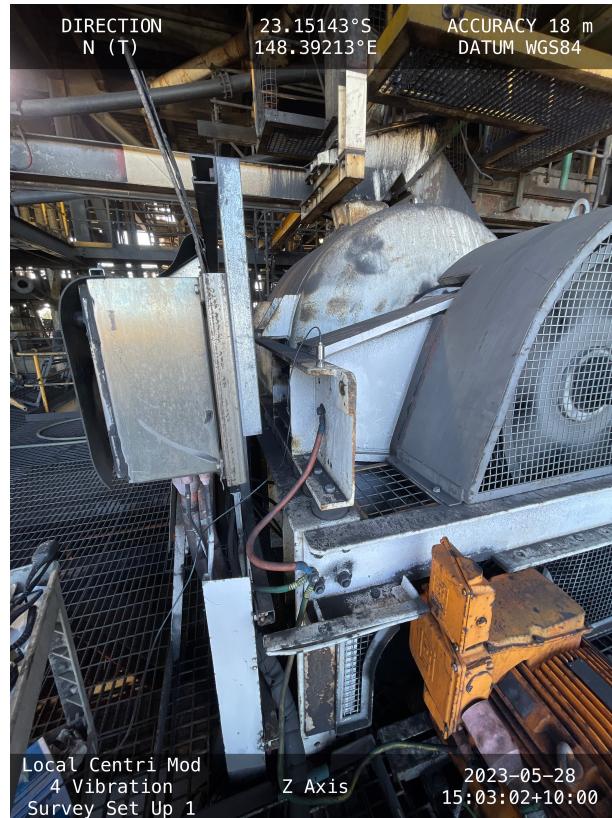
A vibration assessment was carried out in the following centrifuges measuring acceleration above the vibration dampers and in the supporting structure (after the vibration dampers), the following frequencies were identified: [22.36 67.08 44.72] Hz.

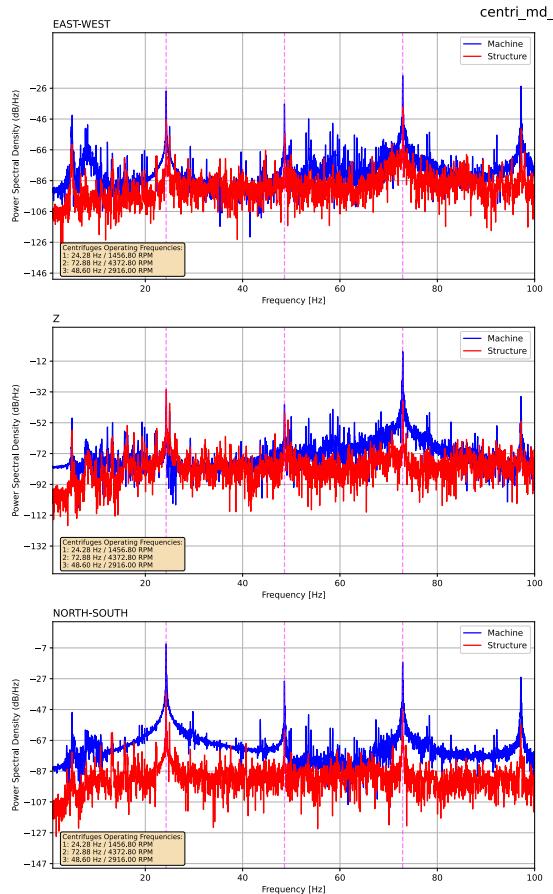
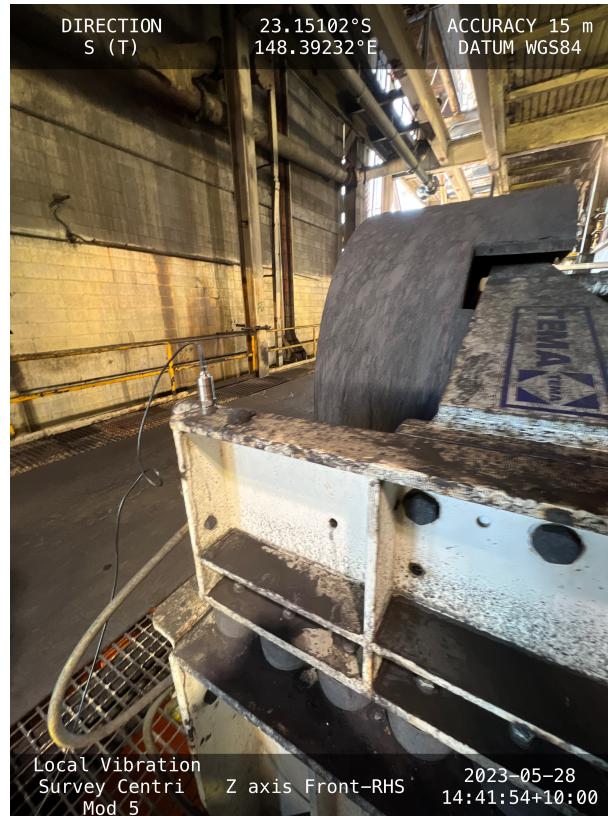
A vibration assessment was carried out in the following centrifuges measuring acceleration above the vibration dampers and in the supporting structure (after the vibration dampers), the following frequencies were identified: [24.28 72.88 48.6] Hz.

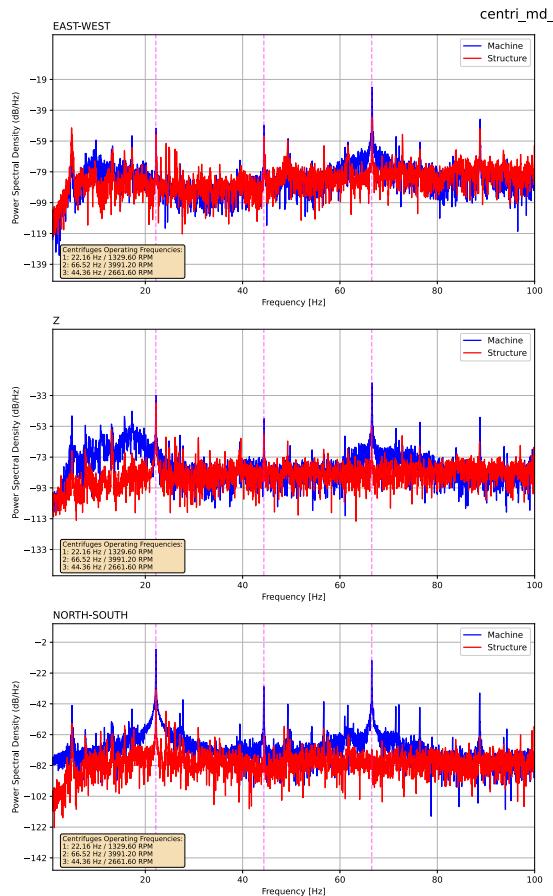
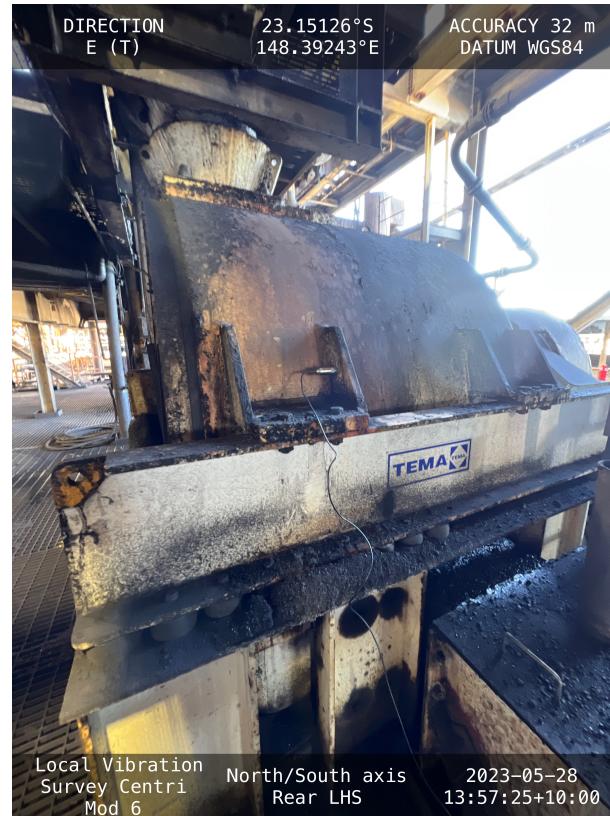
A vibration assessment was carried out in the following centrifuges measuring acceleration above the vibration dampers and in the supporting structure (after the vibration dampers), the following frequencies were identified: [22.16 66.52 44.36] Hz.
