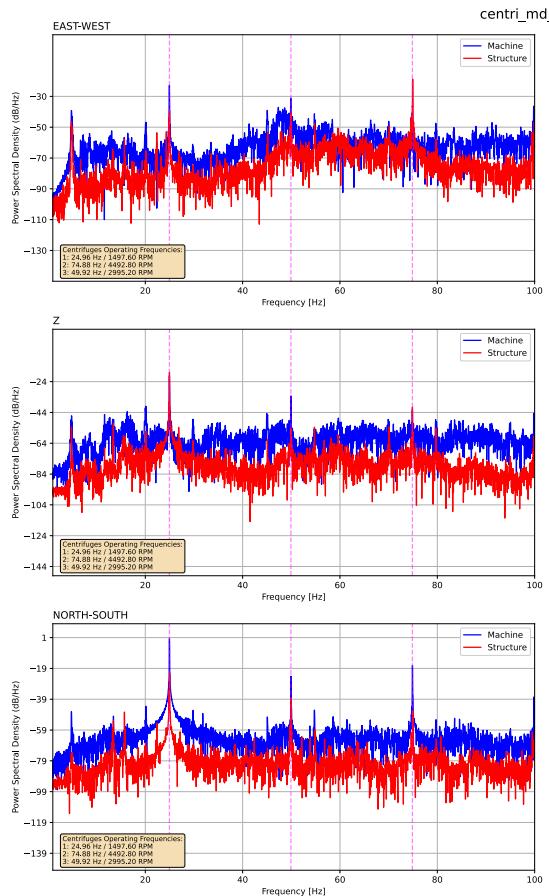
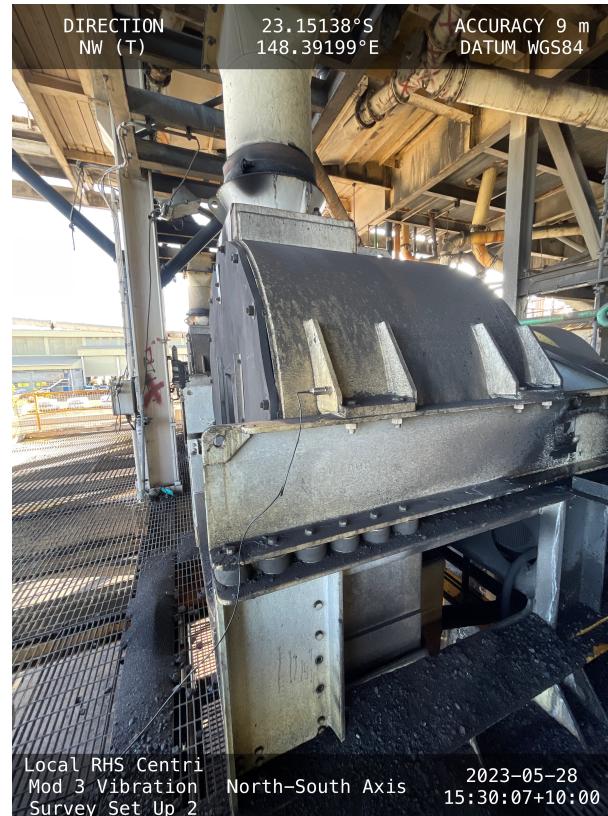
A vibration assessment was carried out in the following centrifuges measuring acceleration above the vibration dampers and in the supporting structure (after the vibration dampers), the following frequencies were identified: [24.96 74.88 49.92] Hz.

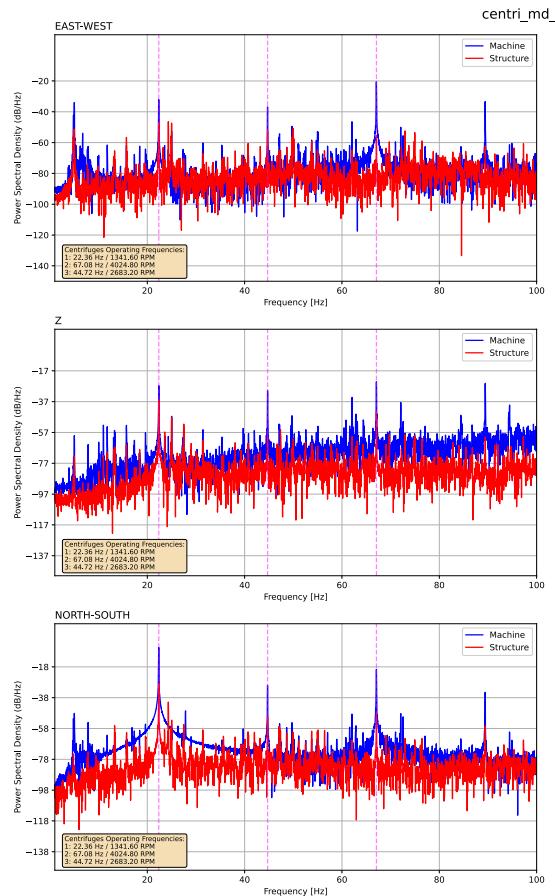
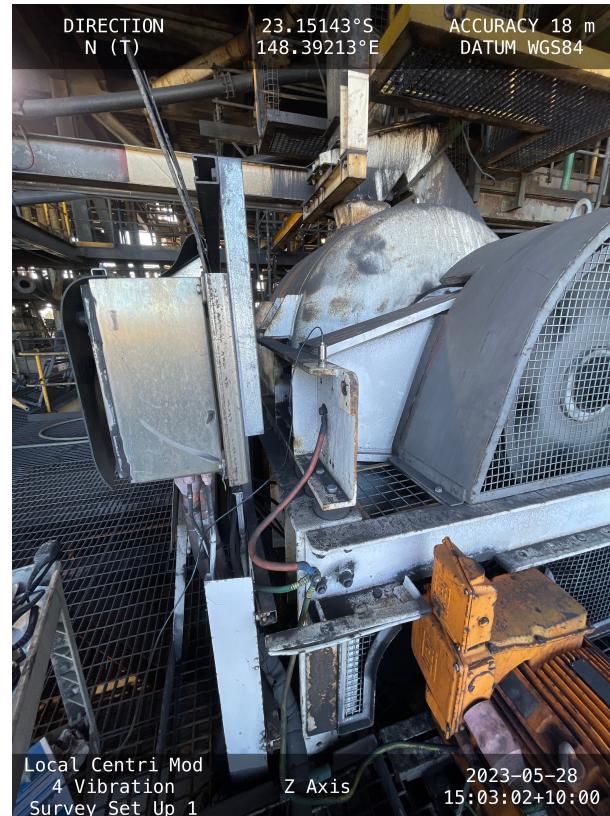
A vibration assessment was carried out in the following centrifuges measuring acceleration above the vibration dampers and in the supporting structure (after the vibration dampers), the following frequencies were identified: [22.36 67.08 44.72] Hz.

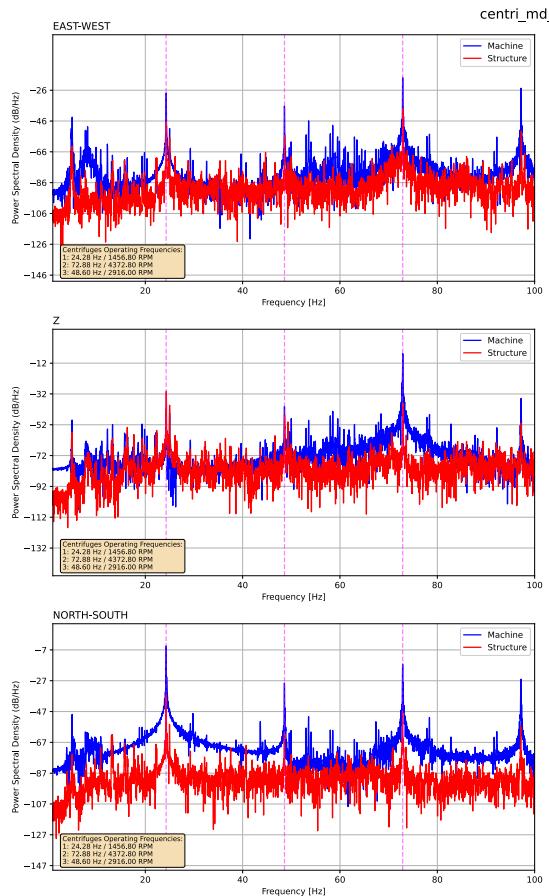
A vibration assessment was carried out in the following centrifuges measuring acceleration above the vibration dampers and in the supporting structure (after the vibration dampers), the following frequencies were identified: [24.28 72.88 48.6 ] Hz.

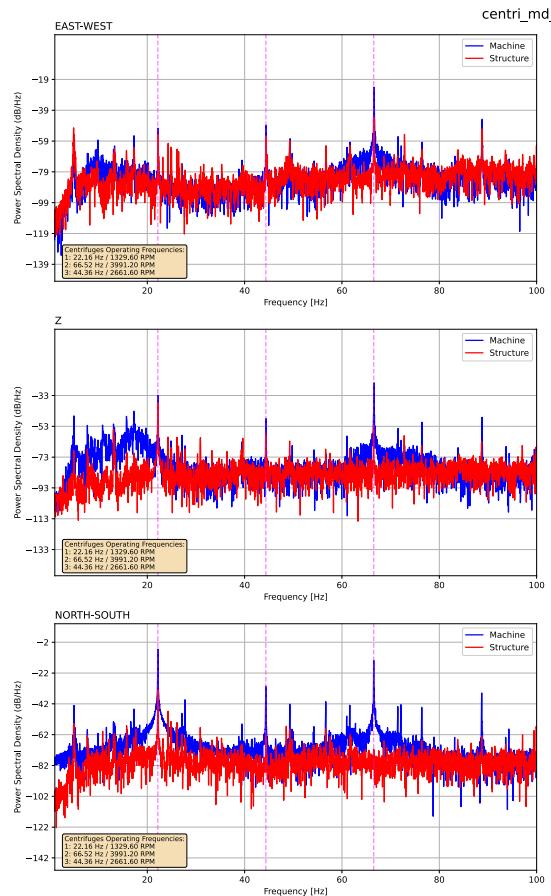
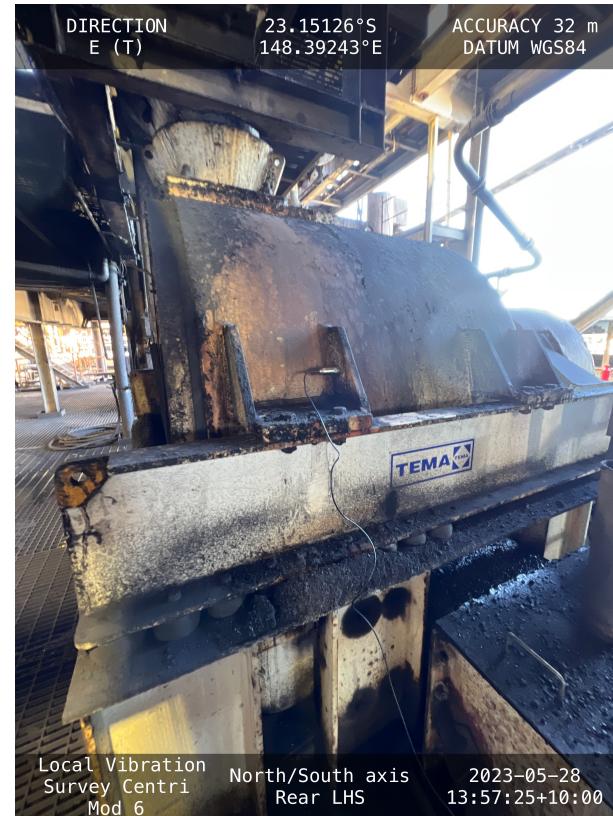
A vibration assessment was carried out in the following centrifuges measuring acceleration above the vibration dampers and in the supporting structure (after the vibration dampers), the following frequencies were identified: [22.16 66.52 44.36] Hz.
