**Remediation Guideline
REV 0****Asset: ROM STRUCTURE (ROM 2)
Location: Grizzly Bridge**

DEFECT INFORMATION**Risk Rating**

Extreme – E19

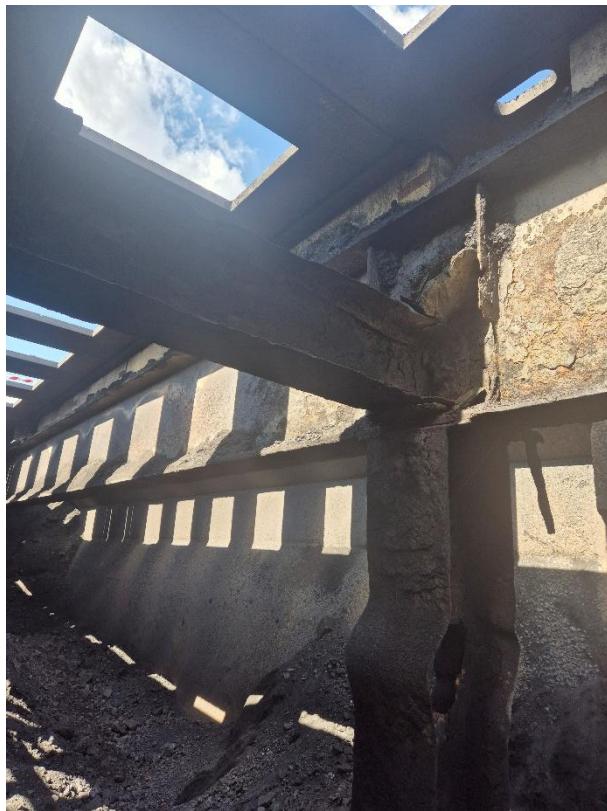
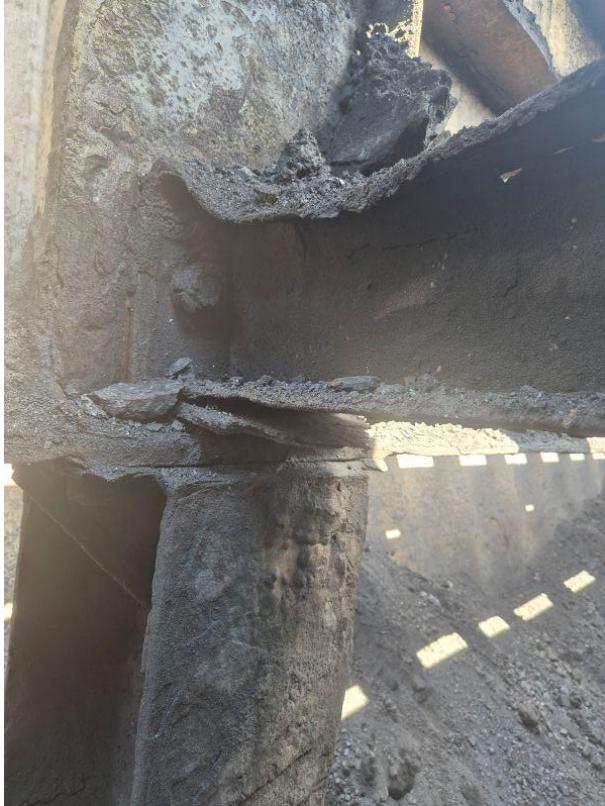
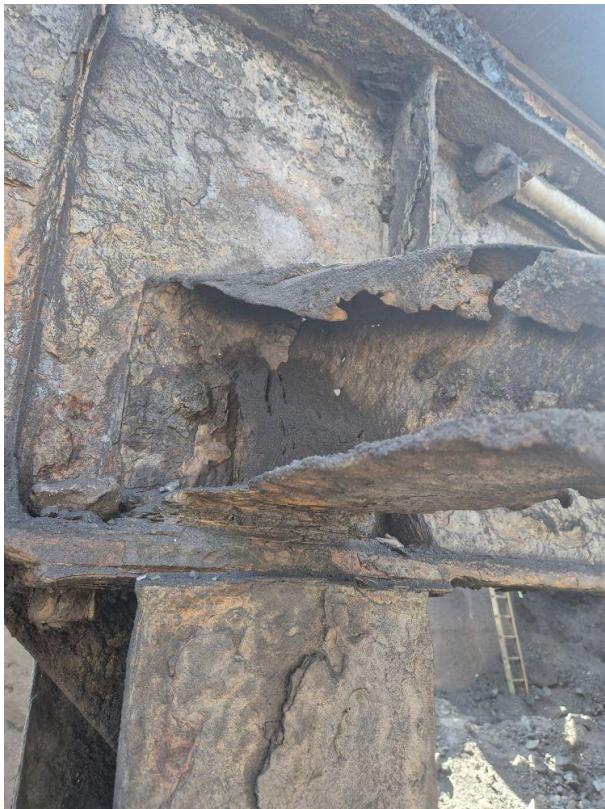
- Defect Description:**
- The 250UC steel cross bracing is heavily corroded and visibly deformed.
 - Bracing is considered unserviceable and no longer providing adequate structural restraint.
- Repair Required:**
- Full removal and replacement of affected cross bracing with new steel bracing of equivalent dimensions, installed to match original support pattern.
- Reference Drawings:**
- J718MCA001-3
 - J718MCA002-3

Midspan cross bracing between main girders on ROM 2 – Grizzly Bridge.
