**Remediation Guideline**  
**Defect:** LS-7

**Asset:** CHPP Centrifuge Floor  
**Location:** Module 5, Grid F3-G3

**Purpose:** This document outlines the governance framework, procedures, and compliance requirements for the replace of steel bracings (Defect LS-7) on the CHPP Centrifuge floor (Module 5, Grid F3-G3). The repair process addresses structural damage caused by continuous mining operations and degradation over time, ensuring compliance with Australian Standards AS4100.

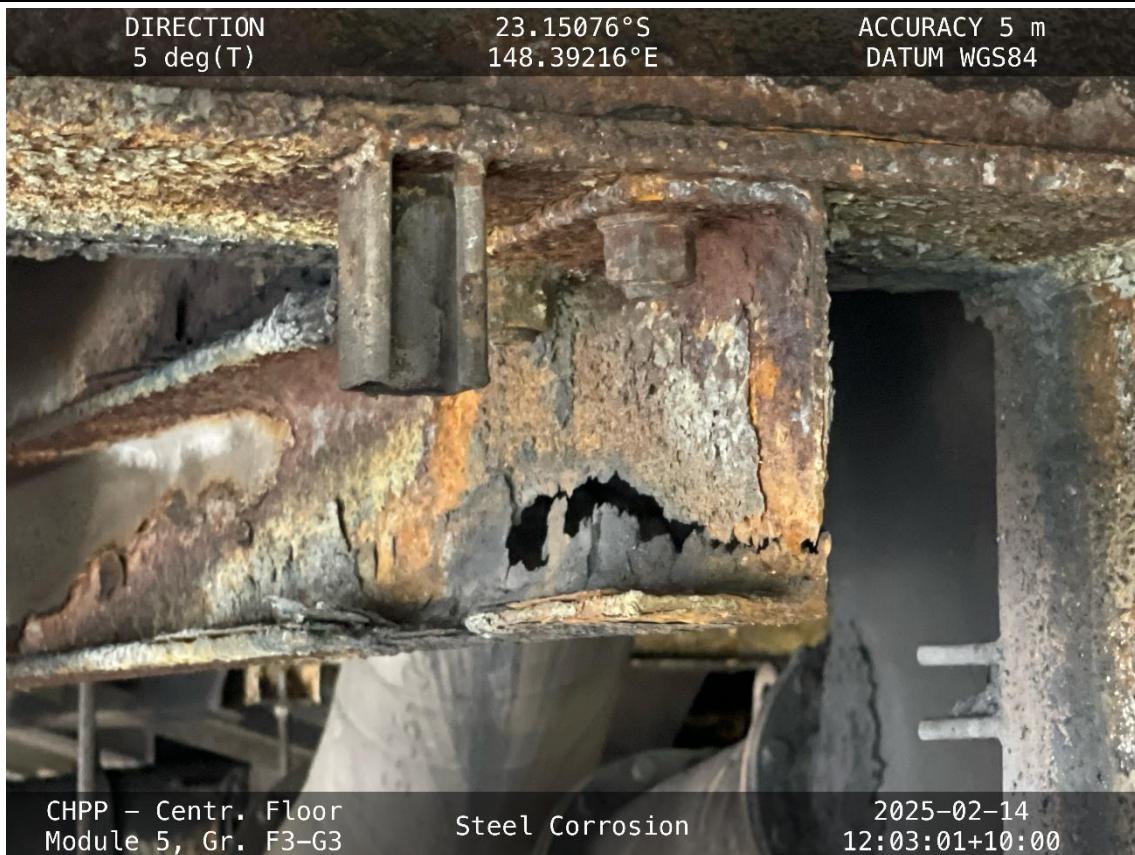
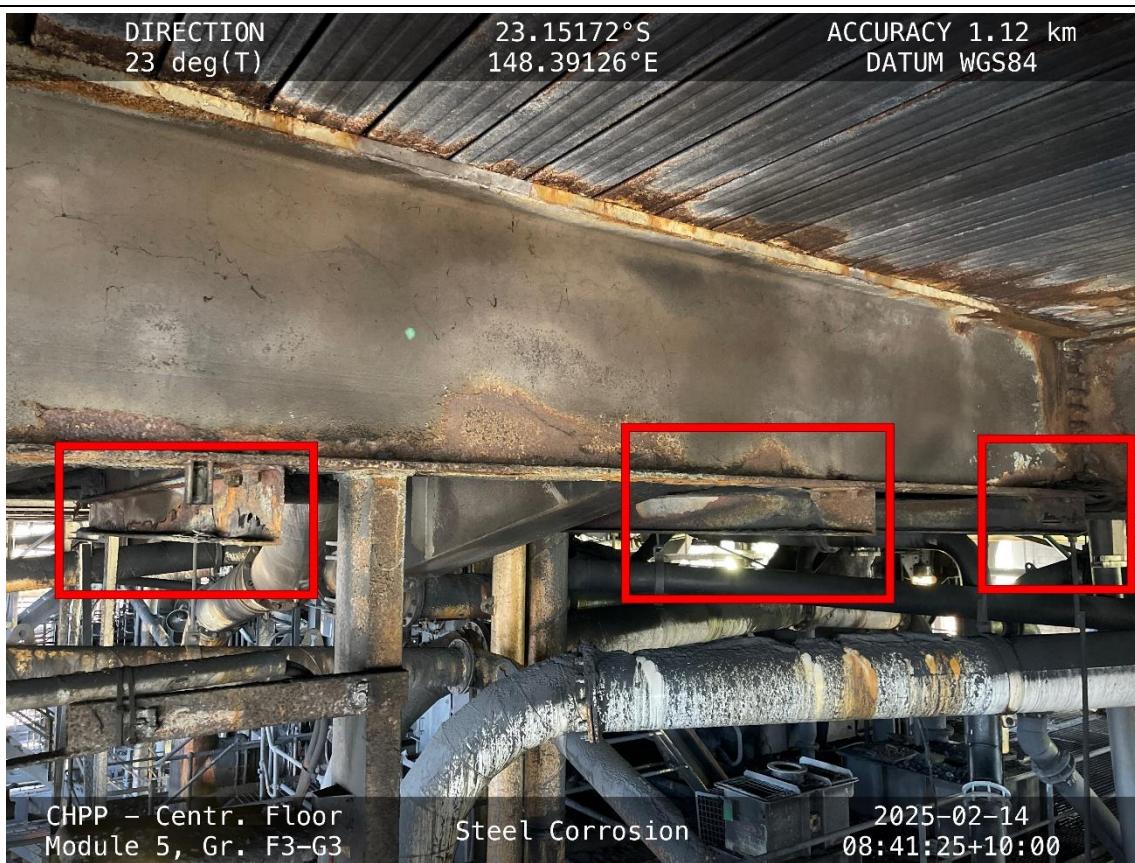
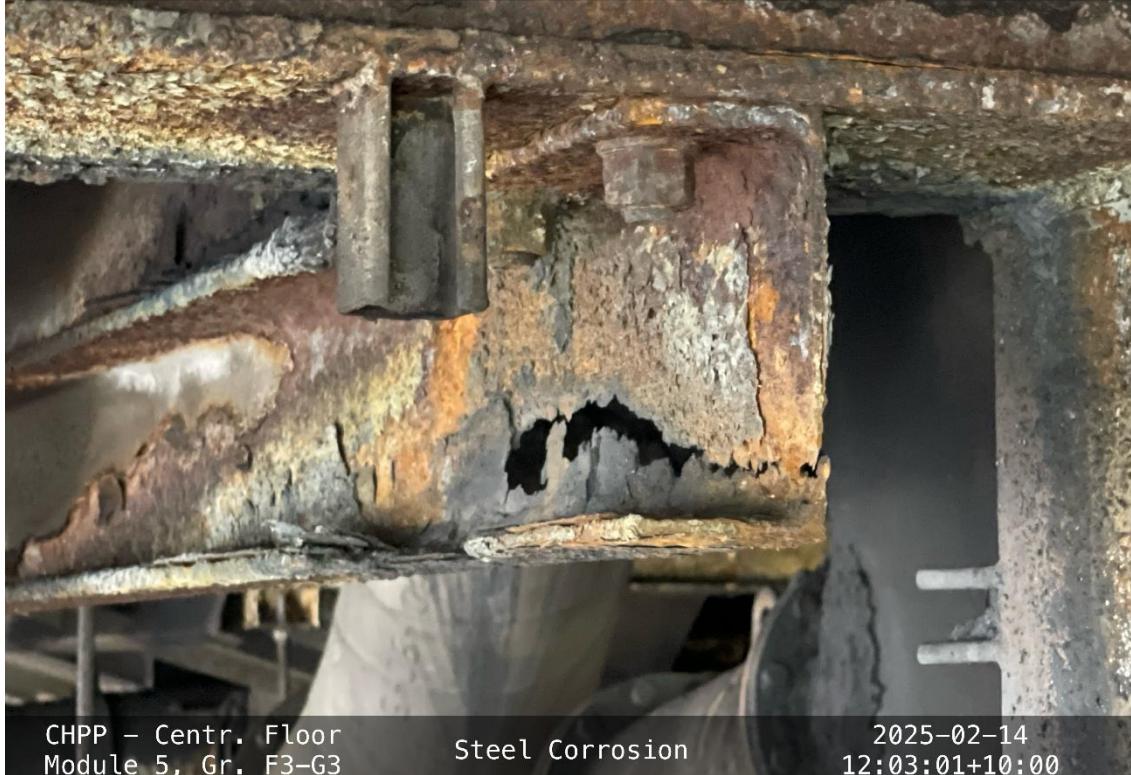
Severe corrosion with significant material loss was observed on the structural frames including purlins and connections, located in Module 5, between Grid F3-G3. This deterioration has reduced the structural capacity, increasing the risk of compromised stability. The damage is likely due to prolonged exposure to a corrosive environment. If left unaddressed, further degradation may lead to structural failure, increased maintenance costs, and operational disruptions. It is recommended to restore the original cross-section and ensure structural integrity through material replacement and the application of a protective coating.

Extreme [18]

Secure the bracing using the designated lifting system for the repair works.

Remove the bolts at each end of every bracing member.

Lower the bracing slowly to the laydown area.

Adjust the length of the braces using the previously removed bracing as reference.

Drill holes at the ends of each brace where the bolts will be installed.

Lift the braces using the designated lifting system and align the brace holes with those on the support beams.

Apply lubricant into beam holes and insert bolts.
