**Frank Mohn Services AS**

**NO. 3 - 1990**

# Service Bulletin

## How to obtain the best stripping result on existing "FRAMO" ships

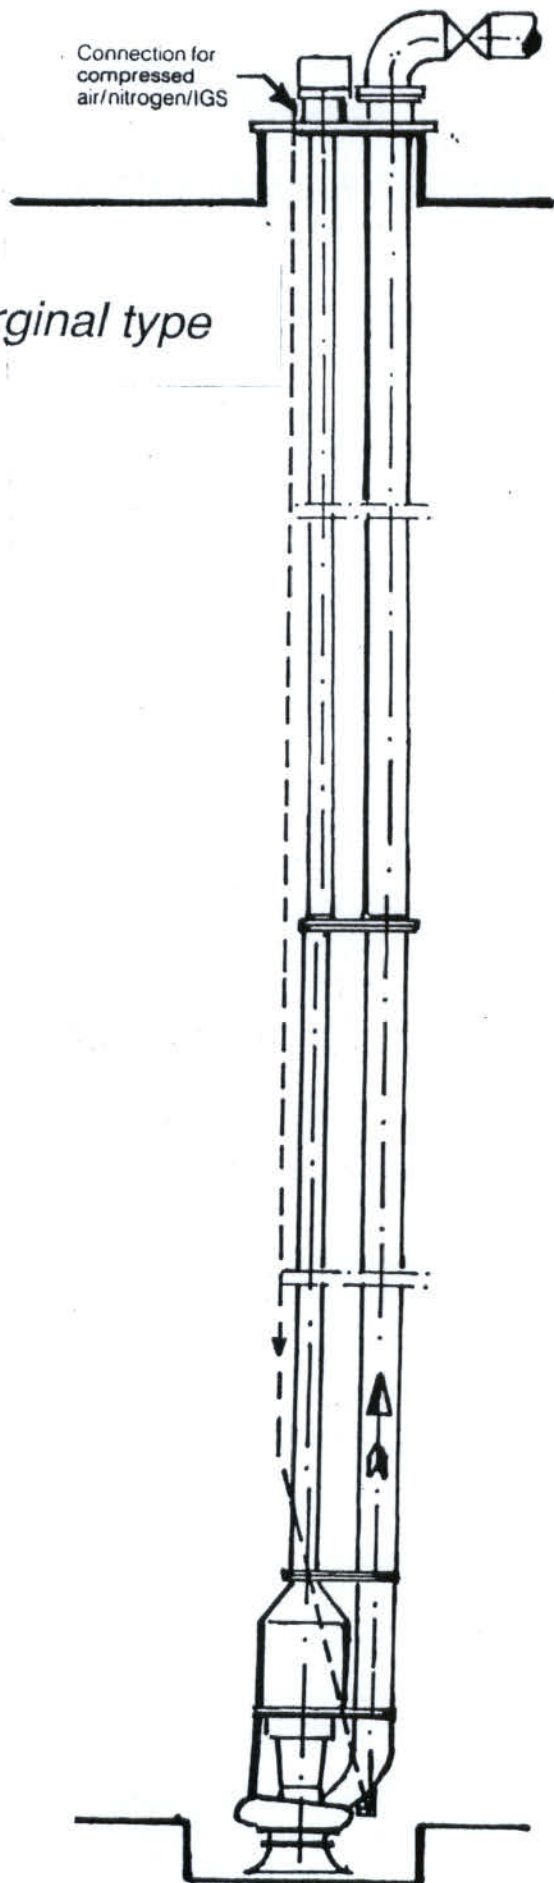
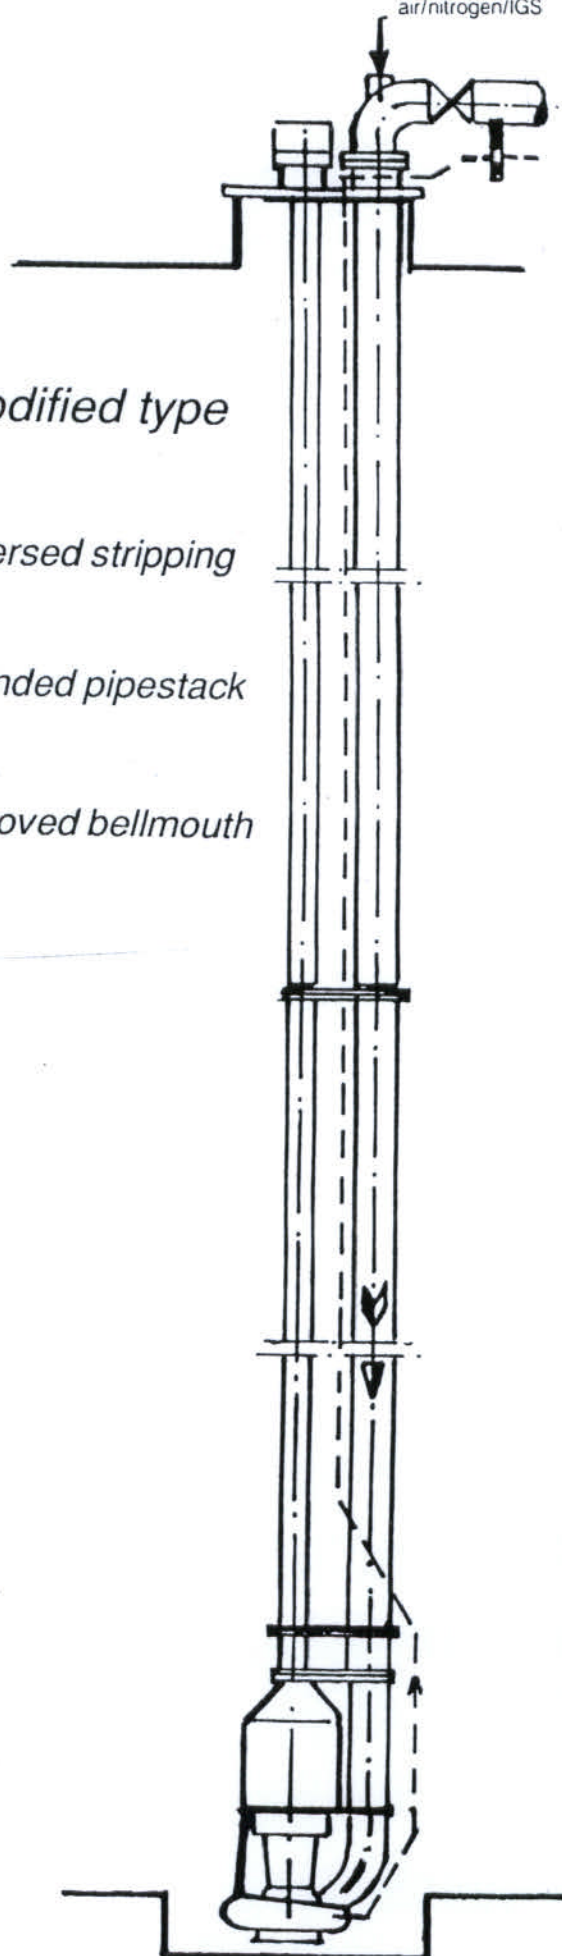
# Improved stripping on old pumps

- *Original type*

- *Modified type*

- *Reversed stripping*

- *Extended pipestack*

- *Removed bellmouth*

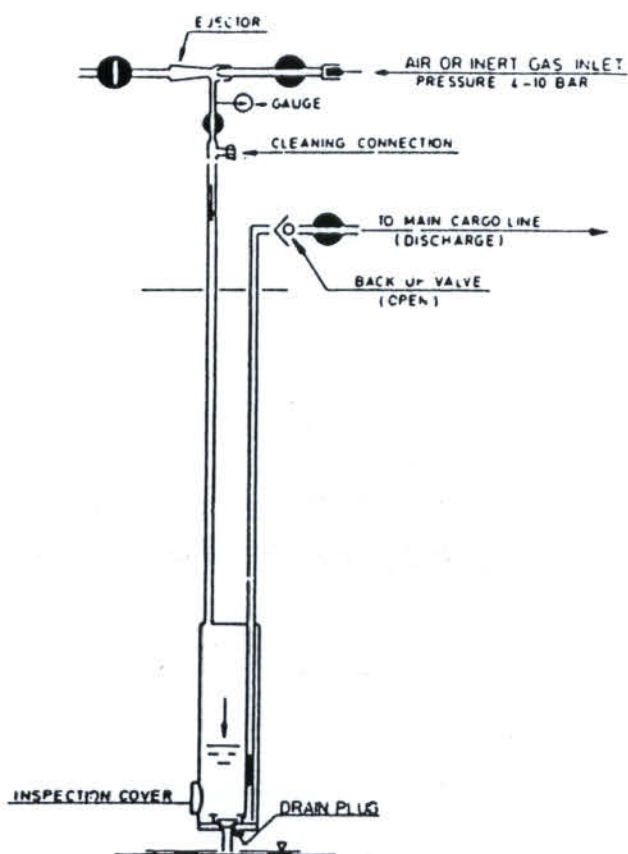
I DISCHARGE

# FRAMO Super-strip

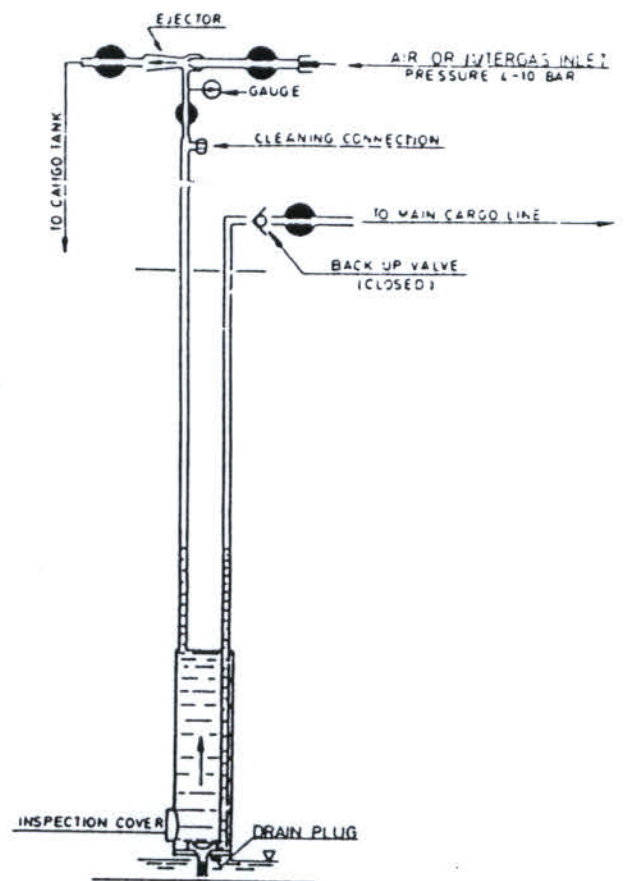
II EVACUATION

Installed on bulkhead or on pumpstack

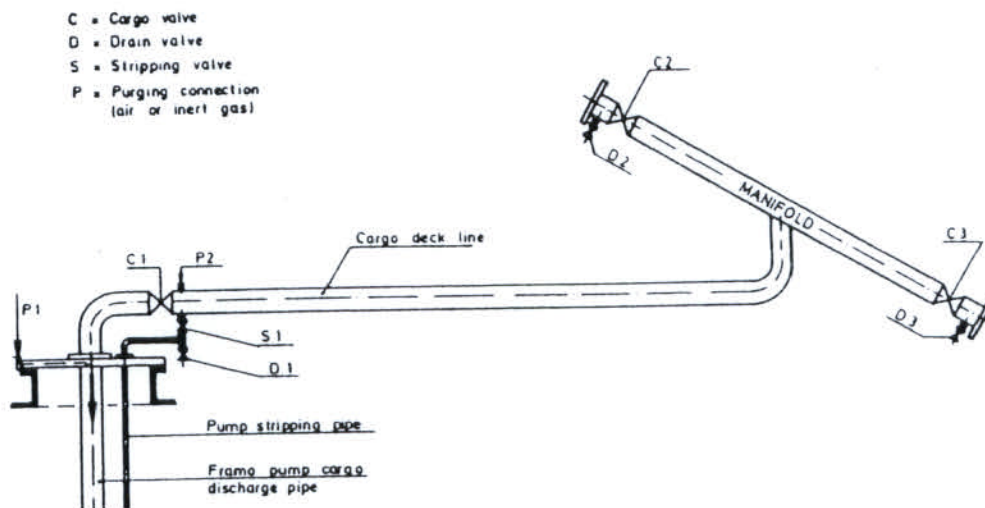
Fig. 1

## PROCEDURE FOR CARGO SYSTEM WITHOUT SPECIAL STRIPPING PIPE (SEE FIG. 1)

### WITHOUT STRIPPING PIPE

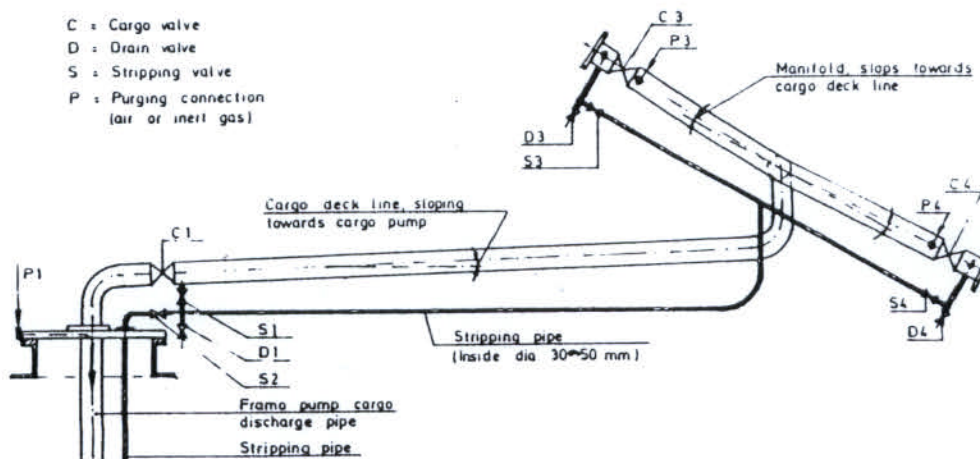
Fig. 2

## PROCEDURE FOR CARGO SYSTEMS WITH SPECIAL STRIPPING PIPE (SEE FIG. 2)

### WITH STRIPPING PIPE
